# Space Needs Analysis Bristol Municipal Buildings

## Police Department

131 North Main

**Mechanical and Electrical Systems**  
**Existing Conditions Narrative**

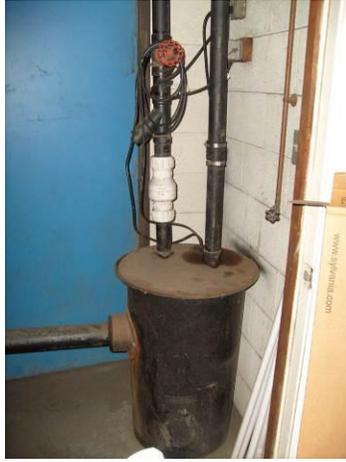
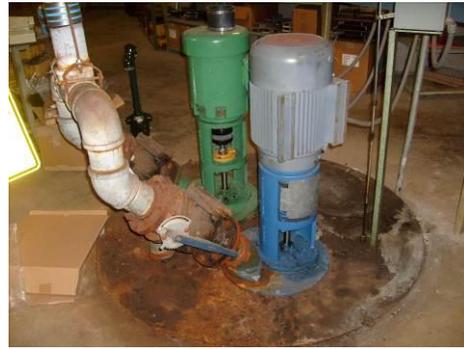
- a. The sanitary sewer system provides sanitary waste drainage for plumbing fixtures located throughout the building. The piping material above grade is primarily cast iron. The plumbing fixtures drain to buried sanitary waste piping to the buildings exterior and to the municipal sewer system. In the lower level of the Police building, sewage ejector pumps are installed to pump the waste into the municipal sewer system. These pumps are in poor condition.

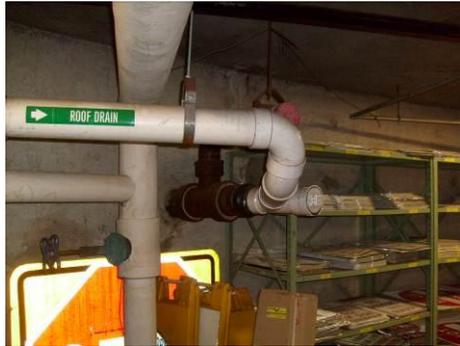
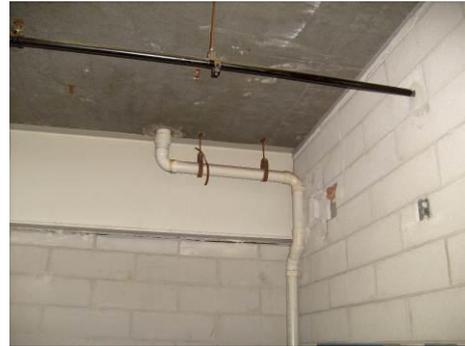
- a. The storm piping is primarily cast iron and drains to the municipal storm water system. Some of the original piping has been replaced with PVC piping. There are no secondary roof drains or strainers on the existing roof drains. Domed strainers should be added to the roof drains to keep debris out of the storm water system.

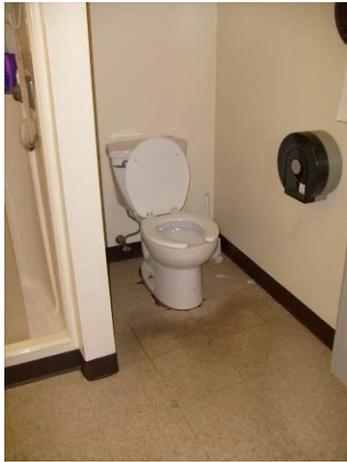
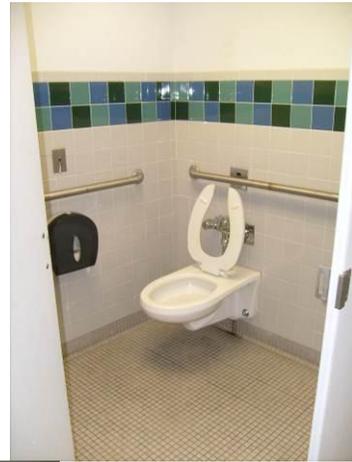
- Water closets are floor or wall mounted; flush valve, vitreous china. Some of the fixtures have been replaced with water conserving fixtures with sensor operated flush valves. The fixtures range from original to the facility in fair condition to new in very good condition. The original fixtures are non-water conserving type and non-ADA compliant.

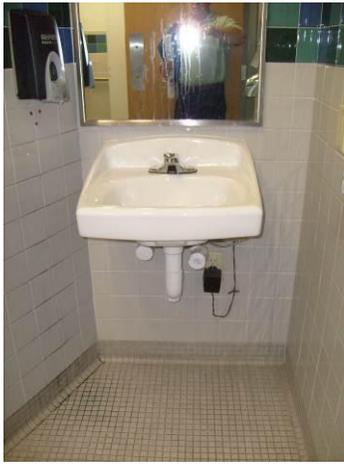
- Lavatories are wall hung vitreous china. Some of the fixtures have been replaced with water conserving fixtures with sensor operated faucets. The original fixtures have two lever handle faucets. The fixtures range from original to the facility in fair condition to new in very good condition. The original fixtures are non-water conserving type and the faucets and drains are non-ADA compliant.

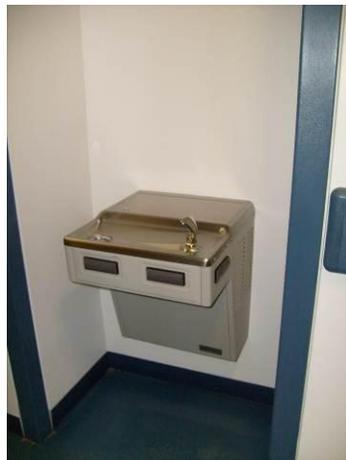
- Drinking fountains are wall mounted stainless steel units in good condition. The amount these units protrude into the path of travel should be reviewed for compliance with current ADA requirements.

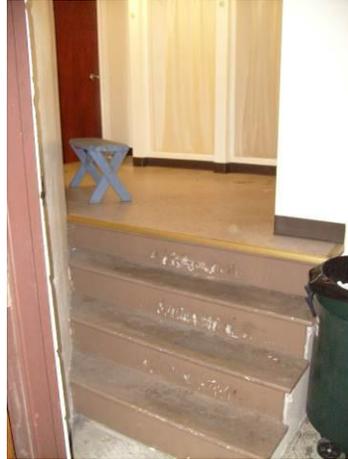
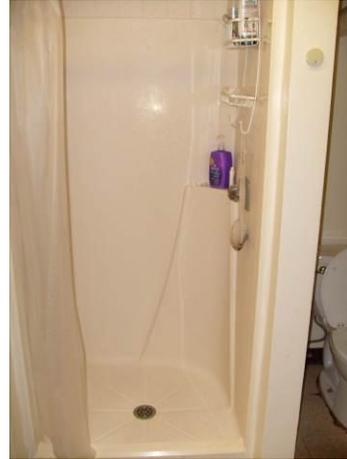
- In the Police Headquarters, there is a single shower located in the lower level training room, up a small flight of stairs. This shower is a fiberglass unit and in good condition. The location of this shower is not ADA accessible.

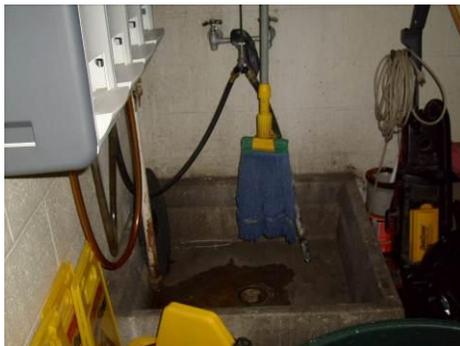
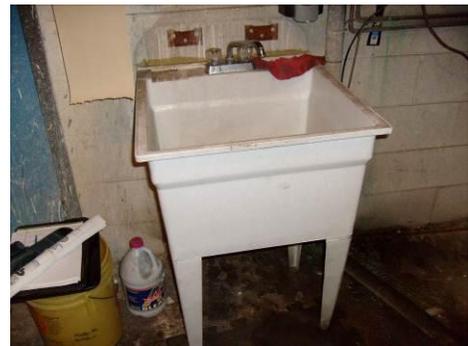
- Janitor sinks are floor mounted cast stone units with two lever faucets or pedestal mounted fiberglass units with two lever faucets. There is no vacuum breaker present at these sinks. The sinks are in fair to good condition.

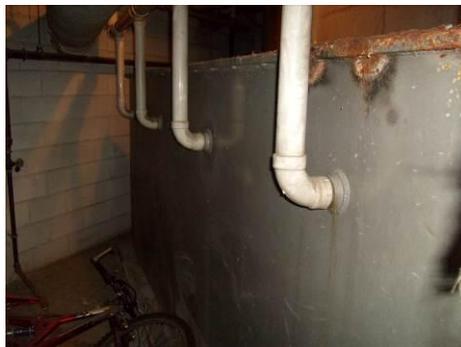
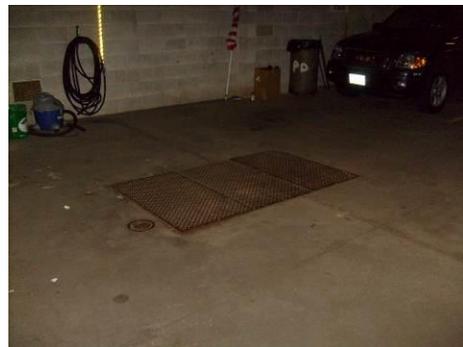
3. There are oil/water separators located in the parking garage. (1) is located above grade and one is located in the floor of the lower level. This equipment is original to the facility and in poor condition.

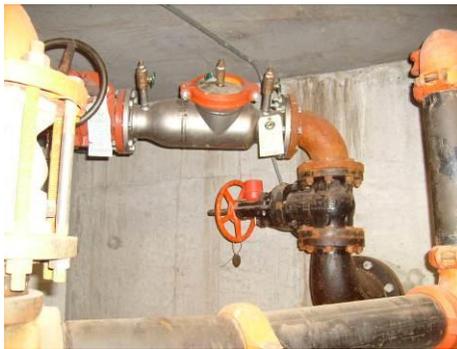
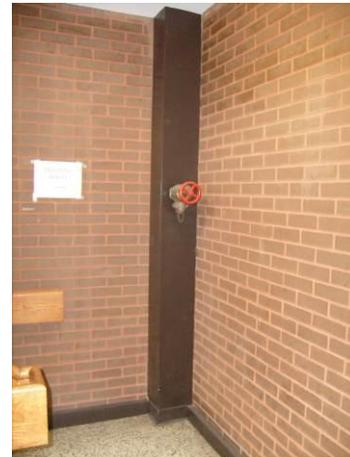
1. The building is served by a 6" fire protection service fed from a fire main in North Main Street. This fire service includes a shut-off valve and Watts Model 774 double check valve. The buildings are protected throughout with a full sprinkler system. There are also standpipes located in the stairs. This backflow preventer equipment has been recently installed and is in good condition. The remainder of the piping and most of the sprinkler heads are original to the building. The sprinkler heads and fire protection piping in the Police Headquarters was modified during the last renovation.

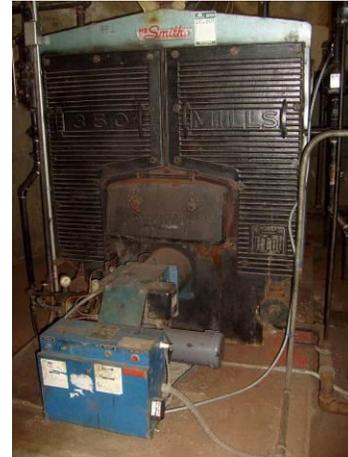
1. The existing building is heated by (2) H.B. Smith 350 Mills, 13-section oil fired steam boilers with Power Flame Model C30-04HBS-10-14 oil burners. There is a separate oil fired boiler that serves the cell block area. It is a Weil McClain Series 78, Model 478 hot water boiler with a Carlin Model 201 CRD-w oil burner. The H.B. Smith boilers, burners, and breeching are original to the building and in poor condition. The Weil McClain equipment is newer and in good condition.

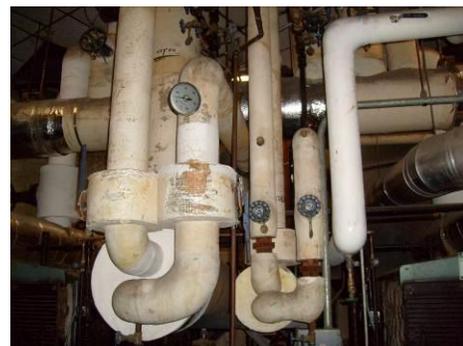
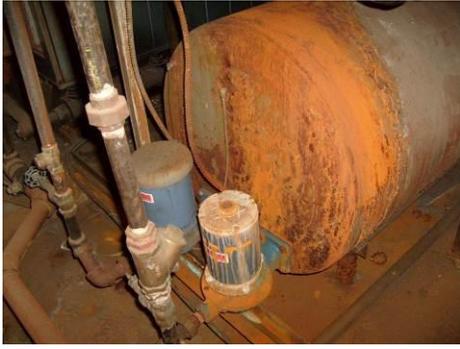
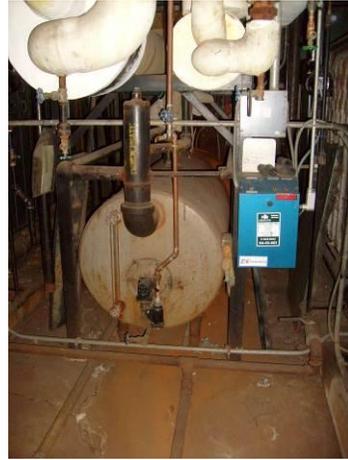
2. The heating plant also includes a condensate receiver, boiler feed system, hot water heat exchanger, condensate receivers, and hot water pumps. All of this equipment is original to the facility and poor condition.

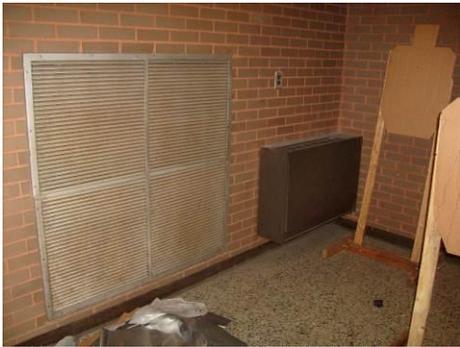
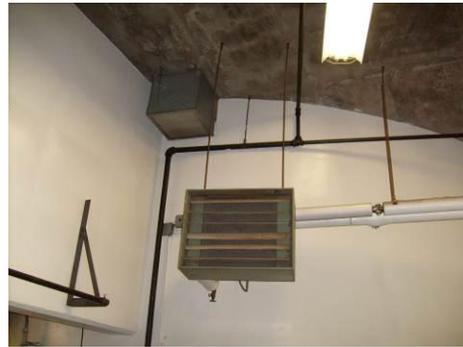
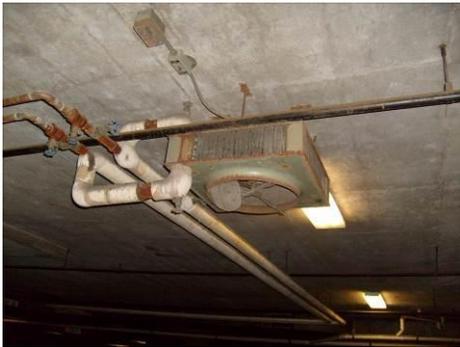
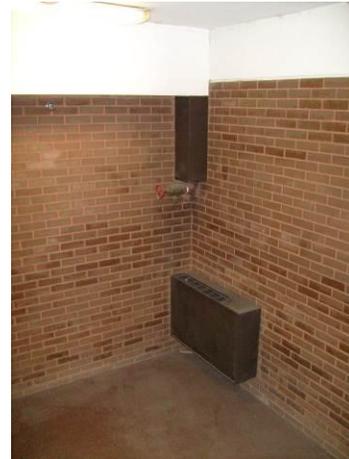
3. The present heating system also includes cabinet unit heaters, and ceiling mounted unit heaters and steam coils in the air handling equipment. This equipment is original to the building and in poor condition.

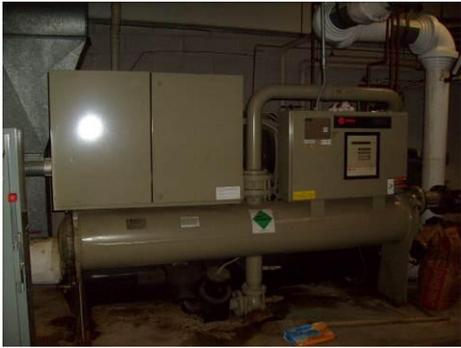
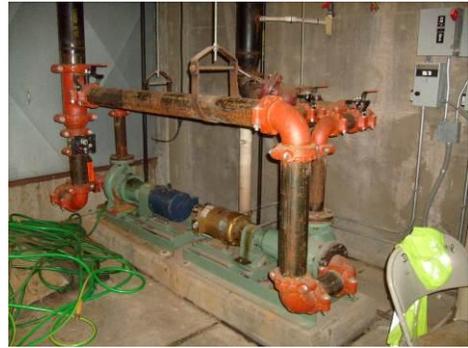
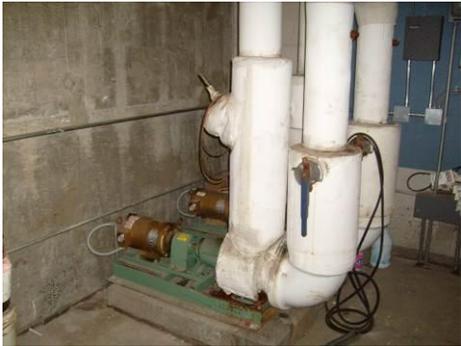
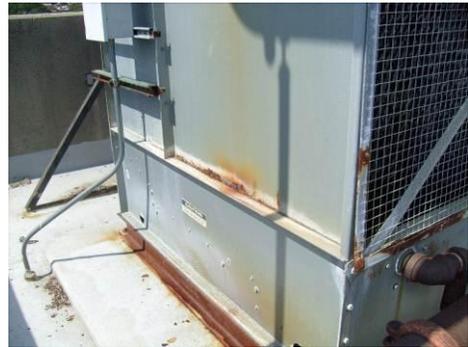
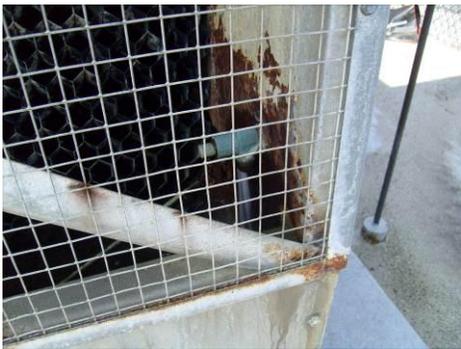
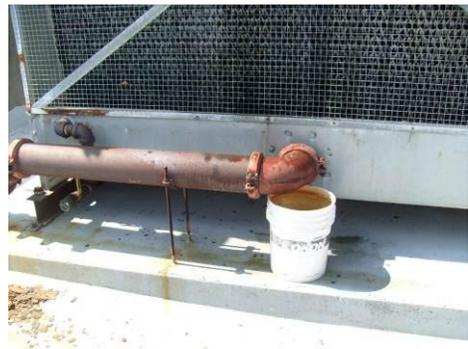
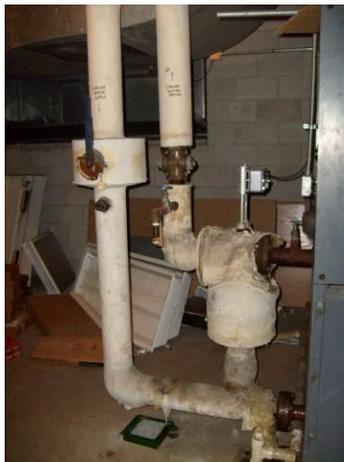
4. The air conditioning system consists of a Trane Series R Centravac chiller, Model RTHB150FMCOONW0000UNN3LF2LF00QU chiller installed in 1996. This chiller is shared between the two buildings. The chiller is in good condition. There is a cooling tower mounted on the roof of the parking facility that is in very poor condition. This piece of equipment has significant corrosion problems and the maintenance staff has made many attempts to repair this sump which has allowed this unit to operate.

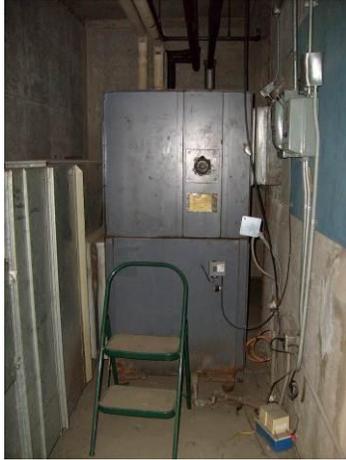
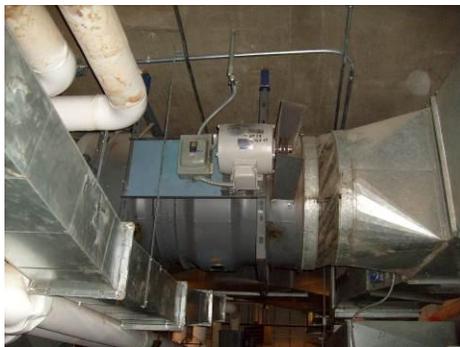
5. The air handling equipment is Trane Climate Changer units that serve as heating and air conditioning units or air conditioning units only. There are also large exhaust/return air fans. This equipment is located in mechanical rooms within the buildings and are original to the facility and in poor condition.

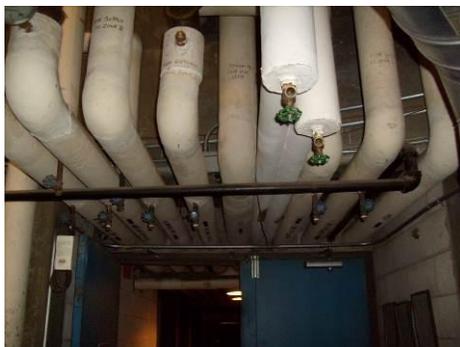
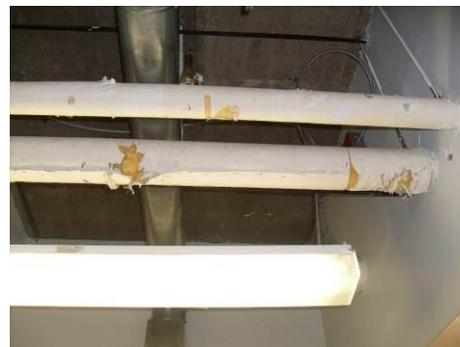
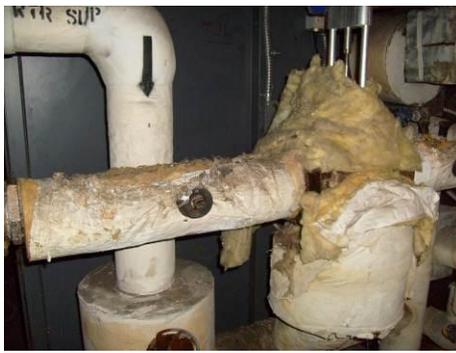
6. The steam and chilled water piping consists of iron supply and return piping. This piping is original to the facility and the steam condensate piping is more than likely in poor condition. There are a number of areas where the pipe insulation has been damaged and should be repaired.

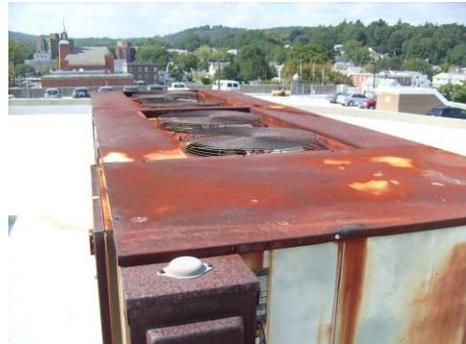
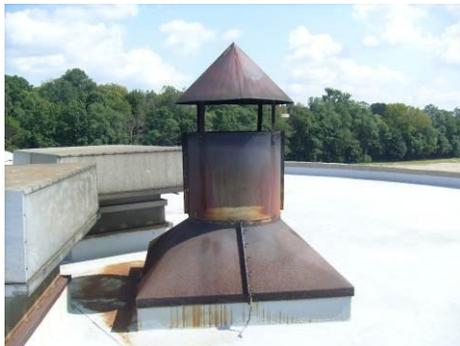
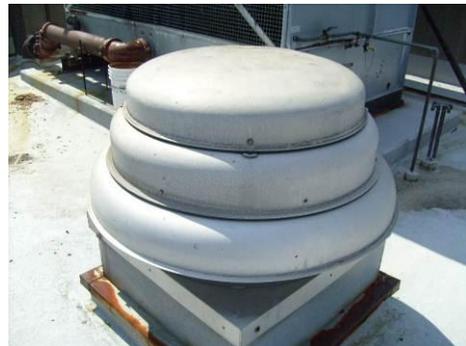
7. The roof mounted equipment consists of exhaust fans, condensing units, etc. This equipment is original to the building and in poor condition.

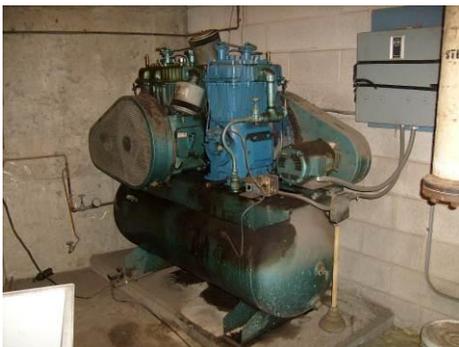
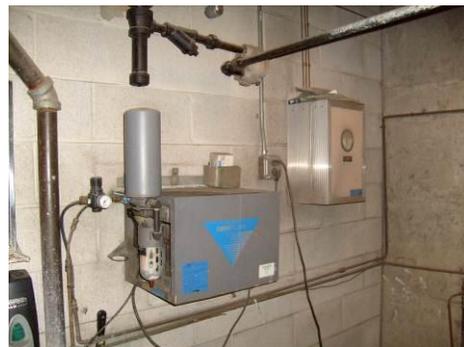
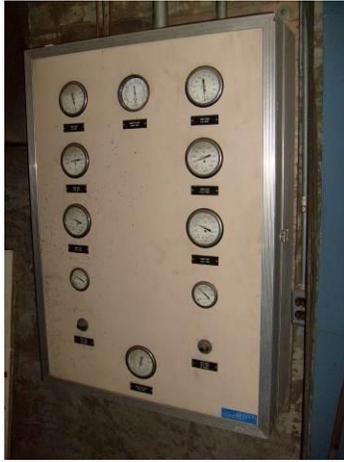
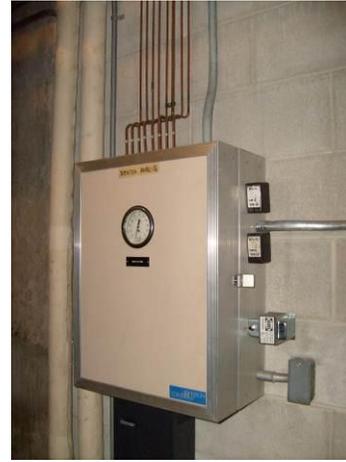
8. The existing temperature control system consists of a pneumatic system by Johnson Controls. This includes an air compressor, air dryer, control panels and pneumatic tubing. Some of the control valves have been replaced as needed. The remainder of the equipment is original to the building and in poor condition.

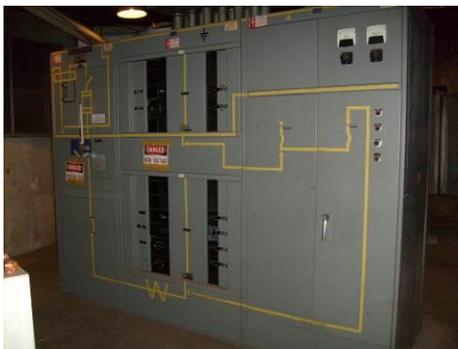
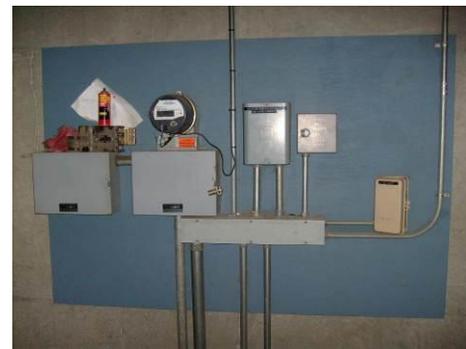
1. The building is served by a single electrical service rated 1600amperes, 480Y/277volts, 3-phase, 4-wire. This service equipment consists of a 1600amp main disconnect switch, distribution sections and metering per utility company requirements. The service equipment is original to the building and is in fair condition. In addition, the current electrical room access does not meet the current code requirements for egress from the room.

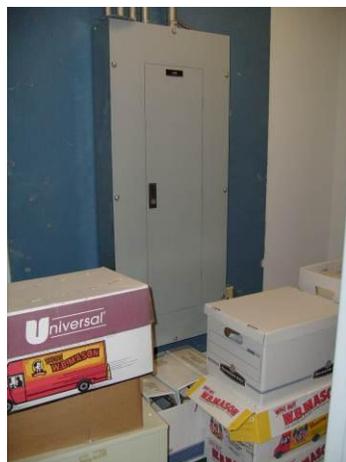
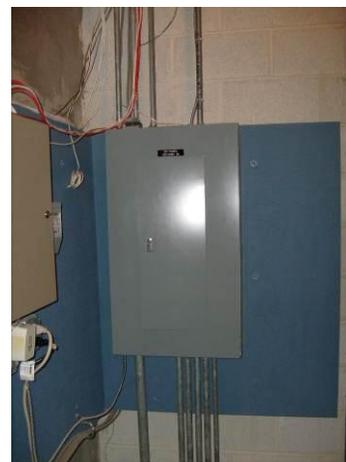
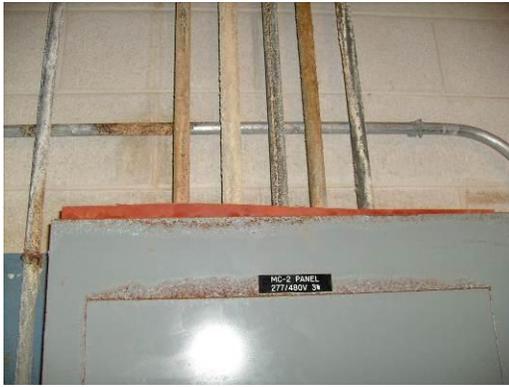
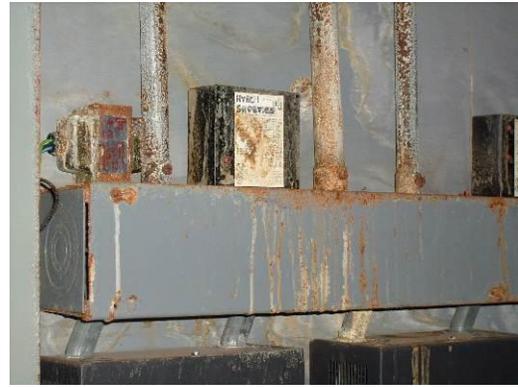
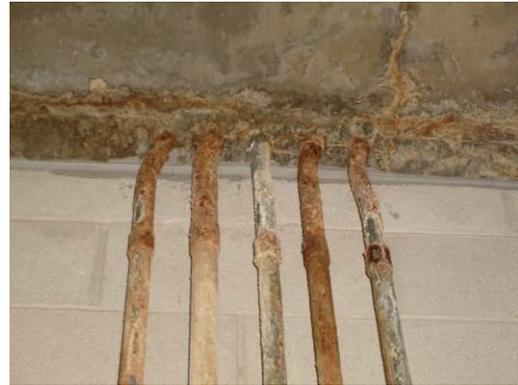
2. There are a number of electrical panels located throughout the facility. Some of these panels are original to the facility and some have been replaced with new. There are a number of panelboards located in storage rooms that have material stored in front of them which is a code violation. In addition, there is one panelboard that has had a significant water leak above it. The conduit, boxes, and panel are showing signs of corrosion. The condition of the panelboards ranges from poor to good.

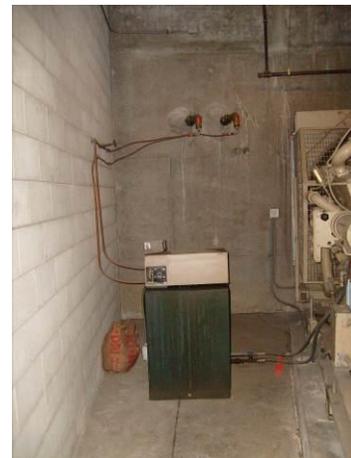
3. The building is served by a Cummings Model 080FDR5057A8W, 410kW, 613kVA diesel generator. The generator is located in the main electrical room. The transfer switch is located in the main electrical switchboard. There is a separate day tank (fuel tank) that pumps fuel oil from the exterior underground tank to feed the emergency generator. To meet current codes, (2) separate automatic transfer switches would be required to separate life safety from other loads in the building. This generator and associated equipment is original to the facility and in good condition.

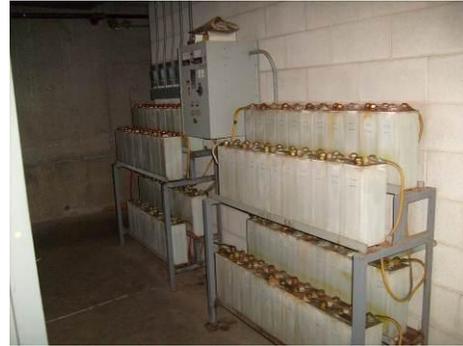
4. In the Main Electrical Room there is a series of (91) wet-cell batteries that serve as back-up power to emergency lighting and other pieces of equipment between when normal utility power is lost and the emergency generator starts. It is controlled by a Dual

Lite Model 120-120-S-791 charger. There is also a number of Dual Lite control panels located throughout the building. Some of these control panels are inaccessible because of items stored in front of them. This equipment is original to the facility and in fair condition. To satisfy current codes, this equipment is required to be in a separate room with adequate ventilation, etc.

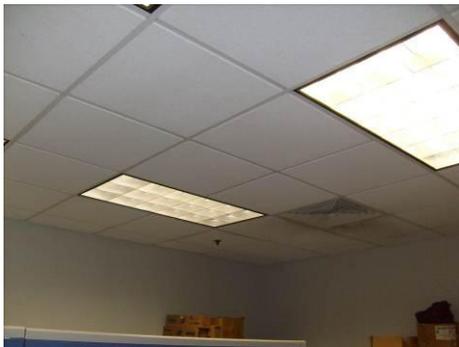
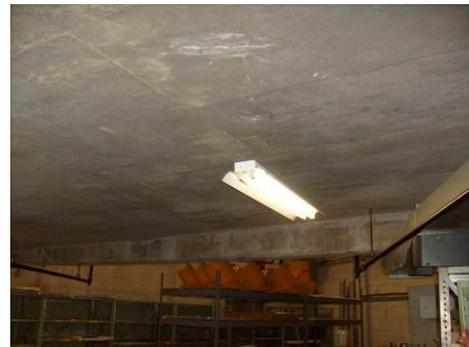
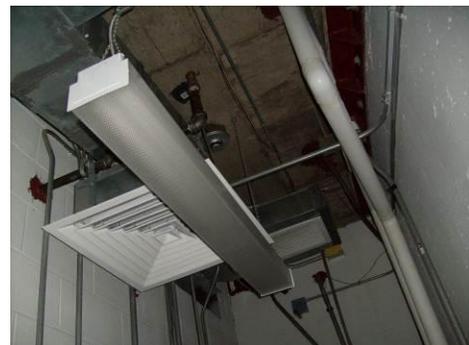
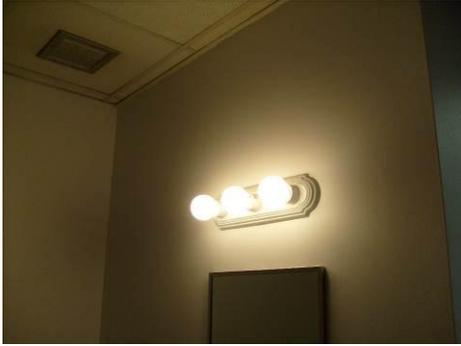
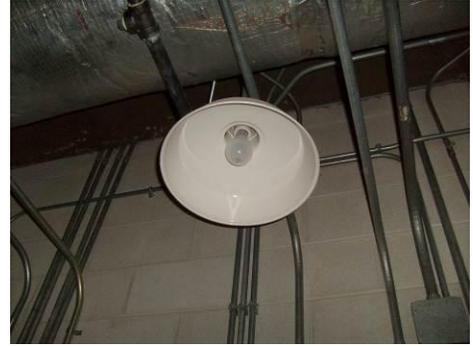
5. The lighting throughout the facility consists of recessed parabolic fixtures, recessed center basket fluorescent fixtures, and recessed mounted acrylic lensed fluorescent fixtures in the office areas, etc. Other fixtures include industrial fluorescent fixtures, wrap around acrylic lensed fixtures, and other miscellaneous fixtures throughout the building. Most of the lighting has been upgraded to newer T8 technology, however, there are other fixtures using older T12 technology or incandescent lamps. The lighting ranges from very good to poor condition.

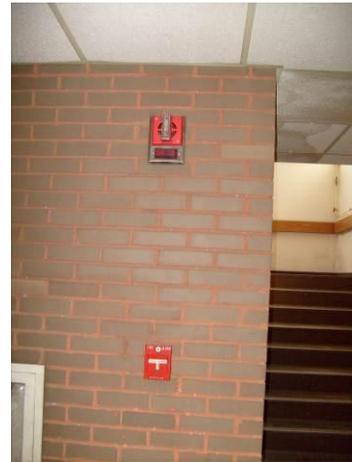
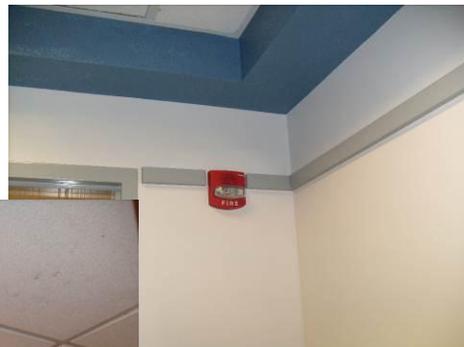
6. The fire alarm system is manufactured by Fire Lite, Model Sensiscan 2000 or Simplex. The system includes control panels, manual pull stations, horn-strobes, and some smoke detectors. This system is in fair condition and portions are non-ADA compliant. Additional audio visual devices should be added to the building as well as upgrading to an addressable ADA-compliant system.

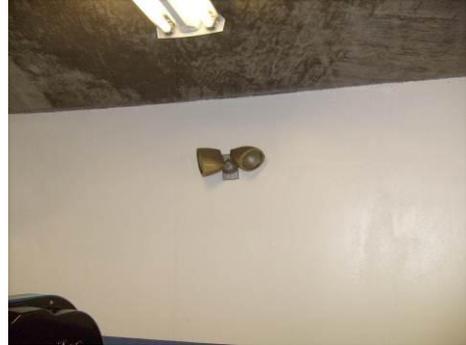
7. The emergency lighting is provided by a Dual Lite Inverter System that includes the inverter, batteries, ceiling mounted remote heads and controls. Although this system is operational, it is in poor condition. Additional lighting fixtures are required to meet current requirements for emergency lighting.

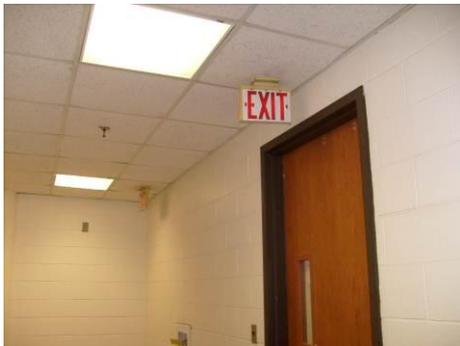
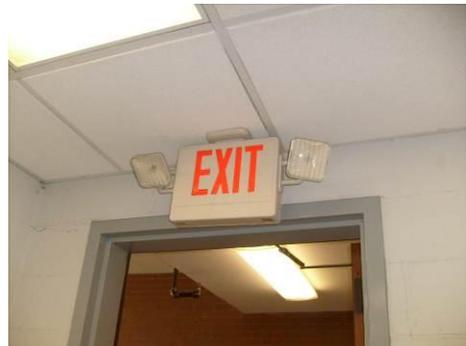
8. The exit signs consist of fluorescent exit signs with batteries. This equipment is in fair condition. Additional exit signs are required to meet current requirements for exit signs.

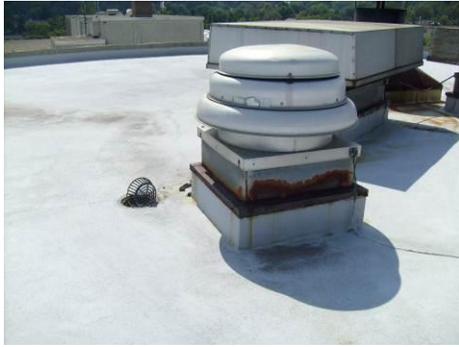
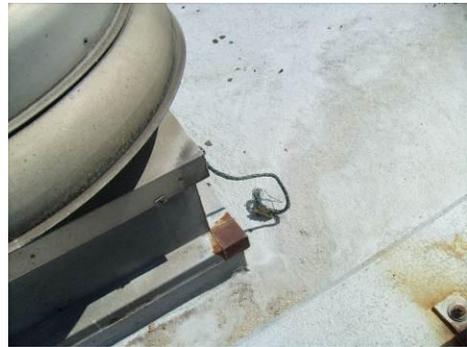
- a. There is a lightning protection system installed at the facility. It appears that during recent roof work, some of the lightning protection system was disconnected. This should be repaired to maintain the integrity and operation of the system.

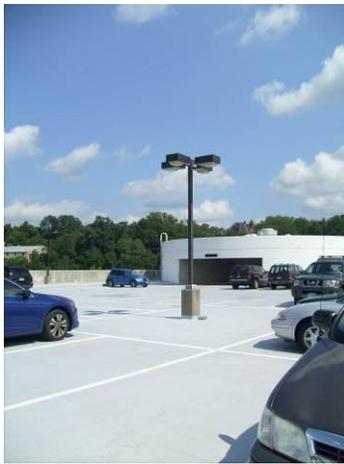
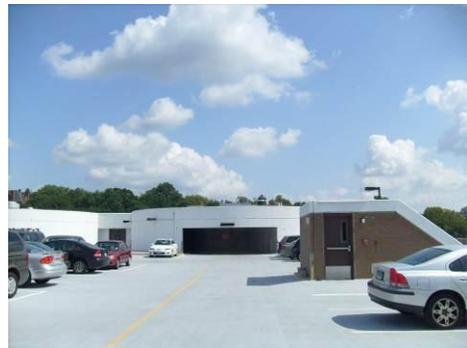
- b. There is a site lighting system on the top level of the parking garage. This lighting system serves the parking areas only and includes pole and wall mounted fixtures. This equipment is in fair condition.
