Space Needs Analysis Bristol Municipal Buildings

Superior Court

131 North Main

Mechanical and Electrical Systems
Existing Conditions Narrative

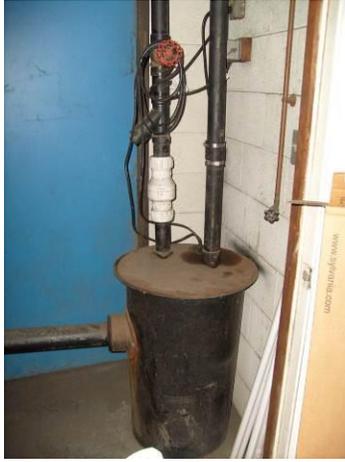
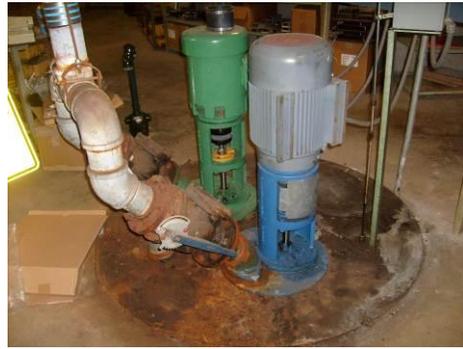
- a. The sanitary sewer system provides sanitary waste drainage for plumbing fixtures located throughout the building. The piping material above grade is primarily cast iron. The plumbing fixtures drain to buried sanitary waste piping to the buildings exterior and to the municipal sewer system. In the lower level of the Police building, sewage ejector pumps are installed to pump the waste into the municipal sewer system. These pumps are in poor condition.

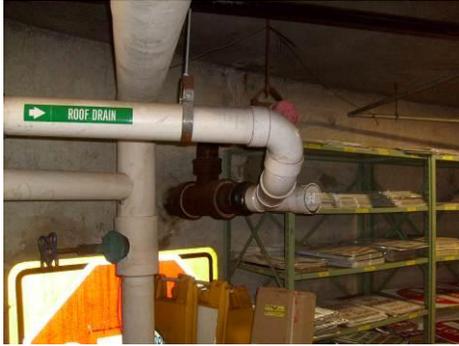
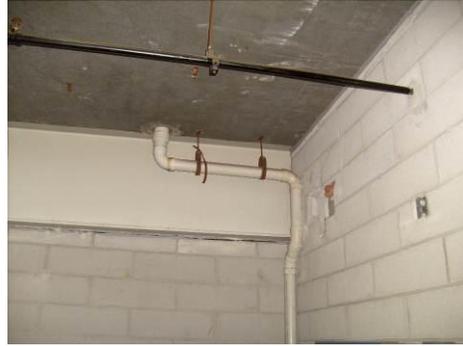
- a. The storm piping is primarily cast iron and drains to the municipal storm water system. Some of the original piping has been replaced with PVC piping. There are no secondary roof drains or strainers on the existing roof drains. Domed strainers should be added to the roof drains to keep debris out of the storm water system.

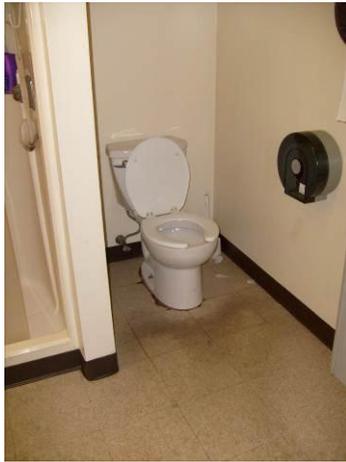
- Water closets are floor or wall mounted; flush valve, vitreous china. Some of the fixtures have been replaced with water conserving fixtures with sensor operated flush valves. The fixtures range from original to the facility in fair condition to new in very good condition. The original fixtures are non-water conserving type and non-ADA compliant.

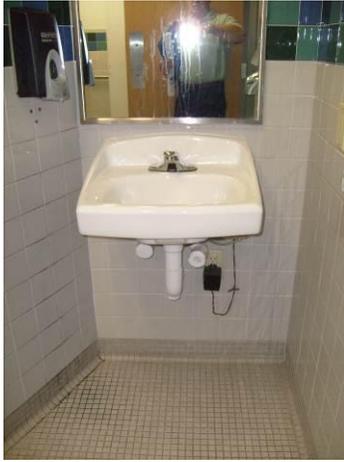
- Lavatories are wall hung vitreous china. Some of the fixtures have been replaced with water conserving fixtures with sensor operated faucets. The original fixtures have two lever handle faucets. The fixtures range from original to the facility in fair condition to new in very good condition. The original fixtures are non-water conserving type and the faucets and drains are non-ADA compliant.

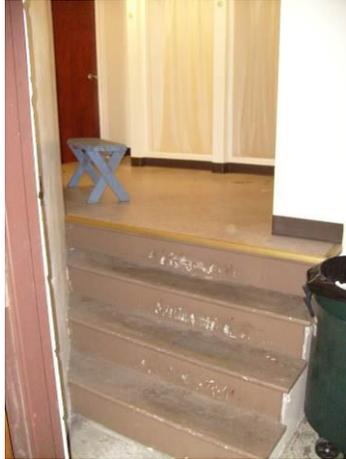
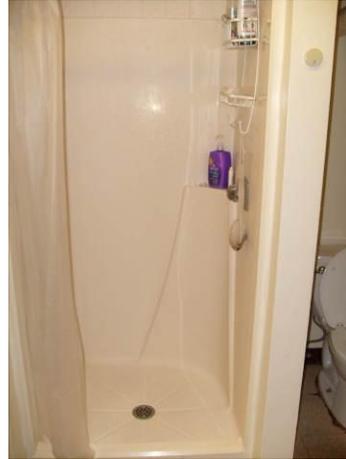
- In the Police Headquarters, there is a single shower located in the lower level training room, up a small flight of stairs. This shower is a fiberglass unit and in good condition. The location of this shower is not ADA accessible.

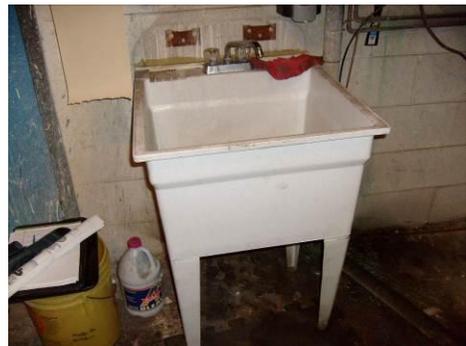
- Janitor sinks are floor mounted cast stone units with two lever faucets or pedestal mounted fiberglass units with two lever faucets. There is no vacuum breaker present at these sinks. The sinks are in fair to good condition.

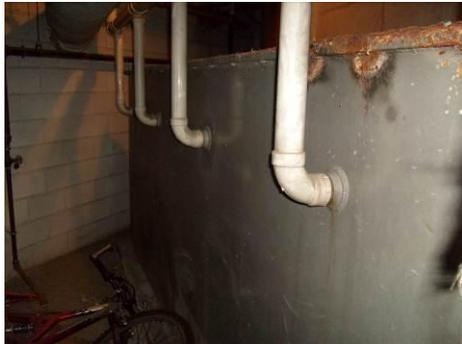
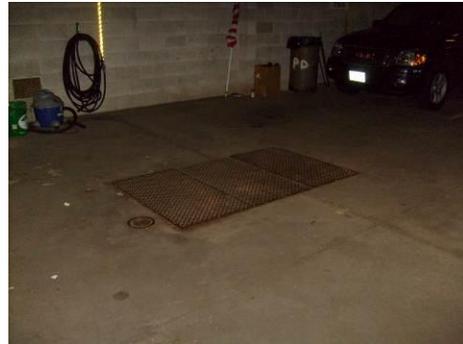
3. There are oil/water separators located in the parking garage. (1) is located above grade and one is located in the floor of the lower level. This equipment is original to the facility and in poor condition.

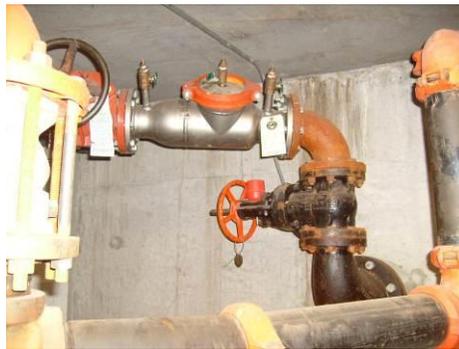
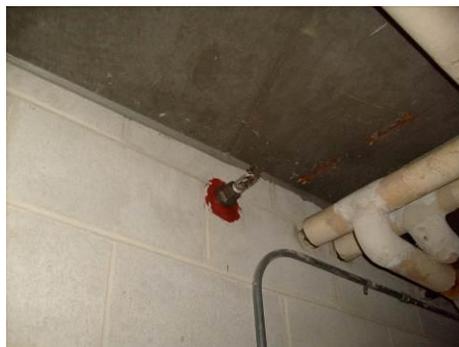
1. The building is served by a 6" fire protection service fed from a fire main in North Main Street. This fire service includes a shut-off valve and Watts Model 774 double check valve. The buildings are protected throughout with a full sprinkler system. There are also standpipes located in the stairs. This backflow preventer equipment has been recently installed and is in good condition. The remainder of the piping and most of the sprinkler heads are original to the building. The sprinkler heads and fire protection piping in the Police Headquarters was modified during the last renovation.

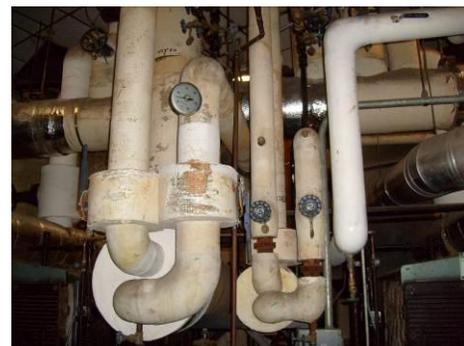
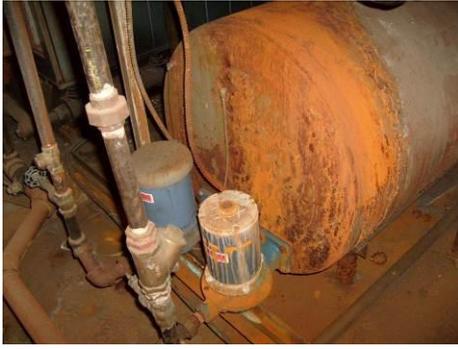
2. The heating plant also includes a condensate receiver, boiler feed system, hot water heat exchanger, condensate receivers, and hot water pumps. All of this equipment is original to the facility and poor condition.

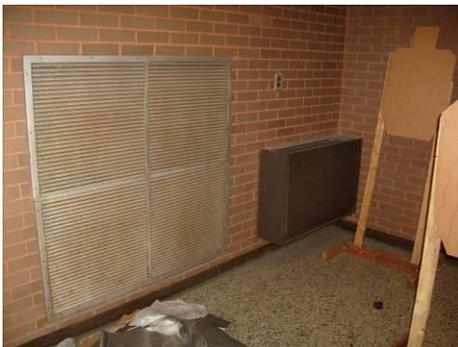
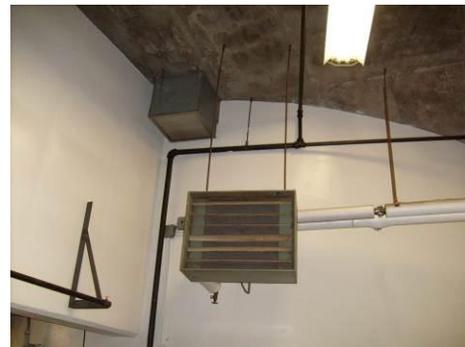
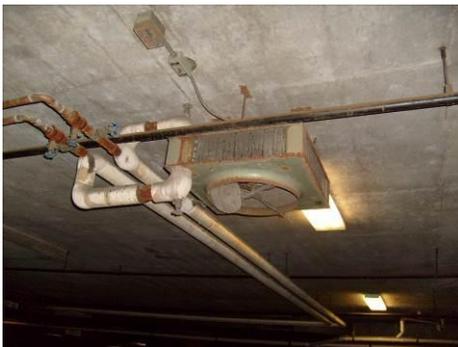
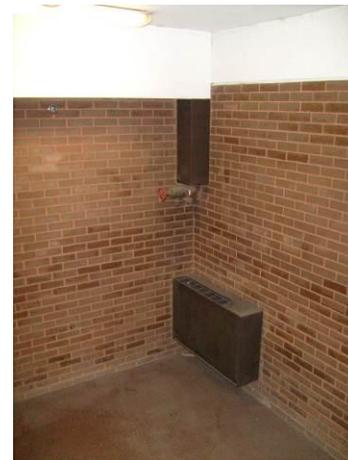
3. The present heating system also includes cabinet unit heaters, and ceiling mounted unit heaters and steam coils in the air handling equipment. This equipment is original to the building and in poor condition.

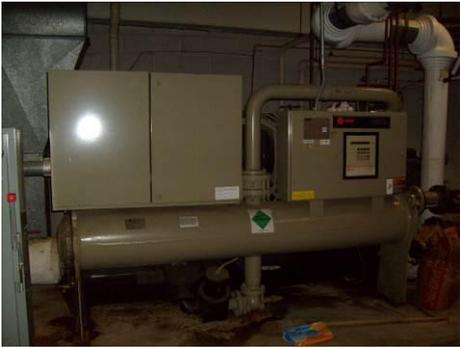
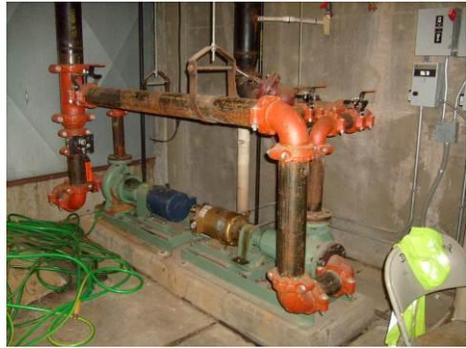
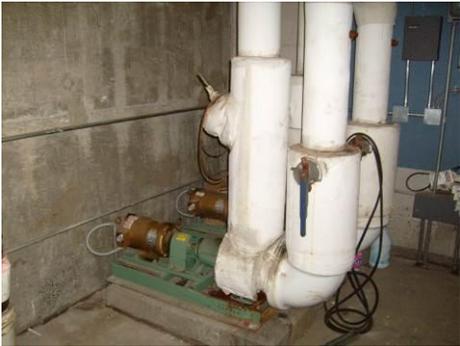
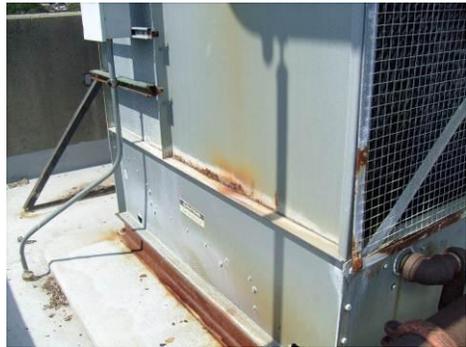
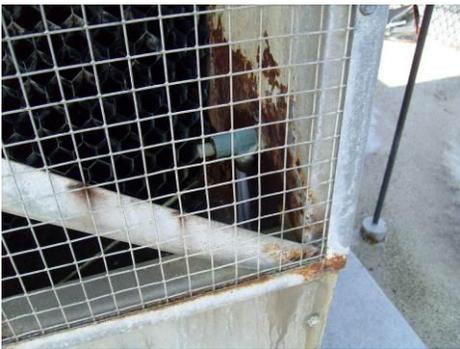
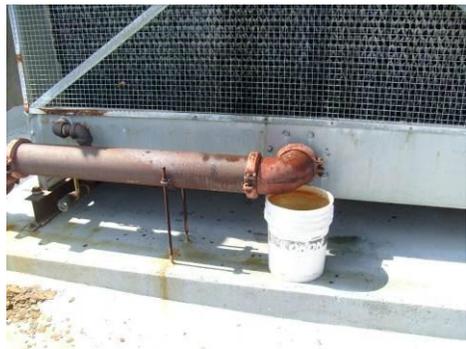
4. The air conditioning system consists of a Trane Series R Centravac chiller, Model RTHB150FMCOONW0000UNN3LF2LF00QU chiller installed in 1996. This chiller is shared between the two buildings. The chiller is in good condition. There is a cooling tower mounted on the roof of the parking facility that is in very poor condition. This piece of equipment has significant corrosion problems and the maintenance staff has made many attempts to repair this sump which has allowed this unit to operate.

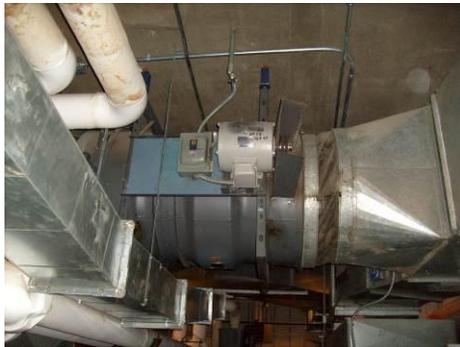
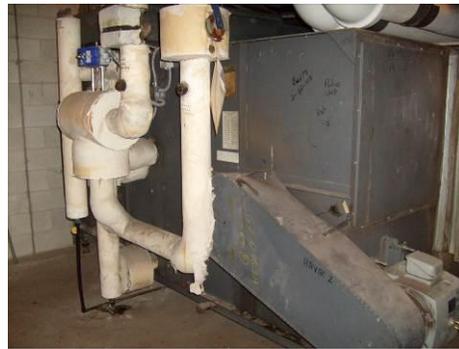
5. The air handling equipment is Trane Climate Changer units that serve as heating and air conditioning units or air conditioning units only. There are also large exhaust/return air fans. This equipment is located in mechanical rooms within the buildings and are original to the facility and in poor condition.

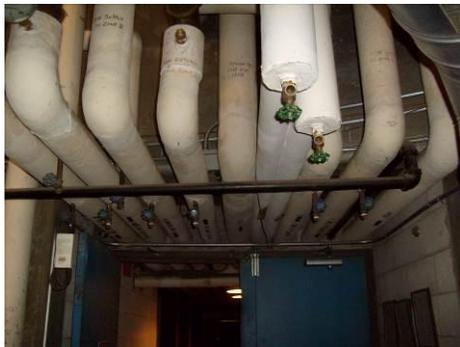
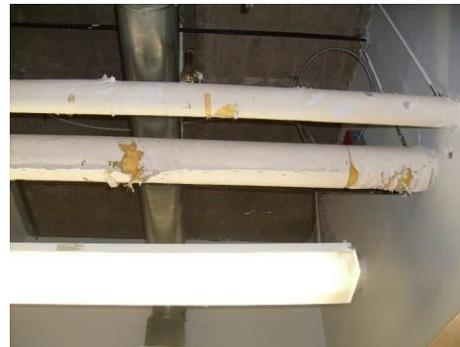
6. The steam and chilled water piping consists of iron supply and return piping. This piping is original to the facility and the steam condensate piping is more than likely in poor condition. There are a number of areas where the pipe insulation has been damaged and should be repaired.

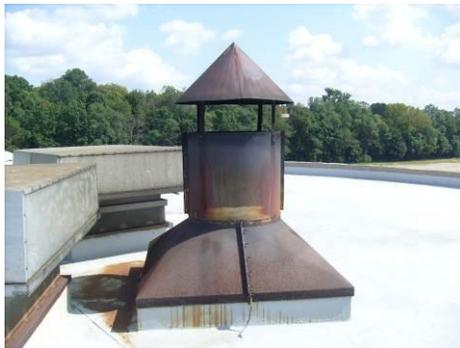
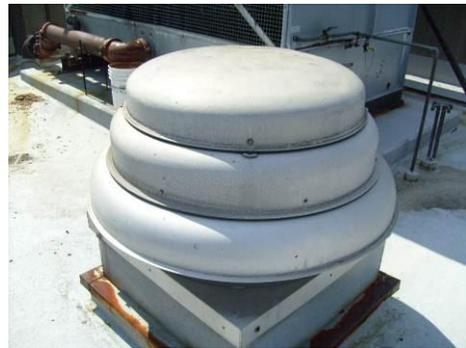
7. The roof mounted equipment consists of exhaust fans, condensing units, etc. This equipment is original to the building and in poor condition.

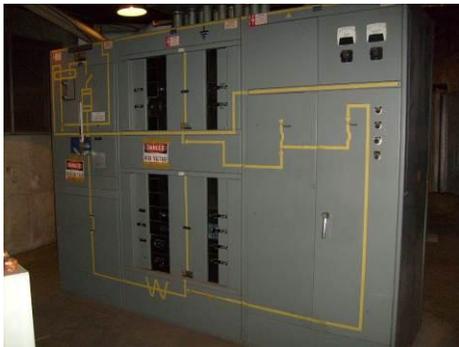
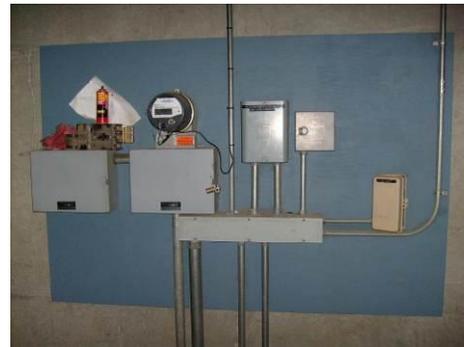
1. The building is served by a single electrical service rated 1600amperes, 480Y/277volts, 3-phase, 4-wire. This service equipment consists of a 1600amp main disconnect switch, distribution sections and metering per utility company requirements. The service equipment is original to the building and is in fair condition. In addition, the current electrical room access does not meet the current code requirements for egress from the room.

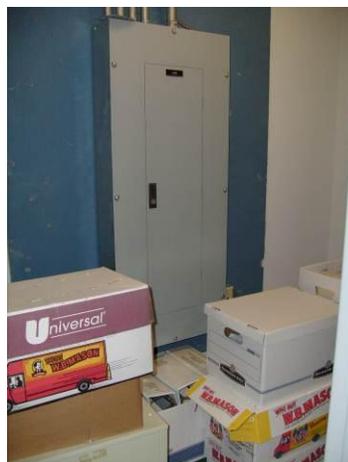
2. There are a number of electrical panels located throughout the facility. Some of these panels are original to the facility and some have been replaced with new. There are a number of panelboards located in storage rooms that have material stored in front of them which is a code violation. In addition, there is one panelboard that has had a significant water leak above it. The conduit, boxes, and panel are showing signs of corrosion. The condition of the panelboards ranges from poor to good.

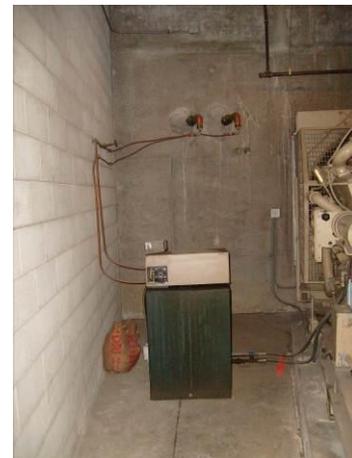
3. The building is served by a Cummings Model 080FDR5057A8W, 410kW, 613kVA diesel generator. The generator is located in the main electrical room. The transfer switch is located in the main electrical switchboard. There is a separate day tank (fuel tank) that pumps fuel oil from the exterior underground tank to feed the emergency generator. To meet current codes, (2) separate automatic transfer switches would be required to separate life safety from other loads in the building. This generator and associated equipment is original to the facility and in good condition.

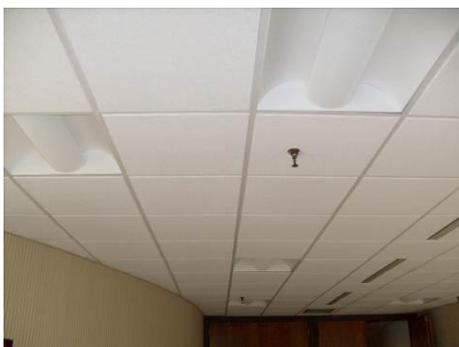
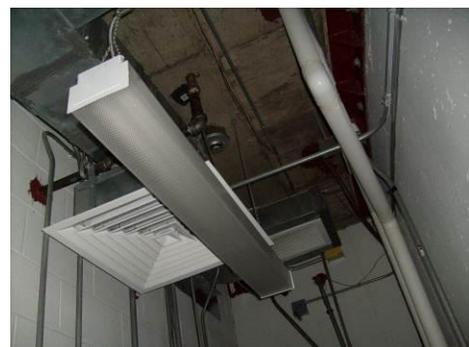
5. The lighting throughout the facility consists of recessed parabolic fixtures, recessed center basket fluorescent fixtures, and recessed mounted acrylic lensed fluorescent fixtures in the office areas, etc. Other fixtures include industrial fluorescent fixtures, wrap around acrylic lensed fixtures, and other miscellaneous fixtures throughout the building. Most of the lighting has been upgraded to newer T8 technology, however, there are other fixtures using older T12 technology or incandescent lamps. The lighting ranges from very good to poor condition.

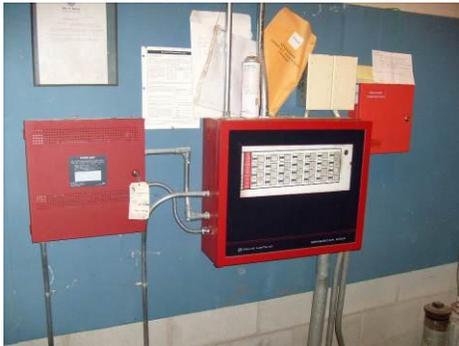
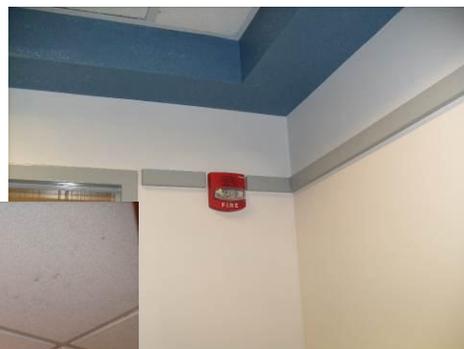
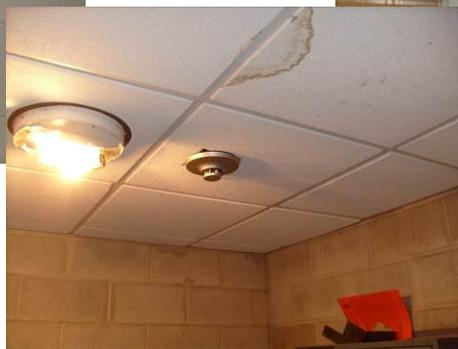
6. The fire alarm system is manufactured by Fire Lite, Model Sensiscan 2000 or Simplex. The system includes control panels, manual pull stations, horn-strobes, and some smoke detectors. This system is in fair condition and portions are non-ADA compliant. Additional audio visual devices should be added to the building as well as upgrading to an addressable ADA-compliant system.

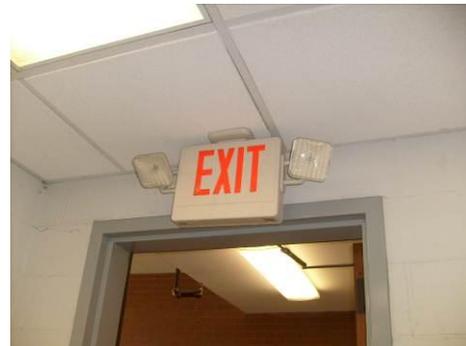
8. The exit signs consist of fluorescent exit signs with batteries. This equipment is in fair condition. Additional exit signs are required to meet current requirements for exit signs.

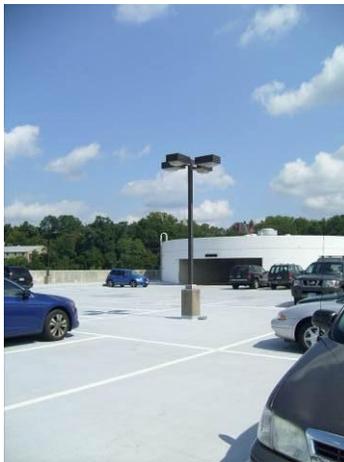
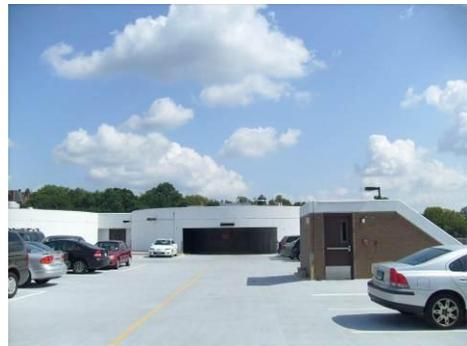
- b. There is a site lighting system on the top level of the parking garage. This lighting system serves the parking areas only and includes pole and wall mounted fixtures. This equipment is in fair condition.
