Space Needs Analysis Bristol Municipal Buildings

Fire Department Headquarters

111 North Main

Current Facility

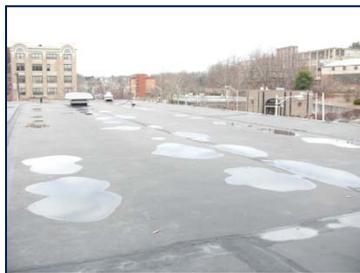
Roof: The roof is a dead-level, mechanically fastened E.P.D.M. system approximately 15 years old. Rainwater ponds on the surface of the roof. The roof should be modified to reduce the amount of ponding and provide positive drainage to the roof drains. If building modifications occur it is recommended that a white roof be installed to reduce energy load.

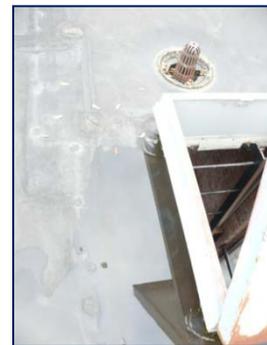
Roof access is by a permanent ladder in one of the stairs. An extension railing should be provided to the ladder and a guardrail added to the roof hatch.

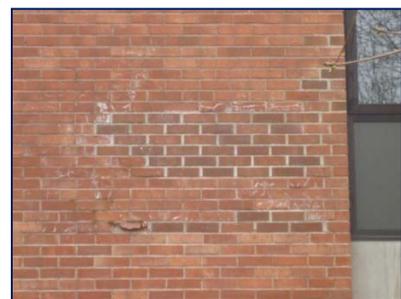
It appears that in the past, the roof has leaked into the walls causing efflorescence on the interior (noticeable in stair enclosures) and severe rusting of the shelf angle. There has also been extensive damage to the

brick including cracking, spalling and shifting. There is a strong possibility that wall ties in the wall may have corroded and failed. Some limited re-pointing and brick replacement has occurred. Also, as evidenced on the interior, there are vertical cracks at some locations where perpendicular walls intersect the exterior wall indicating that the wall is separating from the building.

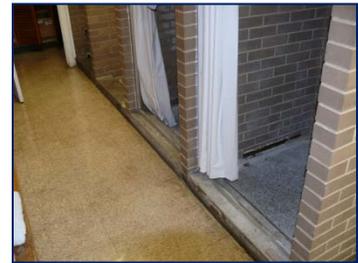
In general the finishes are in good condition but there are some areas of concern. In particular the toilet rooms and showers are constructed with brick. We consider this to be an unsanitary condition as it is very difficult to clean and is porous in nature. Evidence also exists, on the underside of the second floor in the apparatus room that the showers have been leaking.

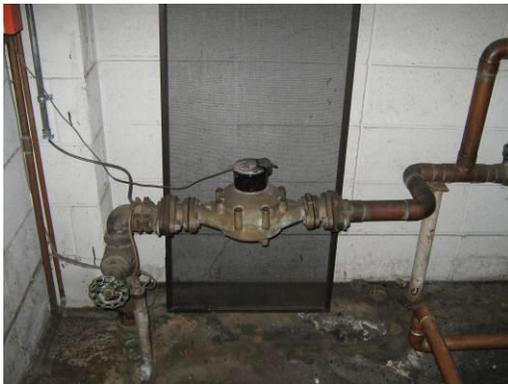
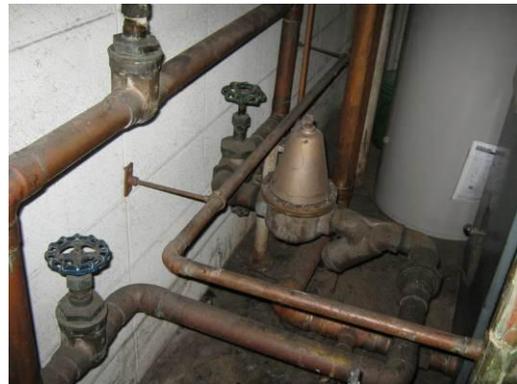
- a. Existing Domestic Water Service: The existing building is currently served by a 2 inch domestic water service. The domestic water service equipment includes a 1 ½ inch water meter, pressure reducing valve, and isolation valves. This water service currently serves all of the building's domestic water needs and has adequate pressure. The water distribution system is original to the building.

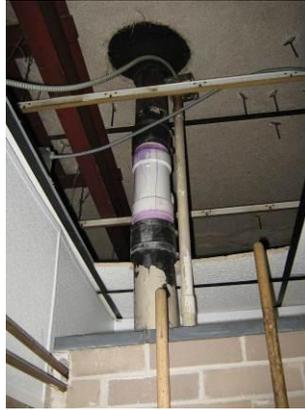
- a. The storm piping is primarily cast iron and drains to the municipal storm water system. There are no secondary roof drains.
- b. There are areas of the storm water system where the piping has been replaced with PVC. Further investigation should be done to determine the exact cause of the failure.

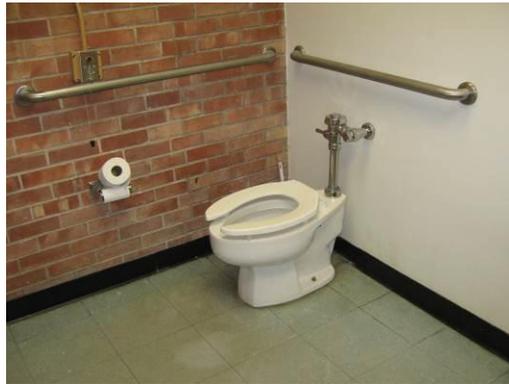
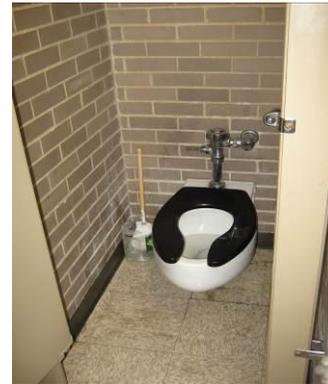
- Water closets are floor or wall mounted; flush valve, vitreous china. These fixtures are non-water conserving type in fair condition. Most of these fixtures are non-ADA compliant.

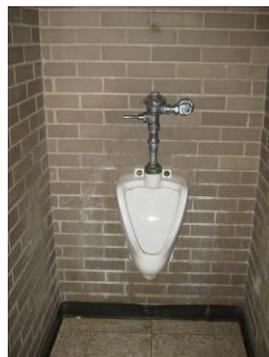
- Urinals are wall hung, vitreous china, with flush valves. These are non-water conserving type and in fair condition.

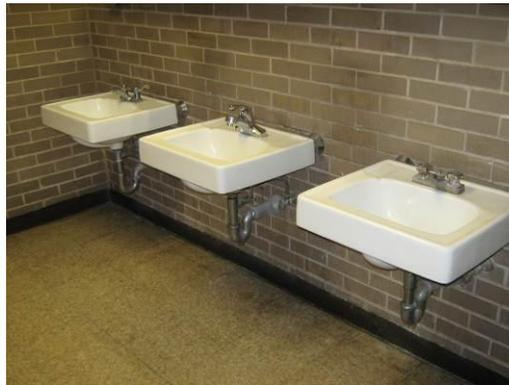
- Lavatories are wall hung vitreous china. Faucets are a combination of single lever handle and two lever handle faucets. The lavatories are in fair condition. The faucets and drains are non-ADA compliant.

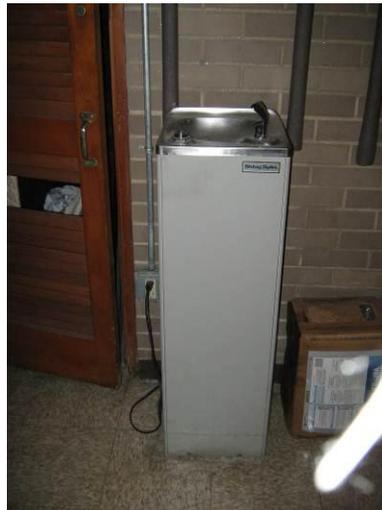
- Drinking fountains are floor mounted steel units, non-ADA compliant and in fair condition.

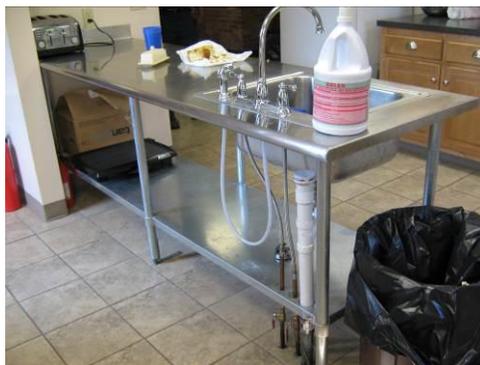
- A stainless steel sink with two lever gooseneck type faucet and spray hose has recently been added to the kitchen. This sink is non-ADA compliant and in good condition.

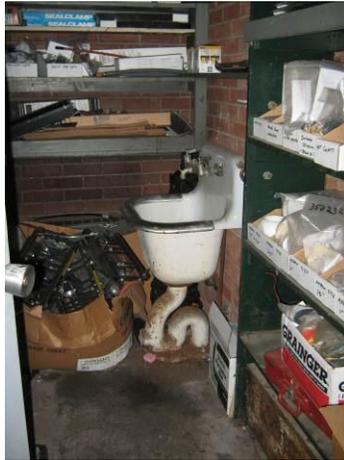
- Janitor sinks are wall mounted cast iron units with two lever faucets. There is no vacuum breaker present at these sinks. The sinks are original to the building and in poor condition.

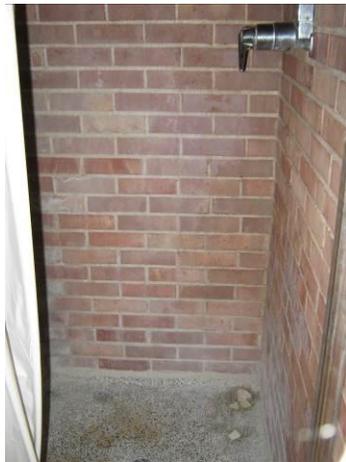
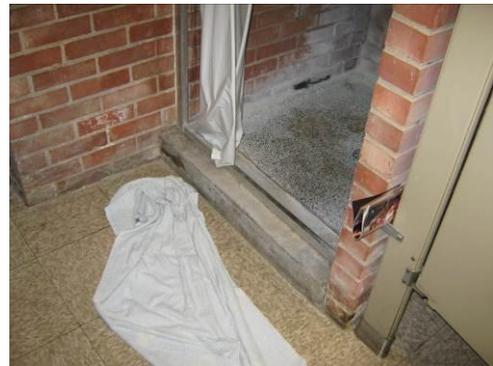
- The showers are constructed of brick with terrazzo type bases. The showers have single lever operators. These showers are non-ADA compliant and in poor condition.

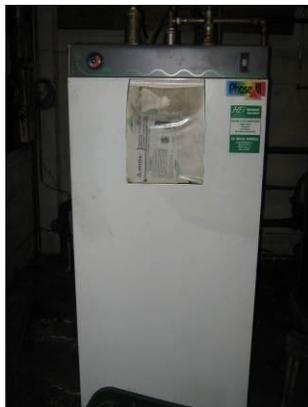
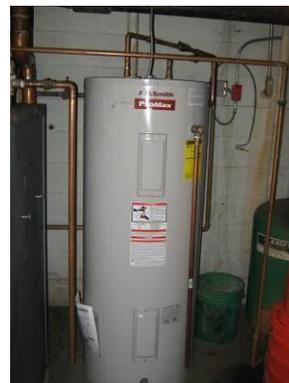
1. The existing domestic hot water system includes a Triangle Phase III indirect water heater which is fed from the existing boiler. The system also includes an A.O. Smith Model ECT 80-200 electric water heater. This equipment is in fair to good condition.

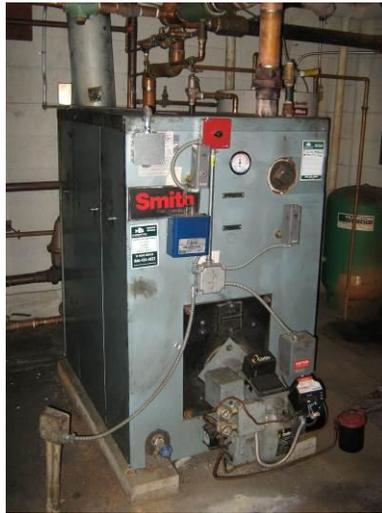
1. The existing building is heated by a single H.B. Smith oil fired hot water boiler. The oil burner is a Carlin Model 702 CRD. The boiler is in fair condition. The oil burner is in good condition.

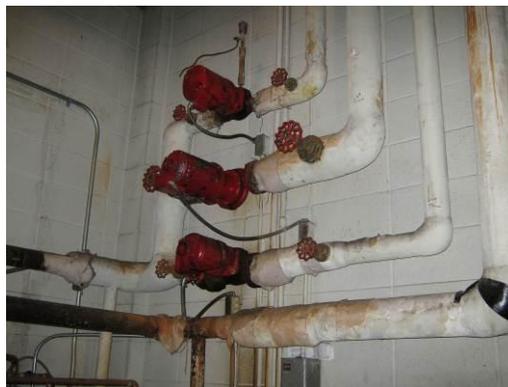
2. There are (3) zones for the heating hot water. Three (3) in-line circulator pumps push water to the three zones. These hot water pumps are in poor condition.

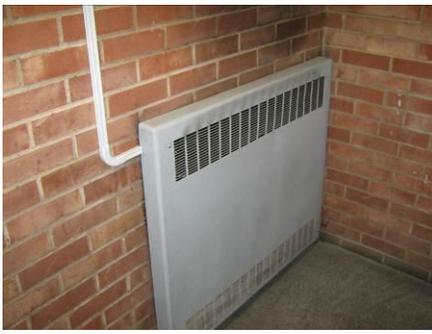
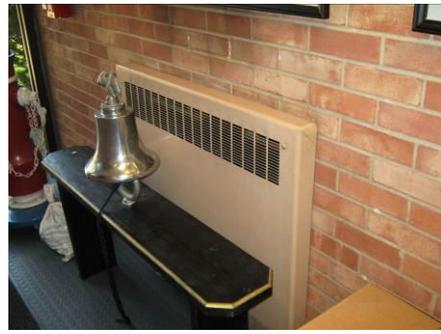
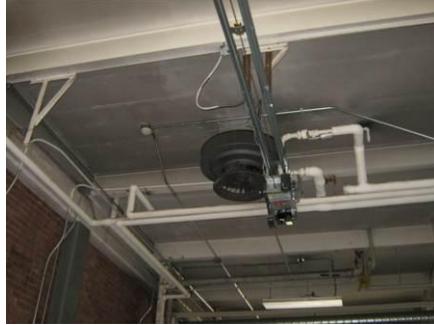
3. The present heating system also includes hot water cabinet unit heaters and baseboard radiators in the occupied areas of the building. Ceiling mounted fan powered unit heaters are located in the apparatus bays.

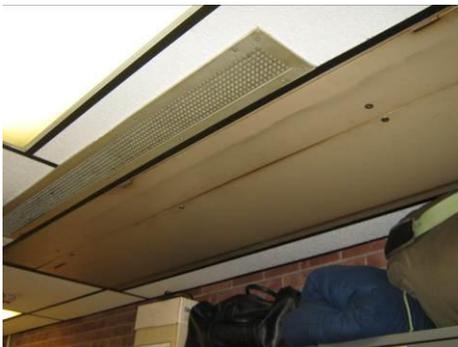
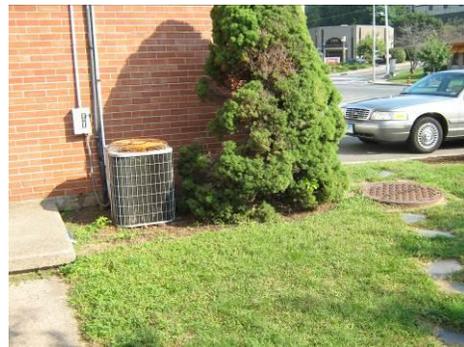
4. There are ceiling mounted fan coil units with supply air ductwork, ceiling mounted supply air diffusers, a single return, and remote condensing units for air conditioning. There are complaints from the occupants because of poor air distribution from these units. This equipment is in poor condition.

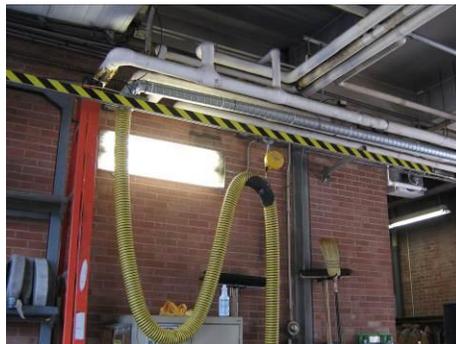
5. Toilet exhaust fans are located on the roof. This equipment is in poor condition.
6. The apparatus bays include a vehicle exhaust removal system manufactured by Plymovent. This includes flexible air hoses connected to the apparatus, support rails for the flexible hose, exhaust ductwork, fans and controls. This equipment is in good condition.

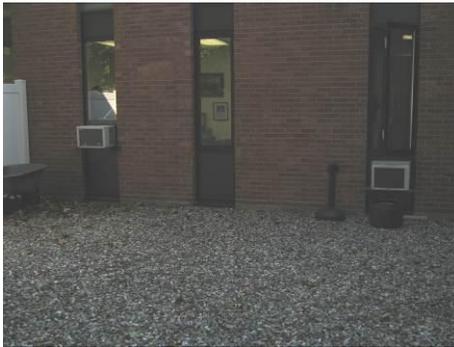
7. Window type air conditioning units have been added to supplement the overhead distribution system.

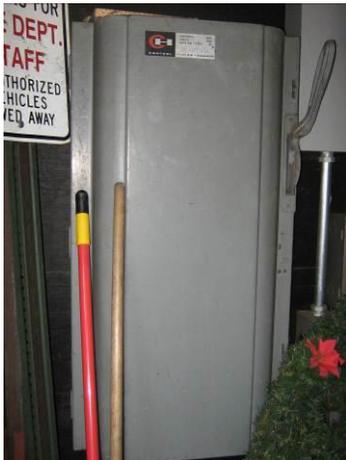
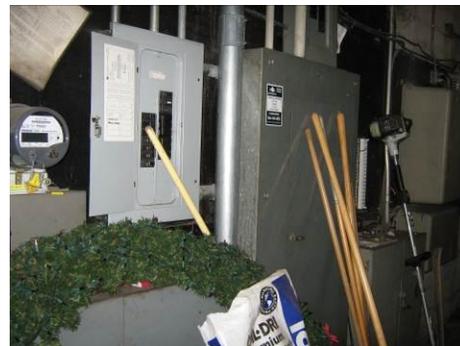
1. The building is served by a single electrical service rated 400amperes, 208Y/120volts, 3-phase, 4-wire. This service equipment consists of a 400amp main disconnect switch, panelboards and metering per utility company requirements. The service equipment is original to the building and is in fair condition.

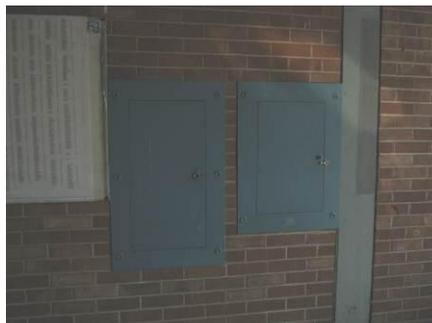
2. There are a number of electrical panels located throughout the facility. These panelboards are original to the facility. The condition of these panelboards is fair. The majority of the panelboards do not have spare circuit breakers available for new circuits to be added, or have space to add new circuit breakers.

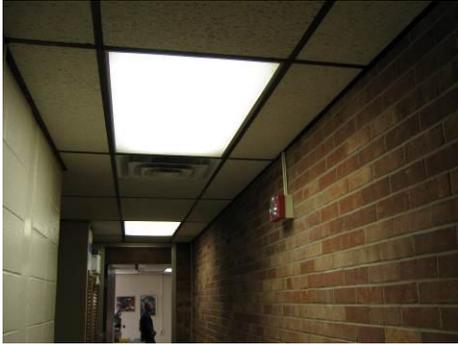
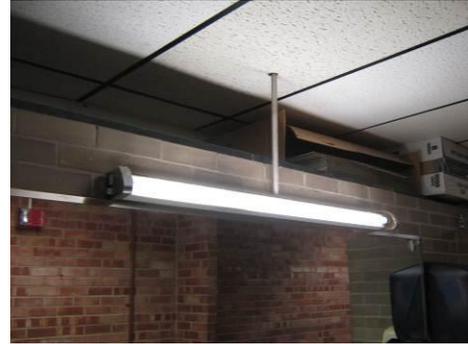
3. The lighting throughout the facility consists primarily of recessed mounted acrylic lensed fluorescent fixtures in the occupied spaces and industrial fluorescent fixtures in the apparatus bays and storage areas. There are other miscellaneous fixtures spotted throughout the building. Most of the lighting is older T12 technology and should be upgraded. There are other fixtures using incandescent lamps that are in poor condition that should be replaced. There are also other fixtures that are damaged that should be replaced. The lighting ranges from poor to fair condition.

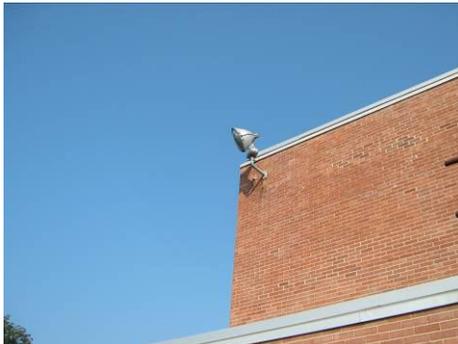
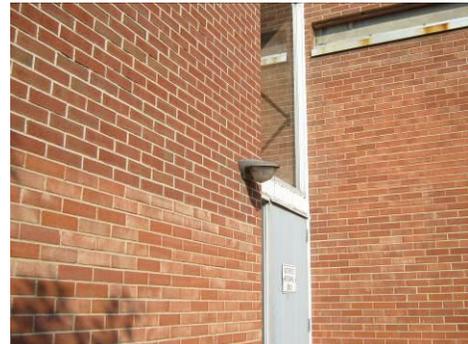
4. Site lighting is limited and consists of building mounted flood lights. These fixtures are not energy efficient and are in poor condition.

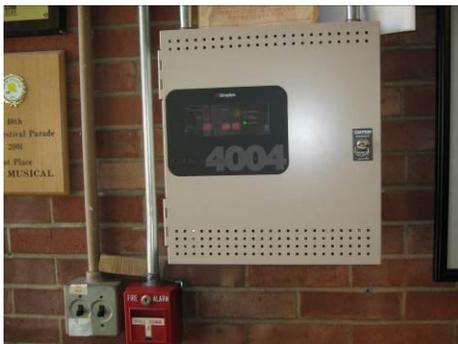
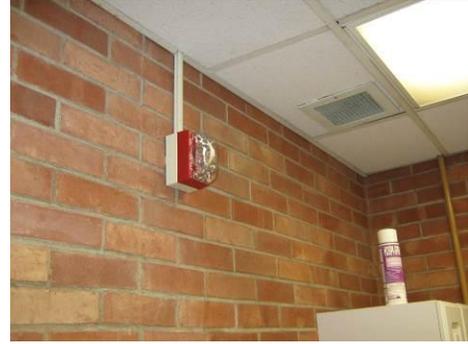
5. The fire alarm system is manufactured by Simplex, Model 4004. The system includes manual pull stations, horn strobes, and ceiling mounted smoke or heat detectors. This system is in good condition. The coverage of smoke detectors and other devices appear to be inadequate. Additional devices, such as horn/strobe units, are required to comply with current ADA requirements.

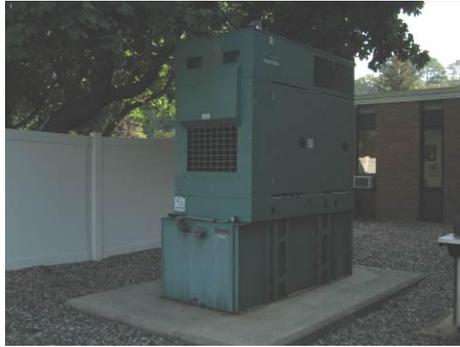
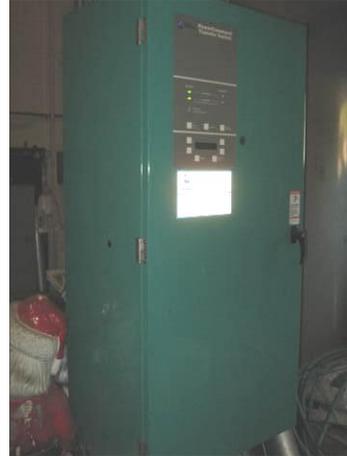
7. The emergency lighting is provided by the emergency generator. This emergency generator serves the entire facility. The emergency generator consists of an external generator manufactured by Cummins/Onan, weatherproof enclosure, base mounted fuel tank, and 400amp automatic transfer switch. This equipment is in very good condition.

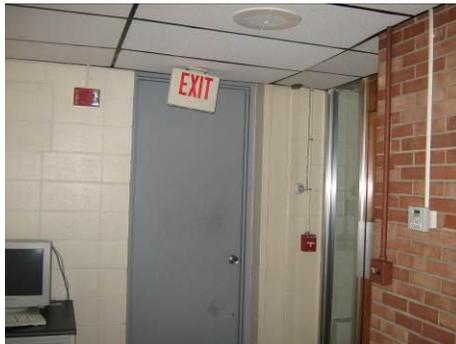
8. The exit signs consist of fluorescent exit signs, some including batteries. This equipment is in fair condition.
