Space Needs Analysis Bristol Municipal Buildings

**Clara T. O'Connell
Elementary School
(Formerly Park Street E.S.)**
120 Park Street

Current Facility

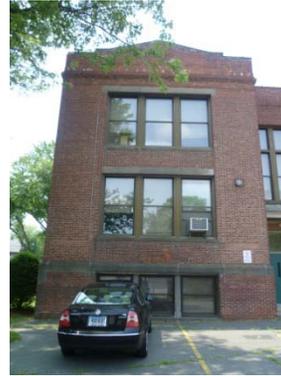
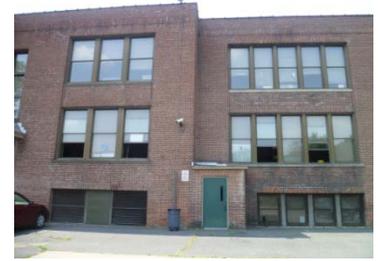
The cheek walls at the main entrance have been concrete on one side which should be replaced with stone.

The brick chimneys need to be re-pointed.

Steel grating on a rear window has rusted and stained the brick. It should be removed and the brick cleaned.

There are some remnants of graffiti that should be removed.

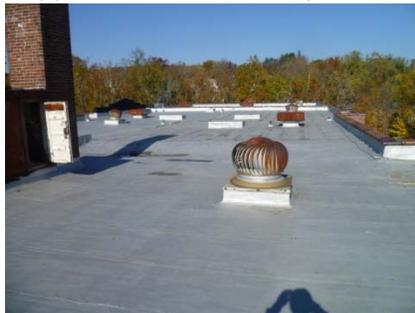
It appears that the built-up roof has had a cap sheet applied and been painted with silver reflective paint

which will reduce the temperature fluctuations that the roofing will experience. Terracotta parapet caps exist at the perimeter and at interior walls (at the back of the original building) and these have shifted and have been patched. We recommend that all interior parapets be removed and the roofing patched to reduce the potential for leaks. Flashing should be extended under all parapet caps and the terracotta reinstalled. In doing so the terracotta becomes decorative

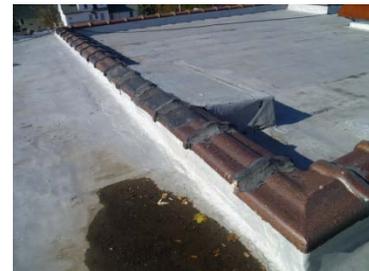
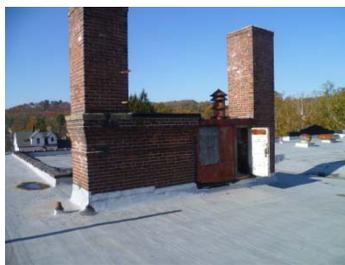
and the flashing becomes the primary source of protection. Roof equipment, typically vent caps, are badly rusted, and, if functioning, should be replaced. The roof has good slope throughout.

Roof access is unsafe and needs corrective work. The enclosure at the roof level needs to be reconstructed.

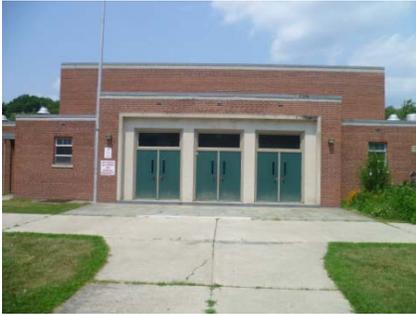
The exterior of the gymnasium consists of brick with limestone trim, a concrete wall cap, glass block windows with inset operable steel windows. Exterior doors are painted wood with wood trim.

The gymnasium windows are single glazed and should be replaced. We recommend that the glass block also be replaced. Wood doors and trim needs to be scraped and repainted.

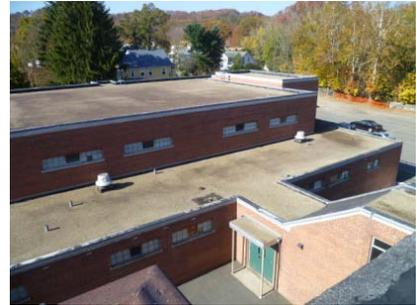
The roof is a built-up system with almost no slope, and, although functioning, it has reached its life expectancy and should be replaced.

The basement area is wet, yet serves as a return air plenum. Gymnasium floor needs to be sanded flat to remove cupping (caused by flooding), and refinished.

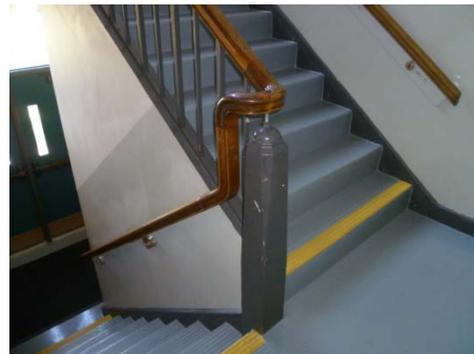
The stair treads and risers do not meet current codes with dimension of up to 7.5" risers and a minimum of 10" treads (code 7" riser, 11" tread). The stairs on the original building do not have any nosings, which, if added, would improve the condition but still not meet code. There also appears to be significant wear in the treads. Guardrails are less than 42" high.

There are an excessive number of egress stairs, possibly due to the number of additions to the original structure. A number could be eliminated to achieve more program space.

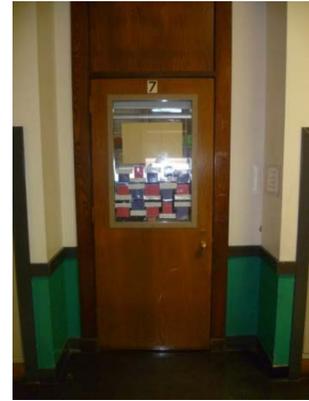
All stairs will require modifications to correct projecting square nosings and make handrails continuous with a smaller diameter to allow gripping. Handrails will also need extensions beyond the top and bottom risers. All doors have knob sets which will need to be changed lever hardware. Some doors are recessed and do not provide adequate clearance on the pull side of the door. This will require partition modifications to correct the deficiency.

Water coolers do not meet ADA . One accessible toilet room is provided on each of the floors of the main building. The toilets and showers in the gymnasium wing are not accessible.

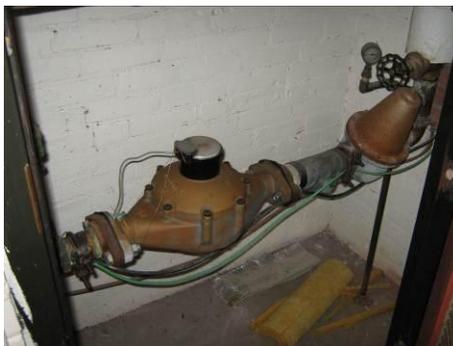
- a. Existing Domestic Water Service: The existing building is currently served by a 4 inch domestic water service. The domestic water service equipment includes a 2 inch water meter, pressure reducing valve, and isolation valves. This water service currently serves all of the building's domestic water needs and has adequate pressure. The water distribution system is original to the building.

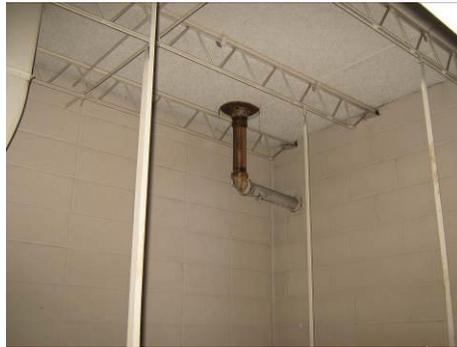
- a. The storm piping consists of roof drains and scuppers. There are no secondary overflow drains. The roof drains discharge into an underground piping system and drains to the municipal storm water system. This piping is in fair condition.

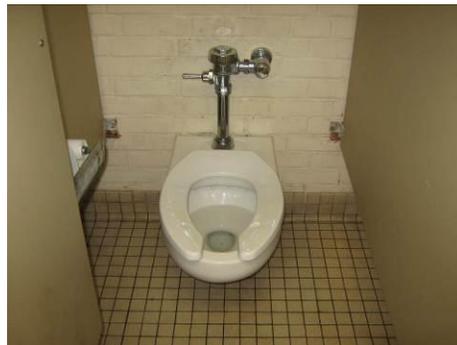
- Water closets are wall mounted vitreous china with flush valves. The fixtures are original to the facility in fair condition. The fixtures are non-water conserving type and non-ADA compliant.

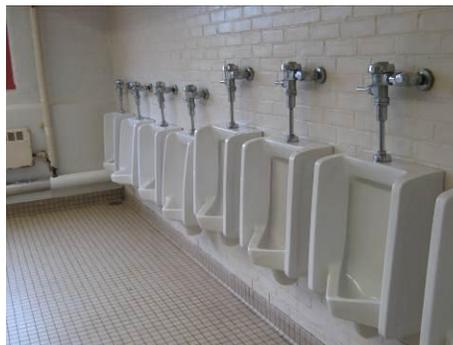
- Urinals are wall hung, vitreous china, with flush valves. The fixtures are original to the facility in fair condition. The original fixtures are non-water conserving type and non-ADA compliant.

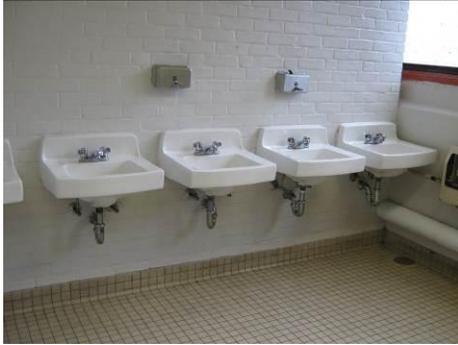
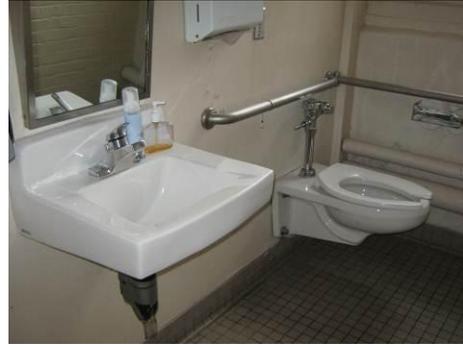
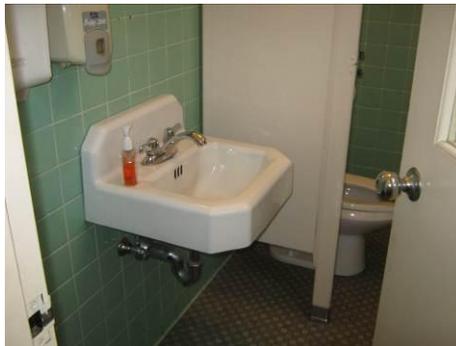
- Lavatories are wall hung vitreous china with either two twist style faucets or single lever type faucets. The fixtures with two twist type faucets are original to the building and in fair condition. These fixtures are non-water conserving and non ADA compliant and in fair condition. Fixtures with single lever faucets appear to be ADA compliant and in good condition.

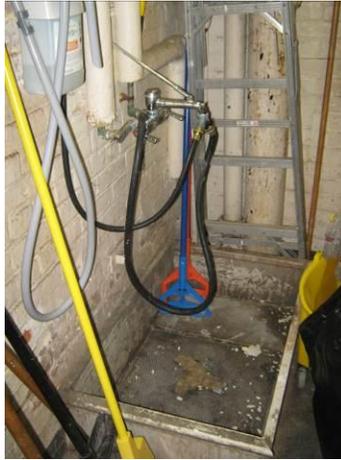
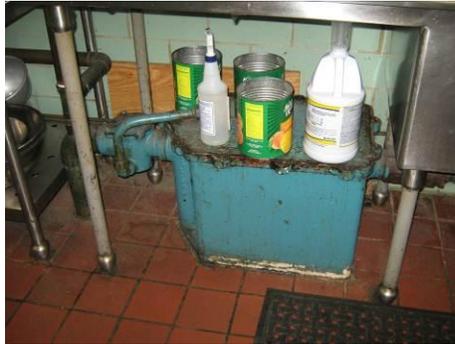
- There is an indoor grease trap in the kitchen. This grease trap is located above the

floor and serves the three bay sink. This grease trap is in poor condition.

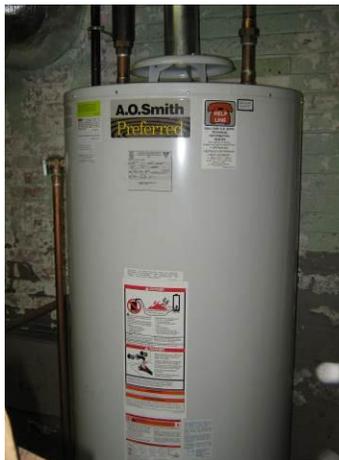
1. The existing domestic hot water system includes an A.O. Smith Model BT-100-300 propane fired domestic water heater as the primary source of domestic hot water. This water heater has been recently installed and is in good condition.

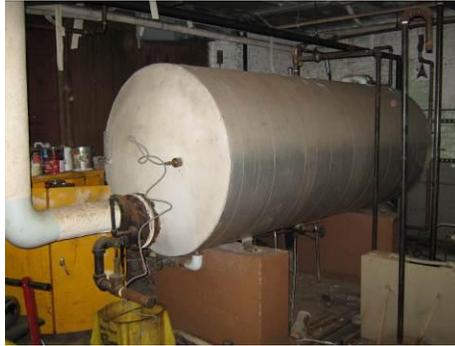
3. There is a large domestic water storage tank that is still in place at the building. This tank is no longer in use and was original to the building.

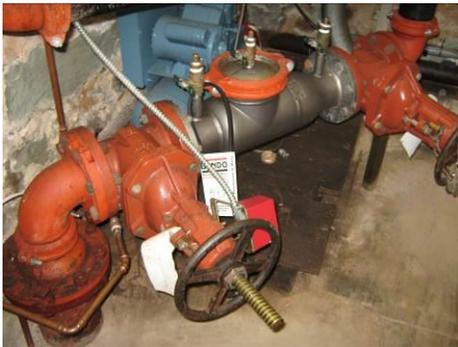
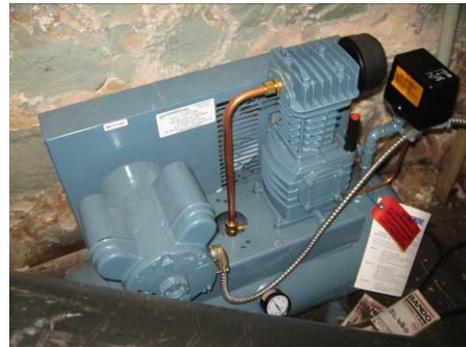
1. The building is served by a 6" fire protection service fed from a fire main in Park Street. This fire service includes a shut-off valve and Watts Model 774 double check valve. This fire protection service feeds sprinklers throughout the building. This is a dry type system. The dry system has a new air compressor installed to maintain system pressure. This fire service equipment has been recently installed and is in good condition, however, the sprinkler piping and sprinkler heads are an older installation, more than 30 years old, and should be replaced.

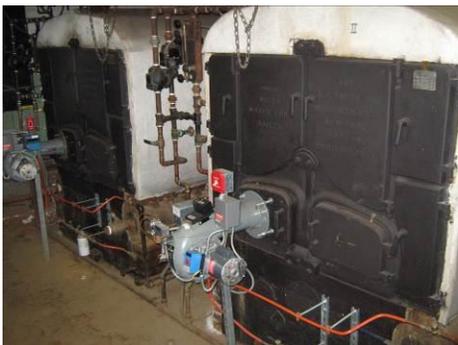
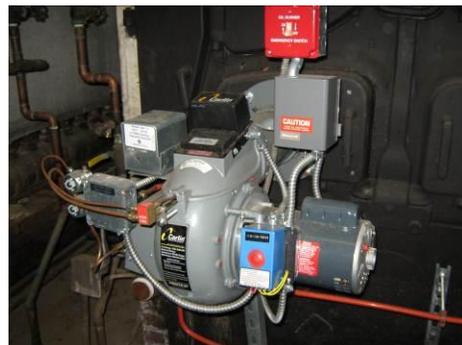
1. The existing building is heated by (2) HB Smith Mills 440 cast iron steam boilers with Carlin Model 1050FFD-20 oil burners. The boilers and breeching are original to the building and in fair condition. The oil burners have recently been replaced and are in very good condition.

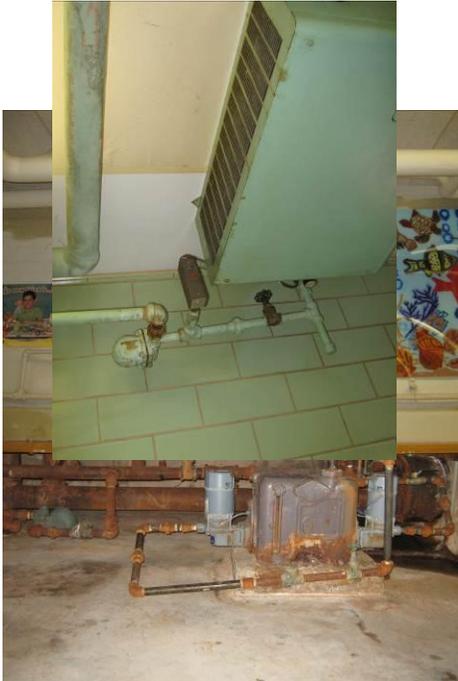
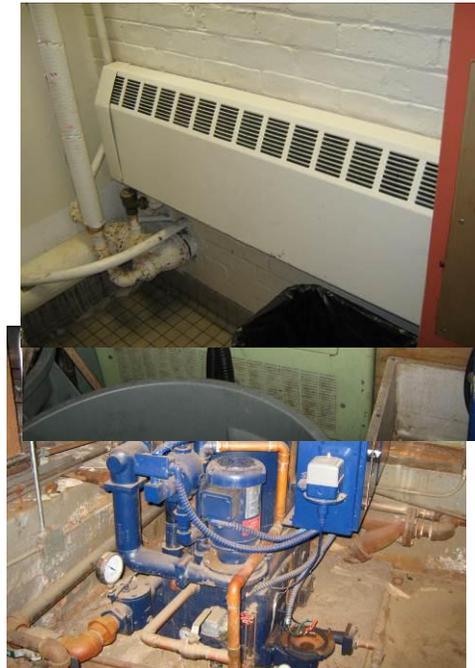
2. The heating plant also includes a condensate receiver and boiler feed system. There were visible leaks in the condensate receiver. Based on the location of the condensate receiver, the recent flooding is something that has happened previously at the building and is contributing to the condition of this equipment. The boiler feed system is in fair condition.

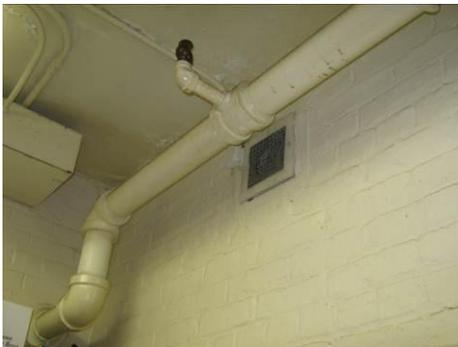
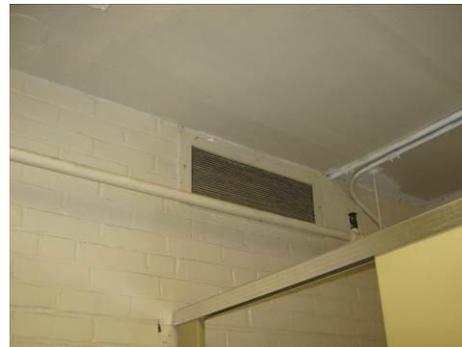
3. The present heating system also includes cabinet unit heaters, ceiling mounted unit heaters, cast iron radiators and baseboard radiation. This equipment is original to the building and in good to very poor condition.
4. There are various exhaust fans throughout the building that serve general areas such as corridors and the gymnasium which includes roof mounted exhaust fans, ductwork, grilles and controls. A lot of the exhaust grilles are dirty and require cleaning. The ventilation systems that are present are original to the building and in poor condition.

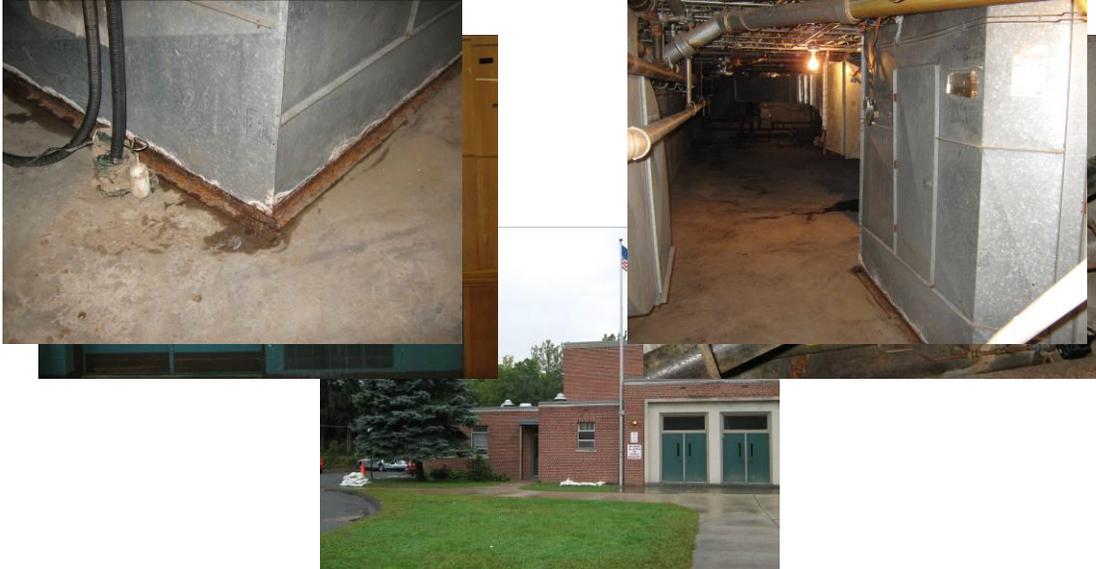
5. The Gymnasium/Cafeteria has two dedicated HVAC units. One unit is located in a mechanical space below the space. This is also access to the tunnel system that runs around the original portion of the building. The HVAC equipment down in this

mechanical space has been exposed to flooding and is in poor condition.

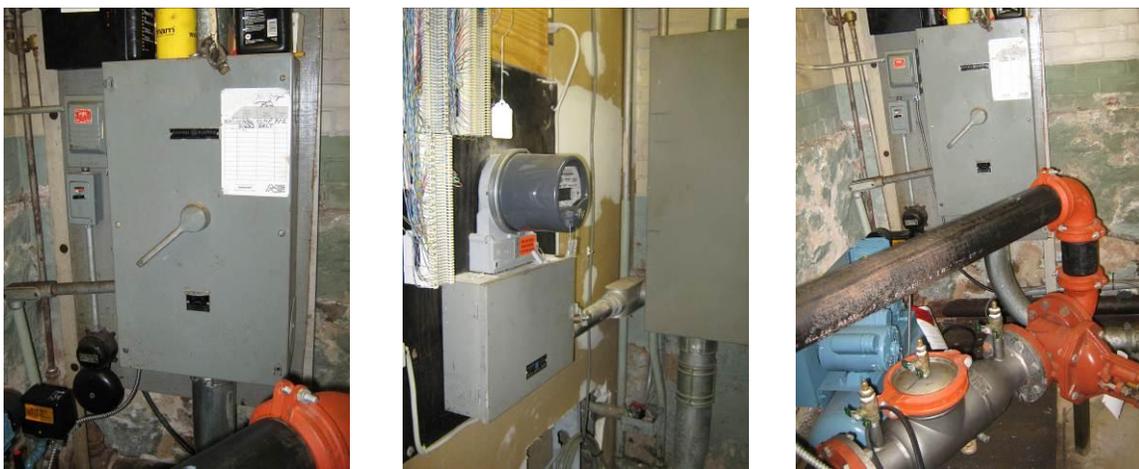
1. The building is served by a single electrical service rated 400amperes, 208Y/120volts,

3-phase, 4-wire. This service equipment consists of a 400amp main disconnect switch, distribution and metering per utility company requirements. The service equipment is original to the building and in fair condition. The work recently performed on the fire protection service has created a code violation with respect to required clearance and access in front of the main service disconnect switch. The backflow preventer and piping is blocking access to the main service disconnect switch.

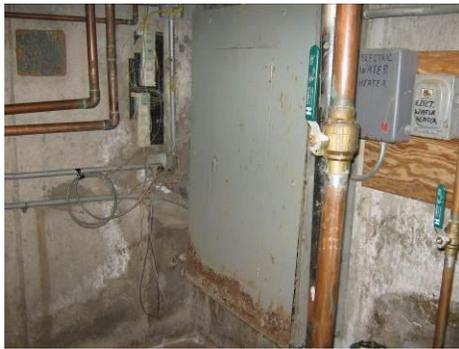
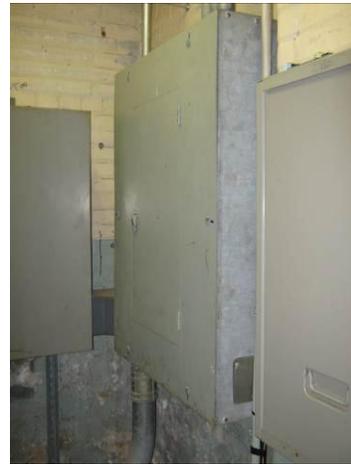
2. There are a number of electrical panels located throughout the facility. These panelboards are original to the facility and in fair to poor condition. There is an electrical panel located in the space below the Gymnasium. This panel is in poor condition because of the water problems within the building. This equipment is showing serious signs of corrosion and should be replaced. The majority of the panelboards do not have spare circuit breakers available for new circuits to be added, or have space to add new circuit breakers.

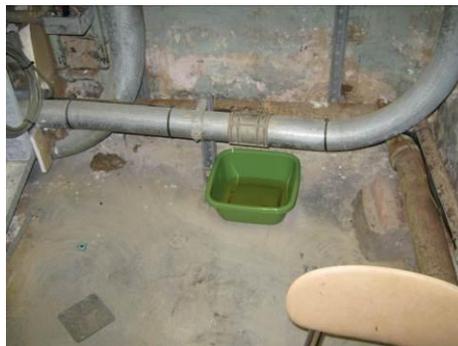
3. Because of the water problems at the building, electrical conduits in the lower level have filled with water. The type of insulation on the wiring should be determined and evaluated to verify that it is water resistant. If not, the wiring should be replaced.

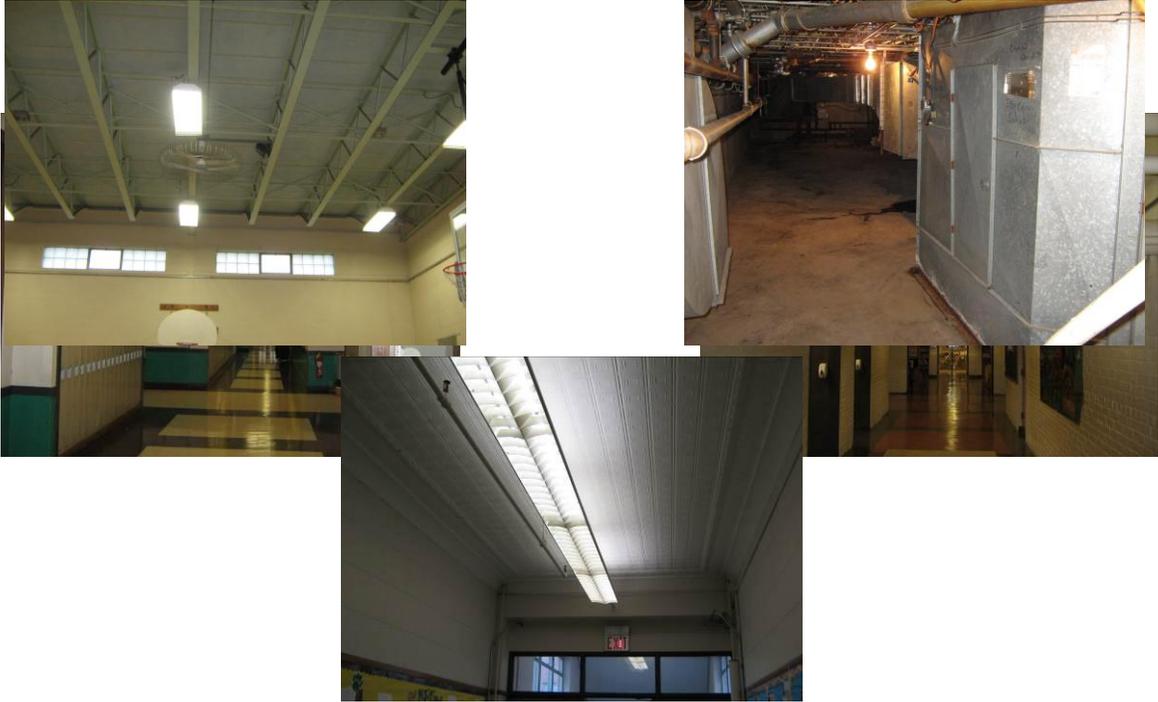
4. The lighting throughout the facility consists primarily of surface mounted acrylic lensed wraparound style fluorescent fixtures or pendant mounted fluorescent fixtures with

louvers. The Gymnasium has had upgrades to the lighting. There are still areas, especially in the area under the Gymnasium that use incandescent lamps. The lighting ranges from good to poor condition.

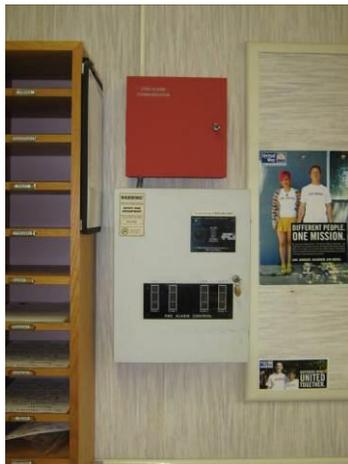
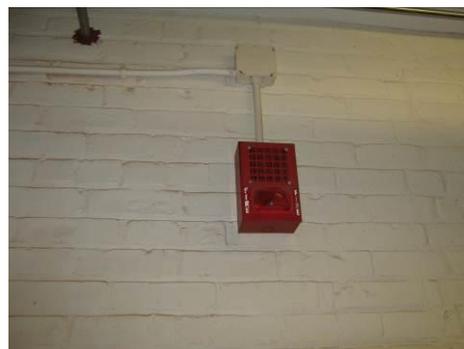
5. The fire alarm system is manufactured by FCI. The system includes manual pull stations and horn strobes. Some of the horn/strobe units are partially blocked by piping. This system is in fair condition and non-ADA compliant. Smoke detectors and additional audio visual devices should be added to the building.

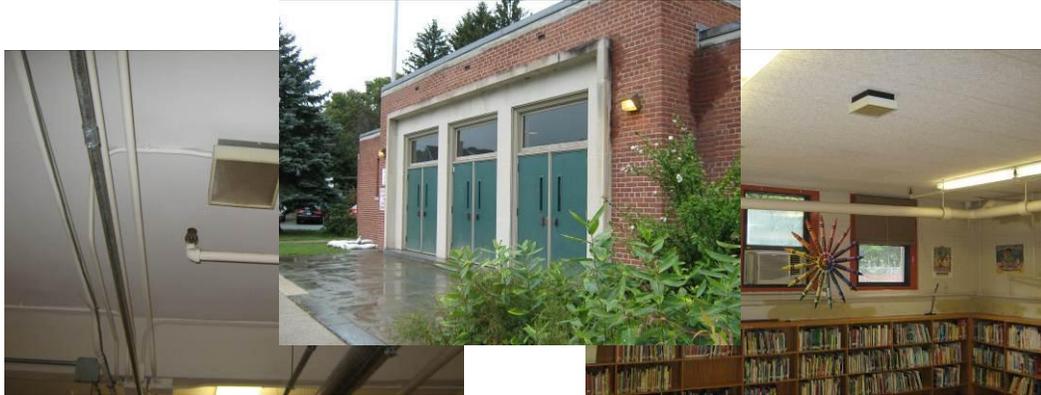
6. The emergency lighting is provided by surface mounted 9"x9" self-contained emergency fixture. This system is operational however the equipment is in poor condition. Additional lighting fixtures are required, such as exterior to the building, to meet current

requirements for emergency lighting.

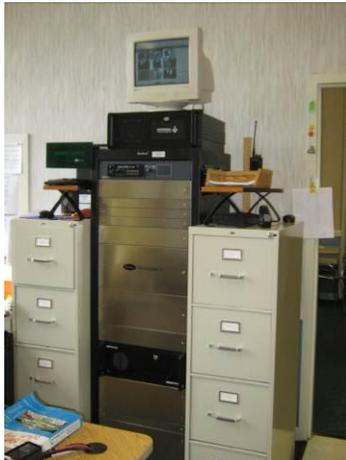
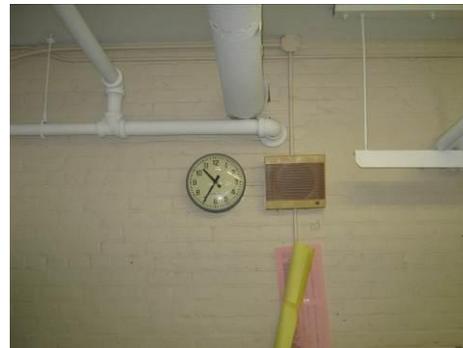
7. The exit signs consist of fluorescent exit signs with batteries. This equipment is in good condition. It was noticed that some exit signs are covered by piping reducing their visibility. Additional exit signs are required to meet current requirements for exit signs.
8. The existing PA system consists of wall mounted speakers and a Rauland Telecenter control system. There is also a central clock system that appears to be operational and in good condition.
