Space Needs Analysis Bristol Municipal Buildings

Memorial Boulevard School

70 Memorial Boulevard

Current Facility

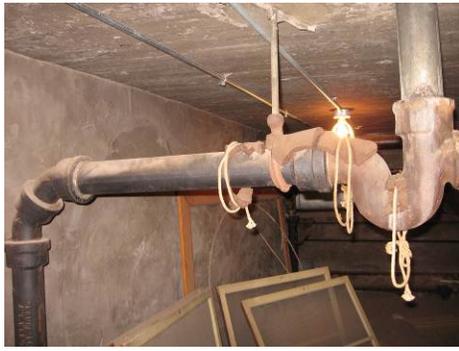
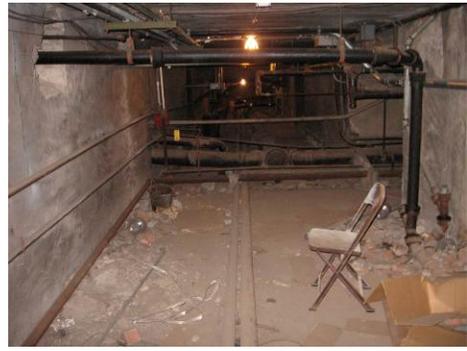
- a. Existing Sanitary Service: The sanitary sewer system provides sanitary waste drainage for plumbing fixtures located throughout the building. The piping material above grade is primarily cast iron. The plumbing fixtures drain to buried sanitary waste piping to the buildings exterior and to the municipal sewer system.

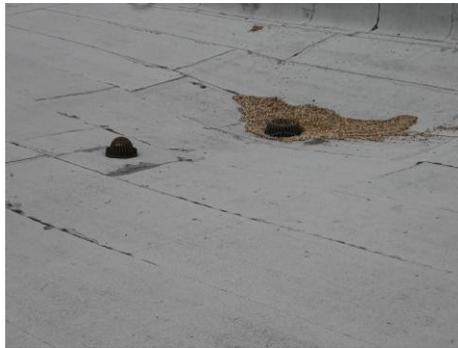
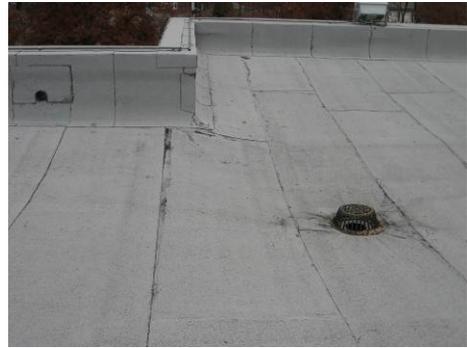
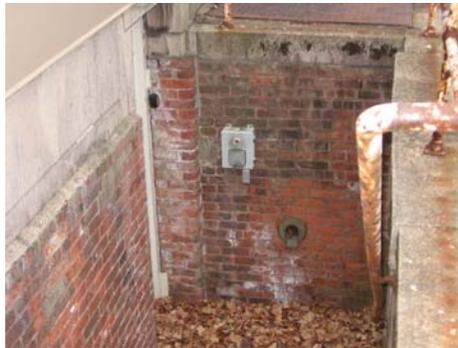
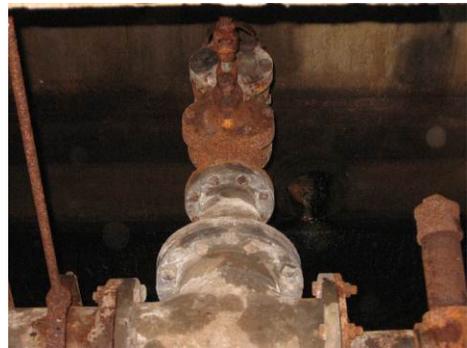
- a. The storm piping is roof drains, secondary roof drains, and downspouts that drain to an underground piping system and drains to a storm water pump station located in an adjacent building at the playfields. Storm water is then pumped to the municipal storm water system. The piping is in fair condition. The storm water pumps and equipment is in poor condition.

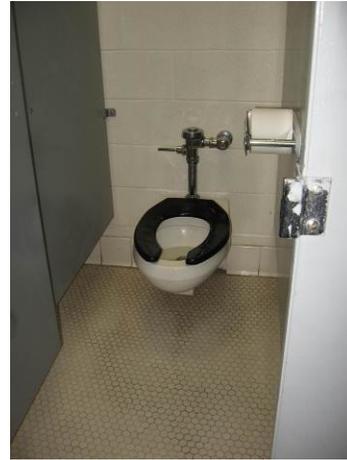
- Water closets are wall and floor mounted vitreous china with flush valves. Most of the fixtures are original to the facility in fair condition. The fixtures are non-water conserving type and non-ADA compliant.

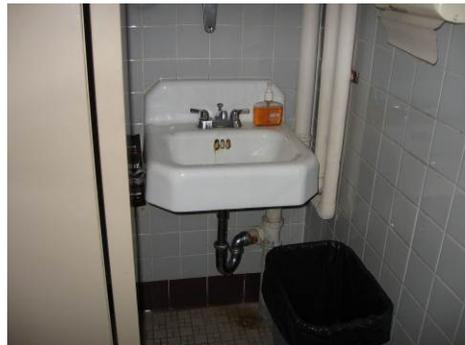
- Lavatories are wall hung vitreous china with two twist or metered style faucets. The fixtures are mainly original to the facility in fair condition. The fixtures are non-water conserving type and the faucets and drains are non-ADA compliant.

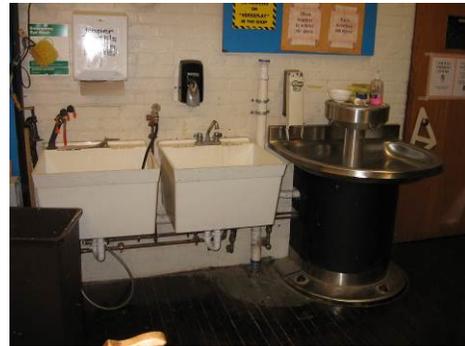
- Classroom sinks consist of pedestal mounted fiberglass units with two-lever faucets. These sinks are in good condition but are not ADA compliant. In the Tech Lab, there is also a wash fountain that is in fair condition.

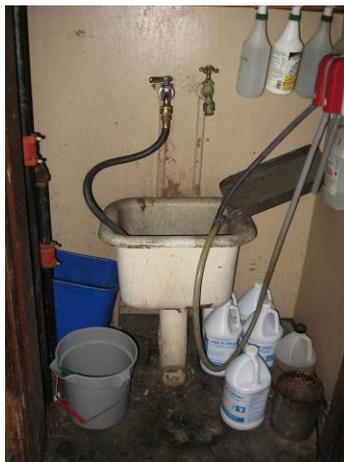
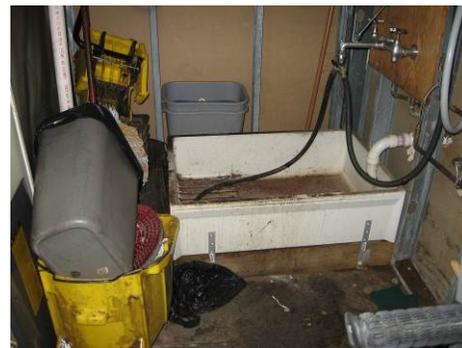
- Janitor sinks are a combination of wall mounted cast iron units with two lever faucets or floor mounted fiberglass units with two lever faucets. Some of these sinks have vacuum breakers. The cast iron sinks are original to the building and in poor condition.

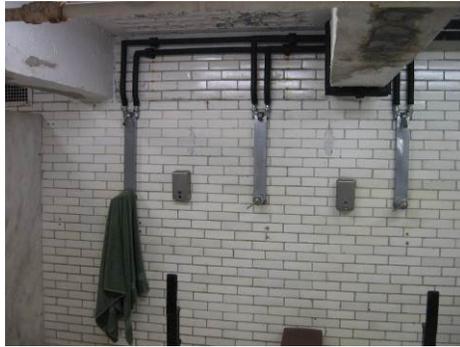
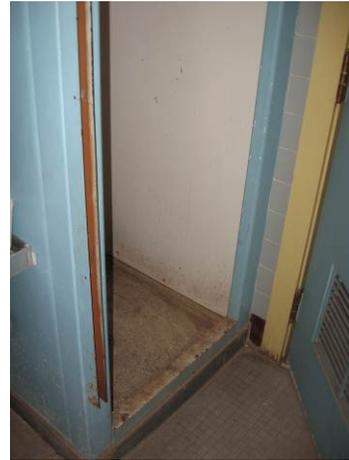
- There are existing showers located in the locker rooms. There is also a single shower in the Custodian Area. This equipment is original to the facility, in poor condition, and non-ADA compliant.

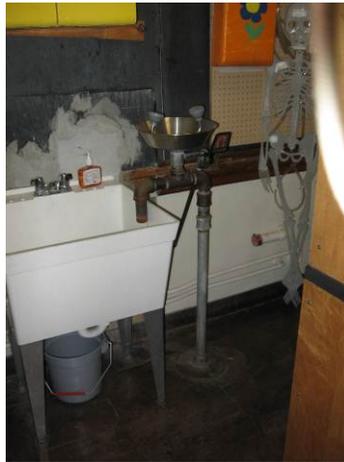
- There are emergency eyewash units located at some sinks in the classroom areas. These units drain directly into the adjacent sinks. These units are in good condition.

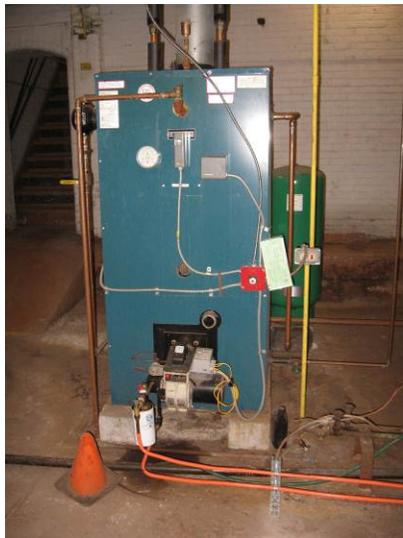
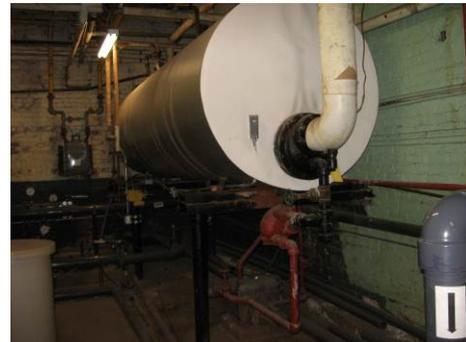
1. The existing domestic hot water system includes a Burnham Model FD2LLVOT low pressure hot water boiler with a Beckett CF800 Burner. This boiler provides water to a 1000gallon domestic water storage tank. The boiler, burner, and storage tank are in good condition. The recirculation pump at the storage tank is in poor condition.

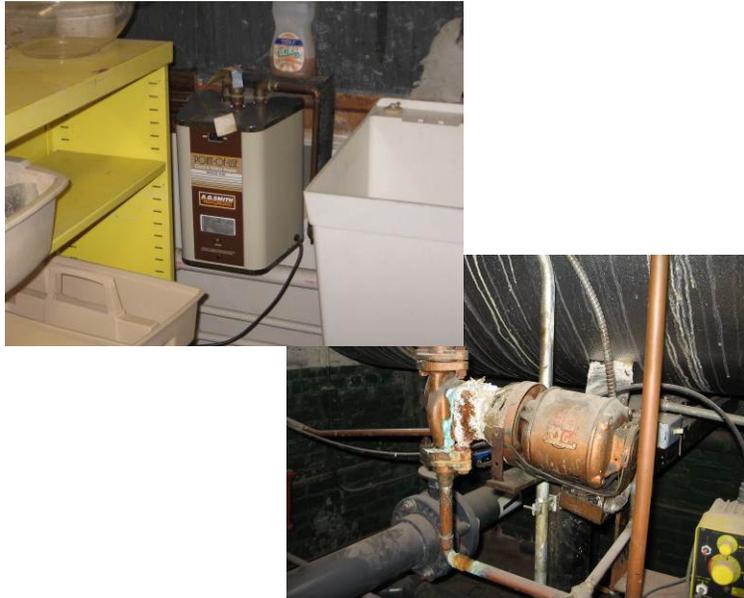
2. At (1) sink in one of the classrooms there is an instantaneous electrical water heater installed to serve that particular sink. This water heater is in good condition.

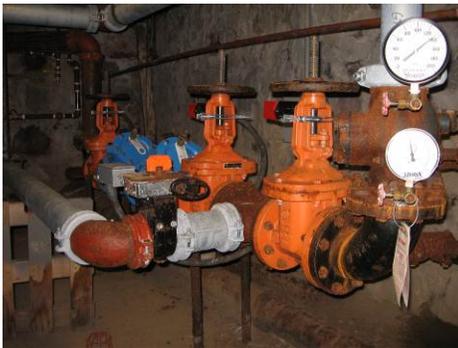
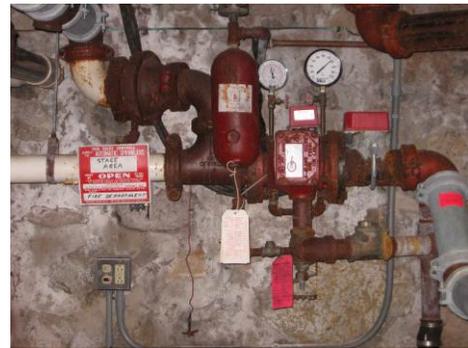
1. The building is served by a 4" fire protection service fed from a fire main in Summit Street. The original fire protection service only fed the stage area of the Auditorium. The fire service was upgraded to include sprinklers throughout most of the building with the exception of the renovated pool area. Sprinklers were not provided throughout the pool area when it was renovated. The fire service includes a shut-off valve and Watts Model 909 reduced pressure

backflow preventer. This fire service equipment has been recently installed and is in good condition, however, the sprinkler piping and sprinkler heads are an older installation, more than 30 years old, and should be replaced.

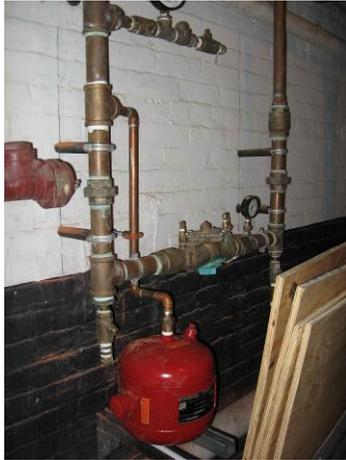
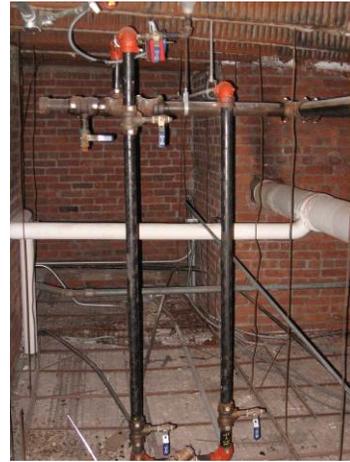
2. The fire protection system includes (2) antifreeze systems where antifreeze is added to the sprinkler piping to avoid freezing of the piping. This equipment is in good condition.

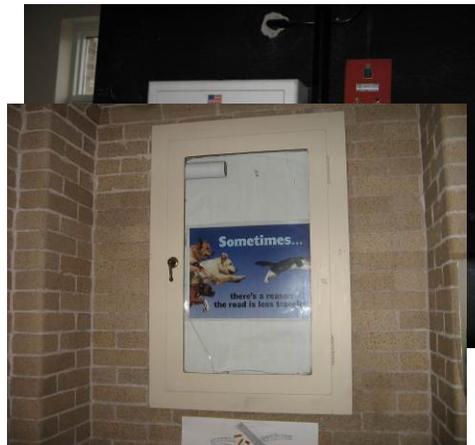
3. There are hose cabinets and standpipes located on the stage. This equipment is in good condition.

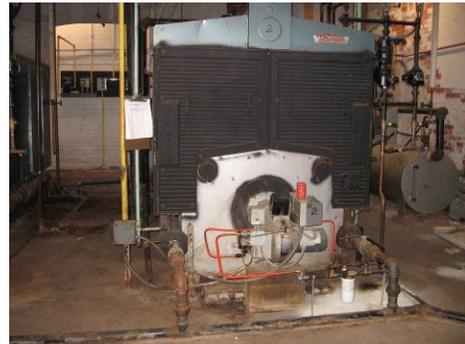
1. The existing building is heated by (2) HB Smith Mills 450 21-section cast iron steam boilers with Carlin oil burners. The boilers and burners were installed in 1974 and are in poor condition. The boilers are showing signs of leaks at the individual sections.

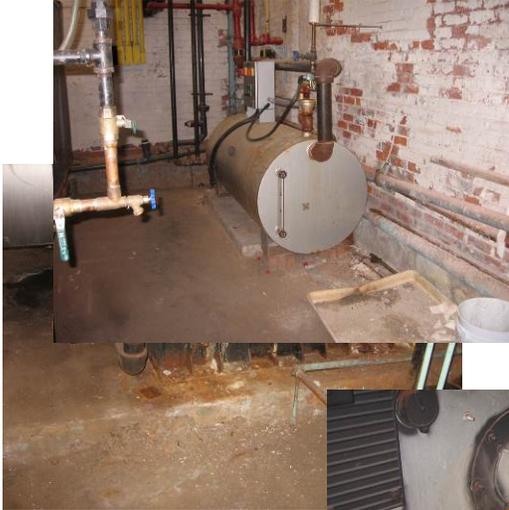
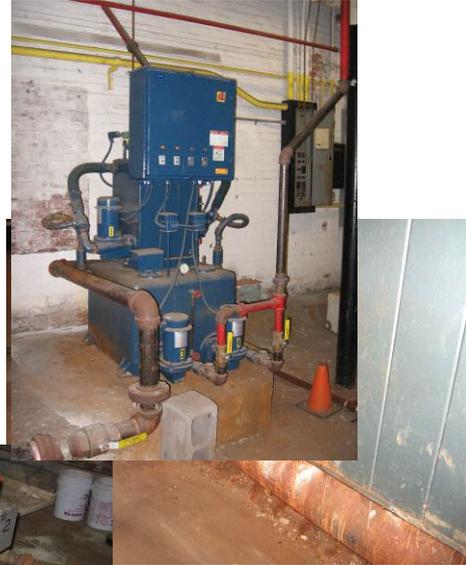
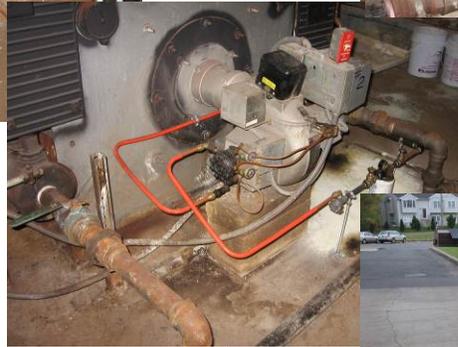
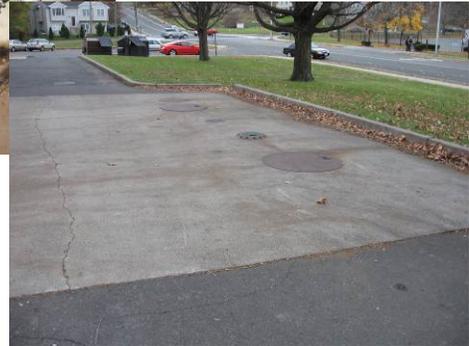
2. The heating plant also includes a vacuum condensate receiver and boiler feed system. The vacuum condensate system is less than ten years old and in good condition. The boiler feed system is also in good condition.

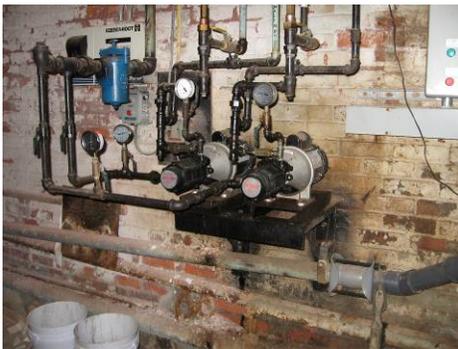
3. There is a buried 10,000 gallon fuel oil tank located on the north side of the building. There is a duplex fuel oil pump set located in the boiler room that pumps fuel oil from the tank to the boilers. There is also a fuel oil fill alarm system. All of this equipment is in fair to good condition.

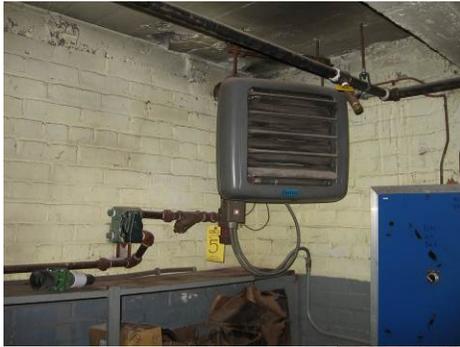
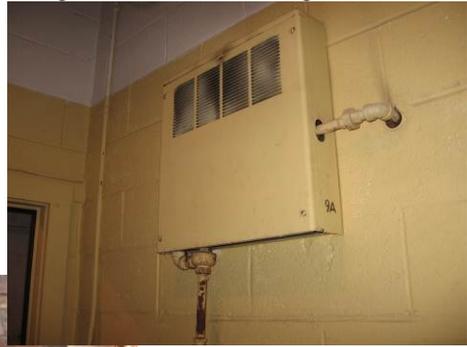
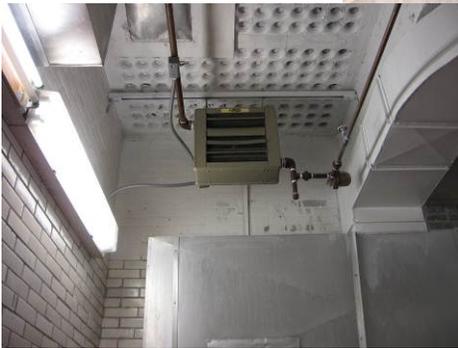
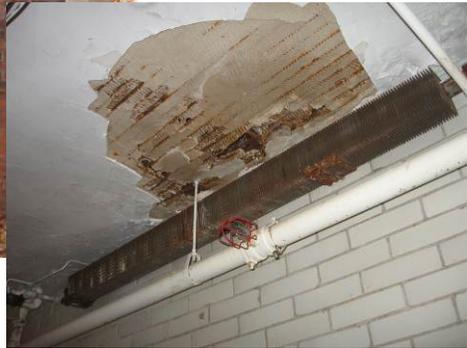
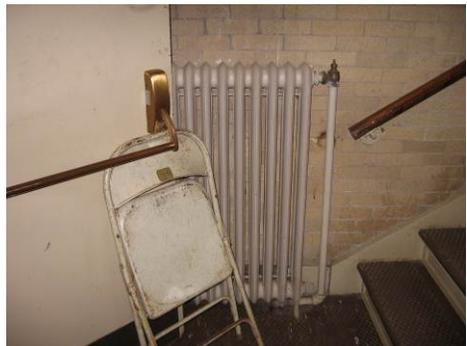
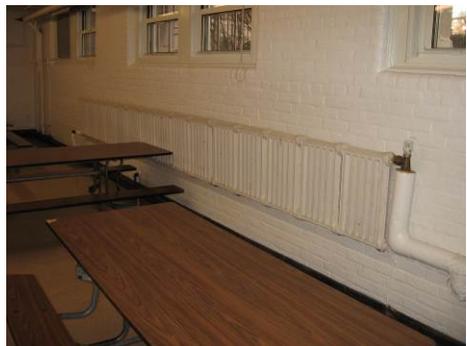
4. The present heating system also includes cabinet unit heaters, ceiling mounted unit heaters, cast iron radiators and baseboard radiation. Most of the heating units within the stairwells have been disconnected. Most of this equipment is original to the building and is in fair to

very poor condition.

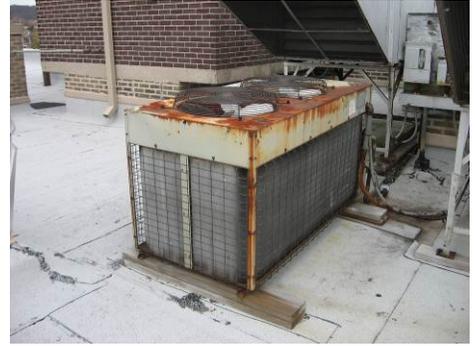
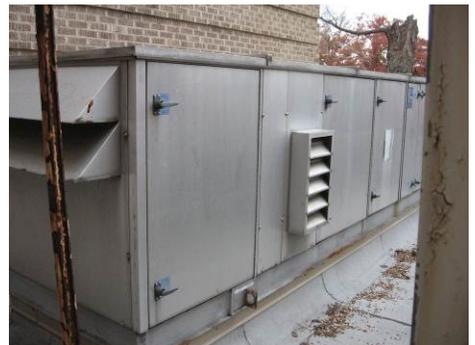
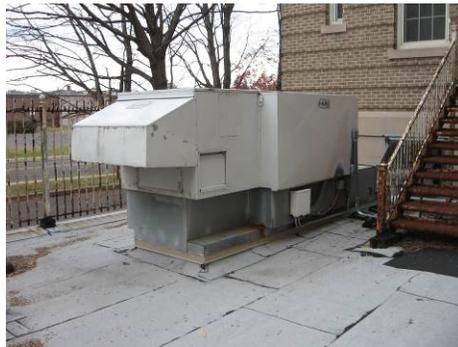
5. There are a number of air handling units that serve various areas of the building. There are (3) Seasons 4 air handling units for heat only. Only (1) of these units is operational. There is

a Herman Nelson Audi-Vent unit that serves the Gymnasium. This unit is in poor condition. There is an Aaon air handling unit that is approximately (10) years old that is not operational. The unit that serves the Auditorium is approximately (20) years old and is used for cooling only. The air handling unit that serves the Administration area is located above the ceiling in the area with a remote condensing unit. The remote condensing unit is over (20) years old and in poor condition.

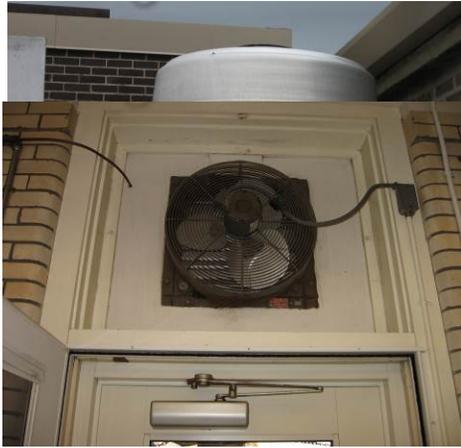
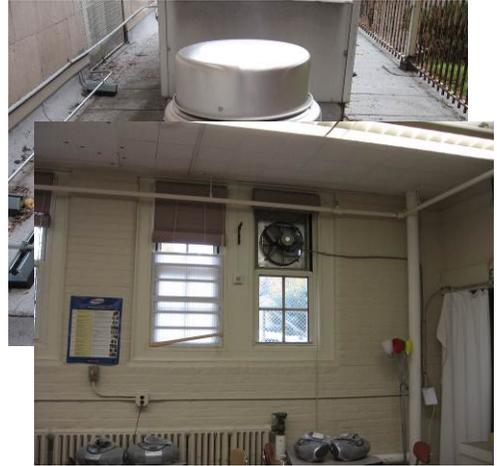
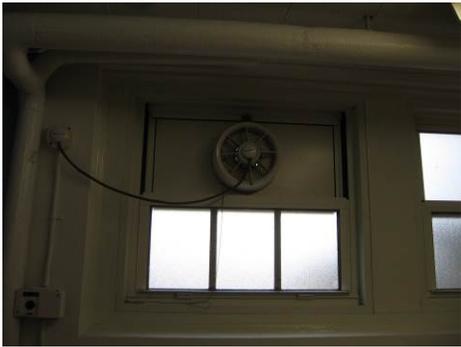
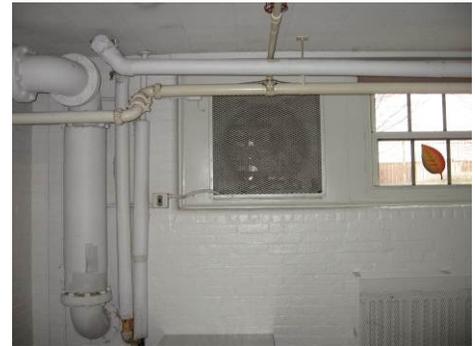
7. There are various exhaust fans throughout the building that serve general areas such as corridors and the gymnasium which includes roof mounted exhaust fans, ductwork, grilles and controls. The ventilation systems do not meet current codes for ventilation rates based on the age of the facility. The exhaust fans range from fair to good condition.

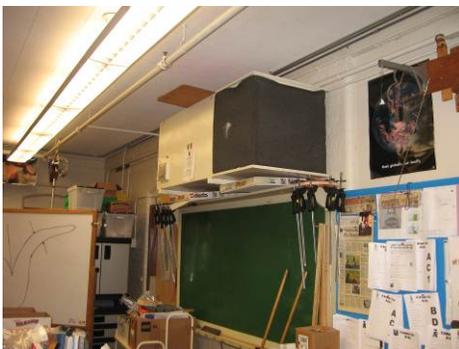
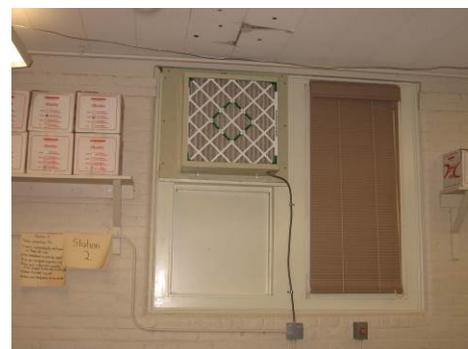
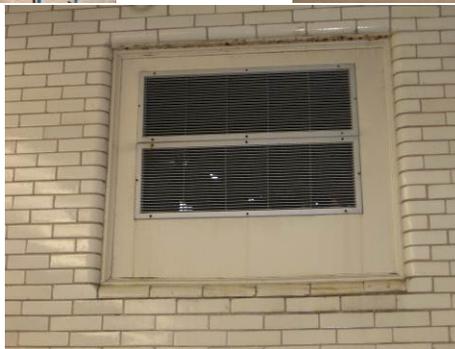
9. The Tech-Ed area has air filtration systems, wall mounted to process the air within the space. This area should have a dedicated exhaust and make-up air system to remove any air with odors, etc.

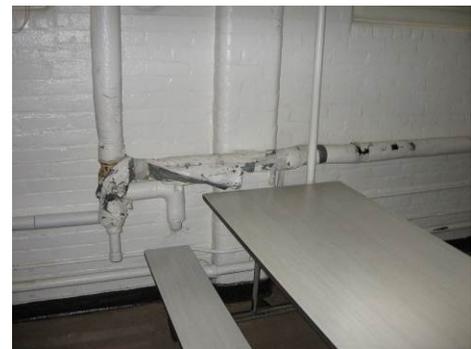
11. The steam piping consists of iron supply and condensate return piping. Some of this piping is missing insulation or the insulation has failed and replaced.

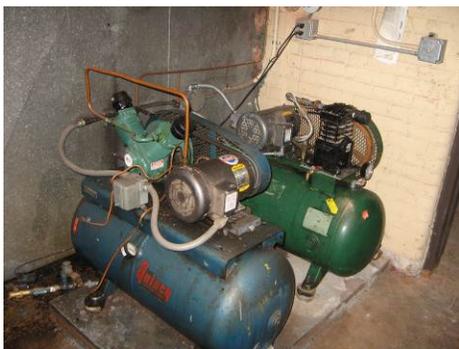
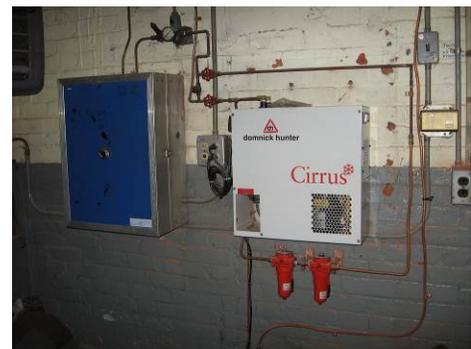
12. The existing temperature control system is a pneumatic system consisting of two air compressors, air dryer, and local controls mounted at the individual radiators, cabinet unit heaters, etc. and additional sensors throughout the building. The pneumatic equipment is in fair condition.

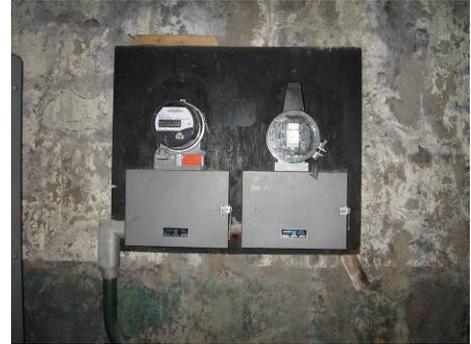
1. The building is served by a single electrical service rated 1600amperes, 208Y/120volts, 3-phase, 4-wire. This service equipment consists of a 1600amp main disconnect switch, distribution section and metering per utility company requirements. The service equipment is approximately 30 years old and in fair condition.

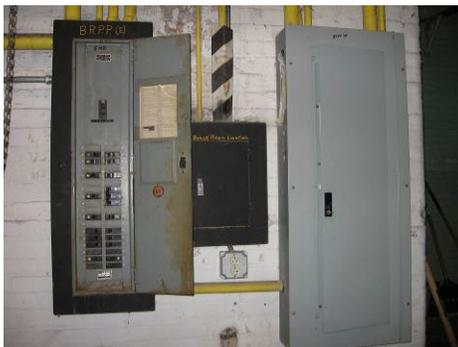
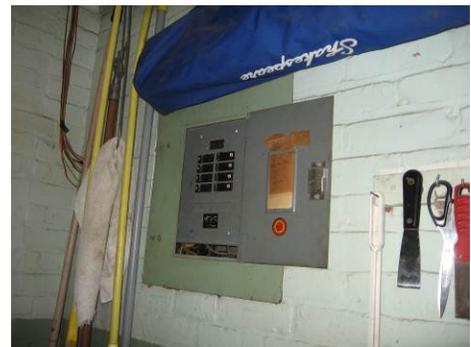
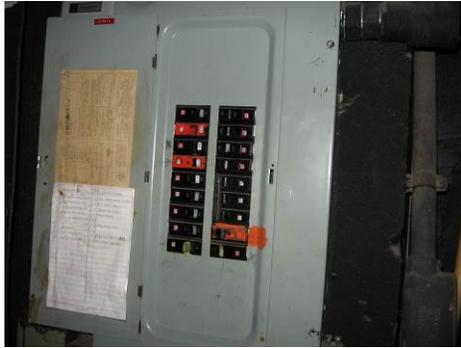
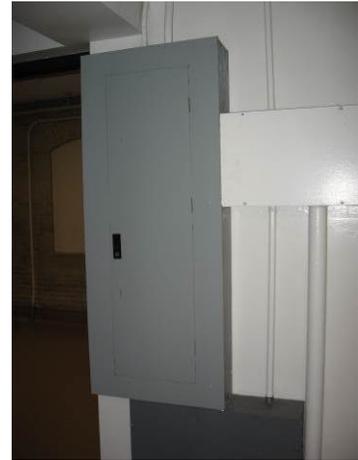
3. There are a number of electrical panels located throughout the facility. These panelboards range from ones that were installed original to the building and others that that have been installed to accommodate the addition of computers throughout the school. The condition of these panelboards range from poor to very good.

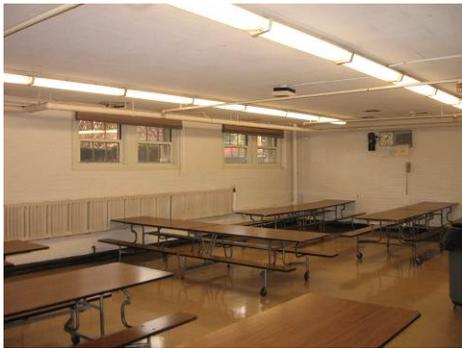
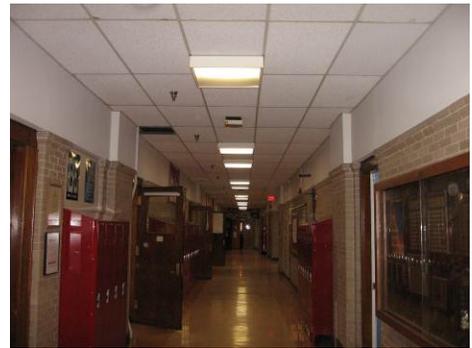
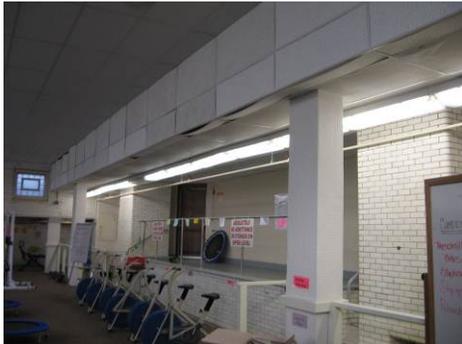
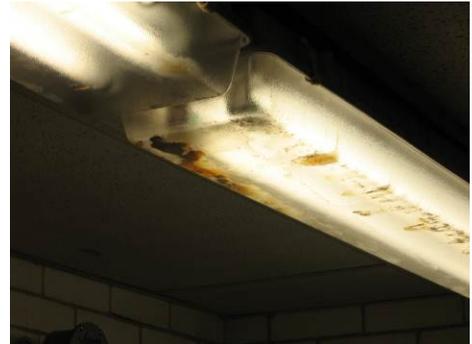
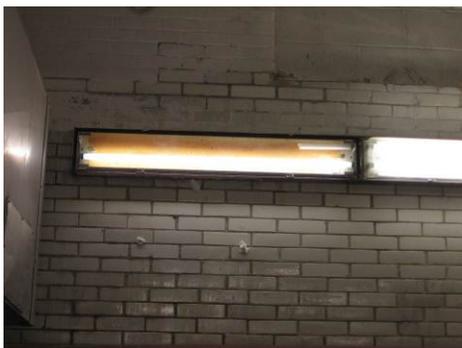
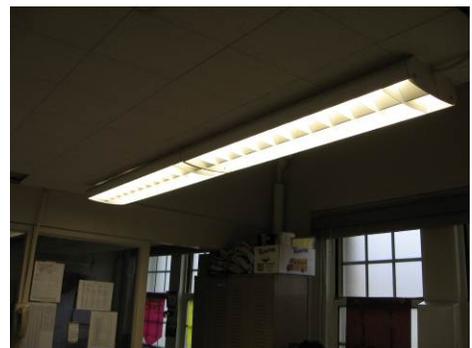
4. The lighting throughout the facility consists primarily of surface mounted acrylic lensed troffer style fluorescent fixtures or pendant mounted louvered fluorescent fixtures. Some areas such as storage rooms, mechanical rooms have industrial fluorescent fixtures. Most of the lighting has been upgraded to newer T8 technology, however, there are other fixtures using older T12 technology or incandescent lamps. Some of the fixtures have been damaged and are missing lenses. The lighting ranges from good to poor condition.

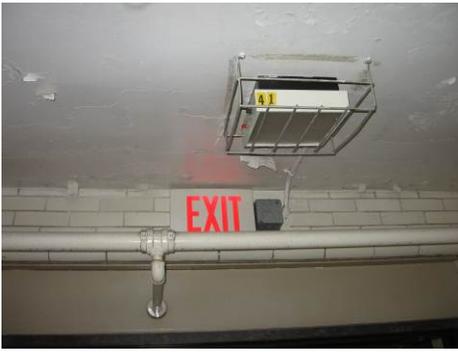
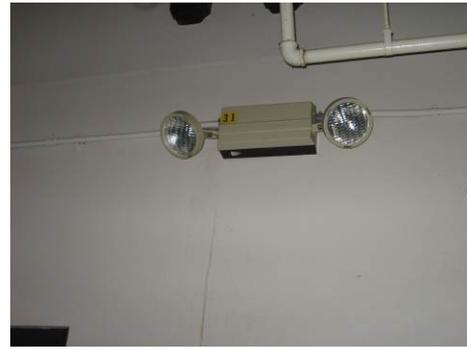
- The emergency lighting is provided by two-head self-contained emergency fixtures with batteries or a surface mounted 9"x9" self-contained emergency fixture. This system is operational however the equipment is in poor condition. Additional lighting fixtures are required to meet current requirements for emergency lighting.

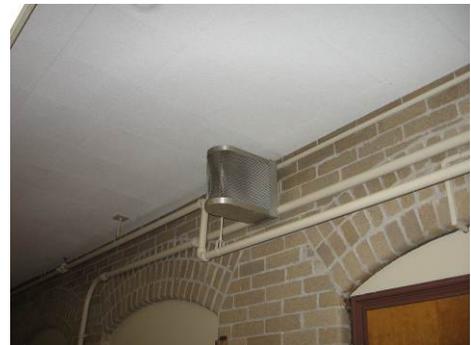
9. The existing PA system consists of wall or ceiling mounted speakers. It is manufactured by Bogen, Model Multicom 2000. The head end equipment is located in the main office. This head end equipment is in very good condition. Some of the speakers show signs of damage and should be replaced.

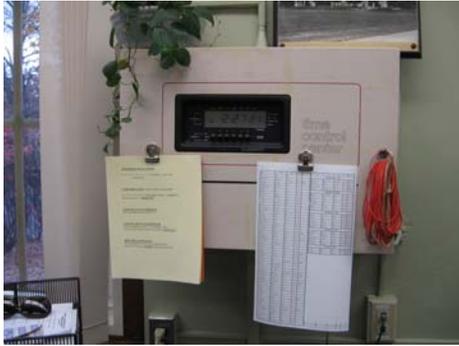
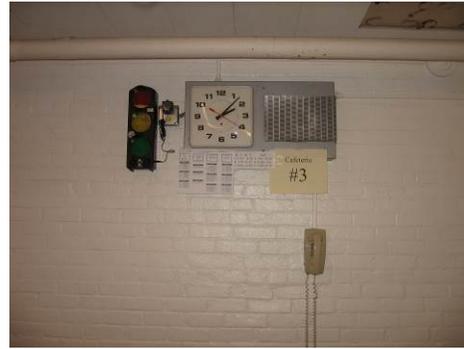
10. A central clock system manufactured by Simplex, including a control panel and wall mounted clocks is existing at the building. It appears that this system is operational and in fair condition. Some areas have had individual battery operated clocks added.
