Storm Water Control Trust
Annual Inspection Report

March 2023

RE: Storm Water Detention Pond Report – March 3, 2023

DETENTION POND INVENTORY REPORT

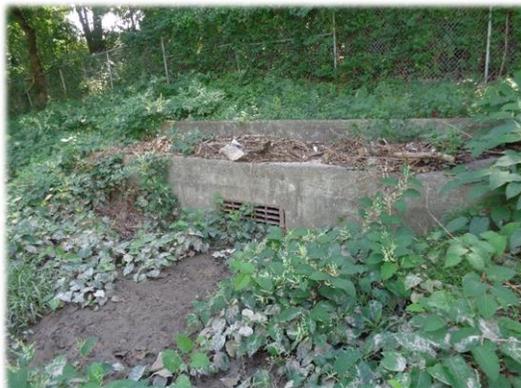
<u>Structures</u>	<u>Vegetation</u>	<u>Site Conditions</u>
Manholes _____ A	Grass _____ V	Animals _____ N/O
Catch basin _____ NA	Trees _____ G	Debris _____ M
Pipes _____ (1)	Brush _____ (4)	Erosion _____ (1)
Inlet condition _____ (1)		Sink holes _____ N/O
Outlet structure _____ A		Trespassing _____ N/O
Pond condition _____ A		Other _____ (3)
Fences _____ (2)

Photo 1: Outlet control structure

- (1) Pipe replacement is scheduled to be replaced (CIP funded), include rip rap check dam and spreader swale to eliminate short circuiting and grading and removal of sediments and excessive millings DPW scheduled to start work in March. Pipe and structure ordered.
- (2) Vegetation control needed, Fence post at west inlet is undermined
- (3) Invasives control needed

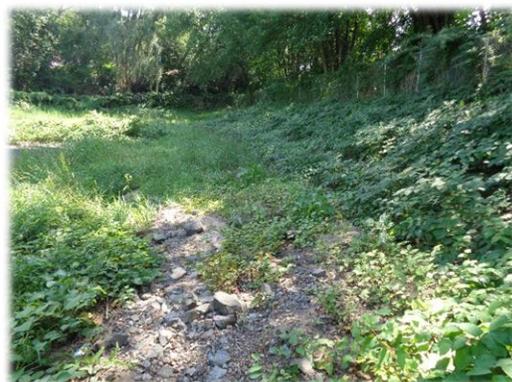
Photo 2: Looking east from west inlet

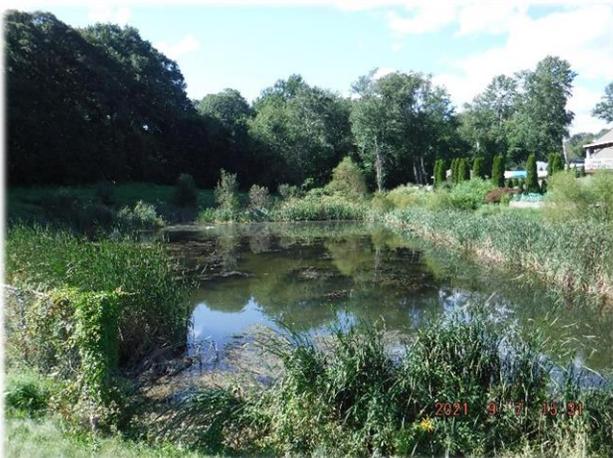
<u>Structures</u>	<u>Vegetation</u>	<u>Site Conditions</u>
Pipes _____ G	Grass _____ V	Animals _____ N/O
Inlet condition _____ (1)	Trees _____ A	Debris _____ M(4)
Outfall condition _____ (2)	Brush _____ na	Erosion _____ M(5)
Overflow _____ A		Sink holes _____ N/O
Fences _____ (3)		Trespassing _____ N/O
Dam _____ A		Other _____ NA
Course pool (n) _____ A		
Course pool (w) _____ A

Photo 1: Hart Street pond view looking north

- (1) Clear vegetation at outlet
- (2) Clear vegetation from fence

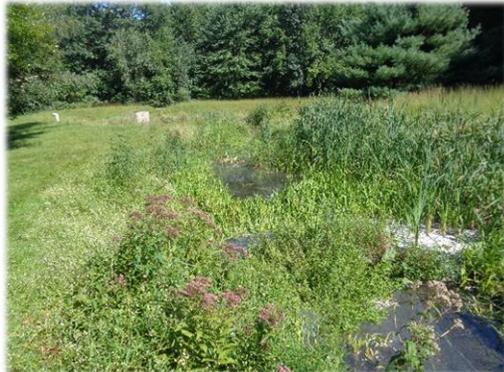
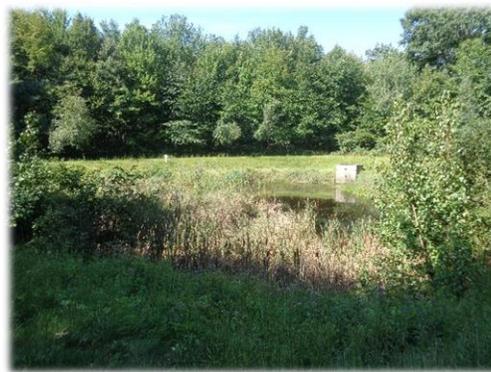
<u>Structures</u>	<u>Vegetation</u>	<u>Site Conditions</u>
Catch basin _____ Vac	Grass _____ (3)	Animals _____ N/O
Inlet condition _____ A	Trees _____ (4)	Debris _____ A
Outfall condition _____ G	Brush _____ A	Erosion _____ N/O
Overflow _____ A		Sink holes _____ N/O
Fences _____ N/A		Trespassing _____ N/O
Pond condition _____ (2)(3)		Other _____ (5)

Photo: Brandon Run pond view looking north and northwest

(1) Clean minor litter (2) Keep trees trimmed along Brandon access path

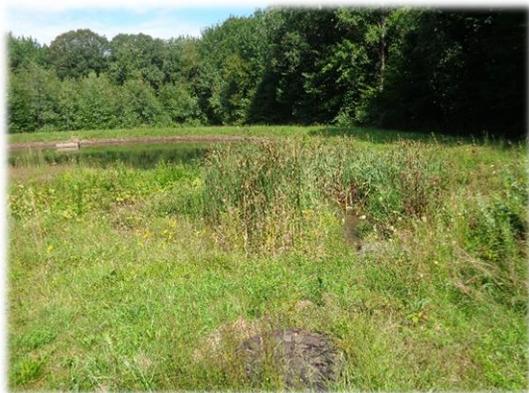
<u>Structures</u>	<u>Vegetation</u>	<u>Site Conditions</u>
Catch basin _____ A	Grass _____ A	Animals _____ (4)
Inlet condition ___(1)(2)(3)	Trees _____ A	Debris _____ N/O
Outfall condition ____ (5)	Brush _____ A	Erosion _____ N/O
Overflow _____ G		Sink holes _____ N/O
Fences _____ N/A		Trespassing _____ N/O
Course pool (n) _____ A		Other _____ (5)

Photo 1: Tiffany Lane pond, looking northwest

- (1) Remove fore bay sediments and vegetation
- (2) Repair erosion at access drive
- (3) Clean minor pond litter
- (4) Keep outley structure clear of debris

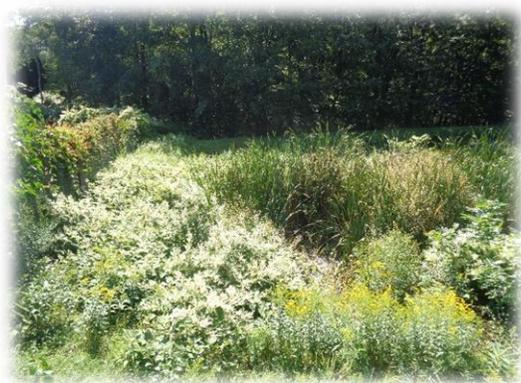
<u>Structures</u>	<u>Vegetation</u>	<u>Site Conditions</u>
Catch basin _____ (1)	Grass _____ (3)	Animals _____ N/O
Inlet condition _____ (2)(3)	Trees _____ A	Debris _____ (5)
Outfall condition _____ G	Brush _____ (4)	Erosion _____ N/O
Overflow _____ A		Sink holes _____ N/O
Fences _____ (4)		Trespassing _____ N/O
Berm _____ A		Other _____ N/A

Photo 1: Tyler Way pond looking south from gate

- (1) In lower basin, remove portions of cattails (max 30% coverage), sediments and construct additional riprap/spreader swale
- (2) Invasives/vegetation removal needed in pond and on fence
- (3) Clean minor litter

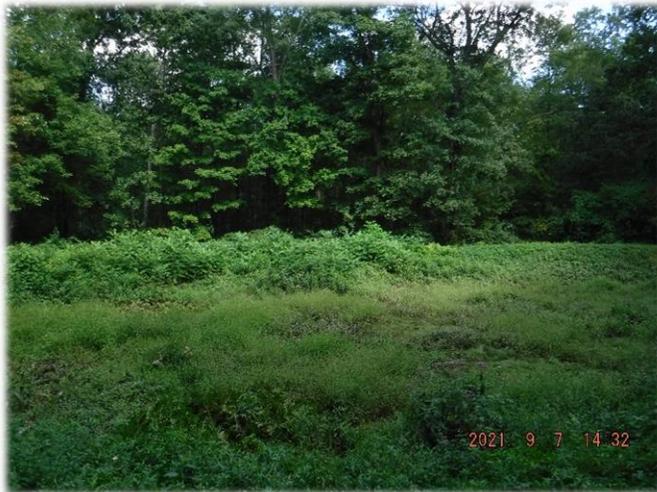
<u>Structures</u>	<u>Vegetation</u>	<u>Site Conditions</u>
Catch basin _____ A	Grass _____ V	Animals _____ N/O
Pipes _____ A	Trees _____ NA	Debris _____ N/O
Inlet condition _____ (1)	Brush _____ G	Erosion _____ N/O
Outfall condition _____ G		Sink holes _____ N/O
Overflow _____ (2)		Trespassing _____ N/O
Fences _____ (3)		Other _____ NA
Berm _____ G

Photo 1: Intervale Road pond, looking east

(1) Clean vegetation off fence

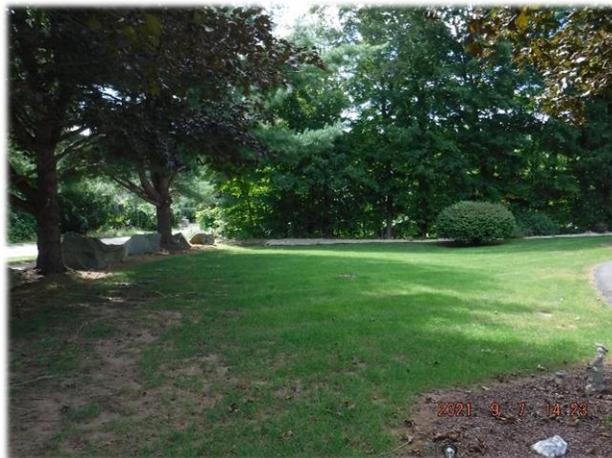
<u>Structures</u>	<u>Vegetation</u>	<u>Site Conditions</u>
Catch basin _____ Vac(1)	Grass _____ A	Animals _____ N/O
Pipes _____ A	Trees _____ A	Debris _____ N/O
Inlet condition _____ (1)	Brush _____ NA	Erosion _____ N/O
Infiltration _____ (e)		Sink holes _____ N/O
Overflow _____ (1)		Trespassing _____ N/O
		Other _____ NA

Photo: Cricket Hill detention area, looking west

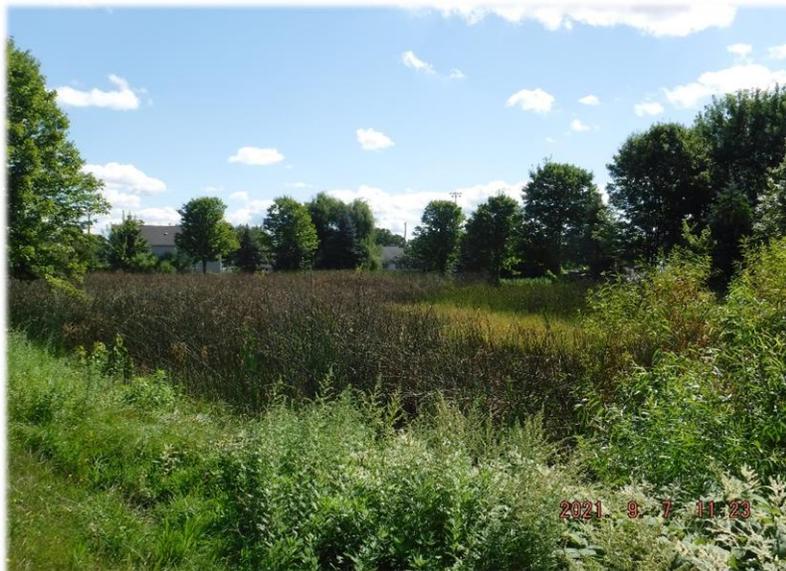
<u>Structures</u>		<u>Vegetation</u>		<u>Site Conditions</u>	
Sed. chamber _____	A	Grass _____	V	Animals _____	N/O
Inlets condition _____	e	Trees _____	G	Debris _____	e
Outfall Condition _____	e	Brush _____	V	Erosion _____	N/O
Overflow _____	A	Aquatic Vegetation __	AV(1)	Sink holes _____	N/O
Fences _____	A			Trespassing _____	N/O
Berms _____	A			Other _____	(2)

Photo 1: Sunnydale detention area, looking east

(1) Invasives and vegetation management needed

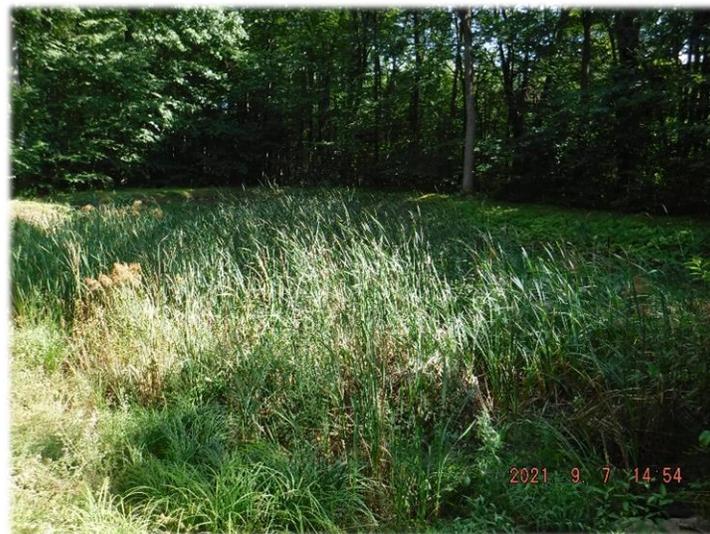
<u>Structures</u>	<u>Vegetation</u>	<u>Site Conditions</u>
Sed. chamber _____ A	Grass _____ G	Animals _____ N/O
Catch basin _____ A	Wetland plants _____ A	Debris _____ N/O
Manhole _____ A	Trees _____ A	Erosion _____ N/O
Inlet Condition _____ A	Brush _____ G	Sink holes _____ N/O
Outfall Condition _____ G		Trespassing _____ N/O
Berms _____ G		Other _____ N/A

Photo: Partridge Run pond basin, looking east

1. Invasive/vegetation management needed

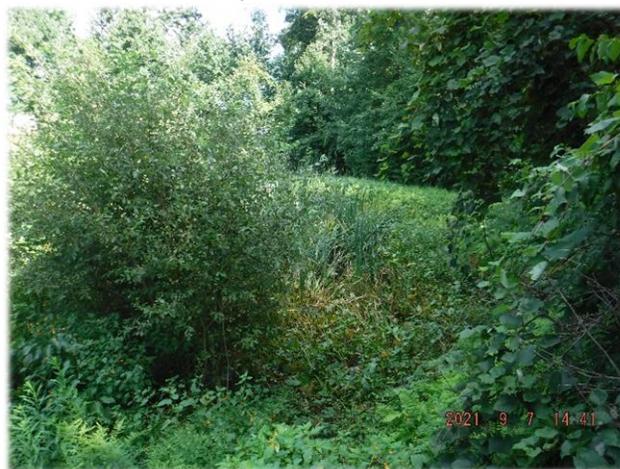
<u>Structures</u>	<u>Vegetation</u>	<u>Site Conditions</u>
Sed. chamber _____ A	Grass _____ G	Animals _____ N/O
Catch basin _____ A	Wetland plants _____ (1)	Debris _____ N/O
Inlet Condition _____ e	Trees _____ A	Erosion _____ N/O
Outfall Condition _____ e	Brush _____ G	Sink holes _____ N/O
Overflow _____ e		Trespassing _____ N/O
Fences _____ (2)		Other _____ NA
Berm _____ e		
Riprap _____ e

Photo 1: Fox Hollow West, looking east

(1) Construct gate access between lots and repair fence

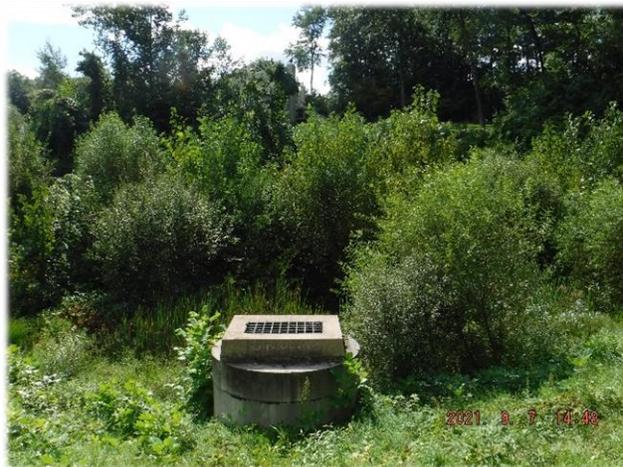
<u>Structures</u>	<u>Vegetation</u>	<u>Site Conditions</u>
Sed. chamber _____ A	Grass _____ G	Animals _____ N/O
Catch basin _____ A	Wetland plants _____ (1)	Debris _____ N/O
Inlet Condition _____ e	Trees _____ (1)	Erosion _____ N/O
Outfall Condition _____ G	Brush _____ (1)	Sink holes _____ N/O
Overflow _____ G		Trespassing _____ N/O
Fences _____ G		Other _____ NA
Berm _____ G		
Riprap _____ G		
Course pool _____ (1)(2)

Photo 1: Fox Hollow East basin area, looking west

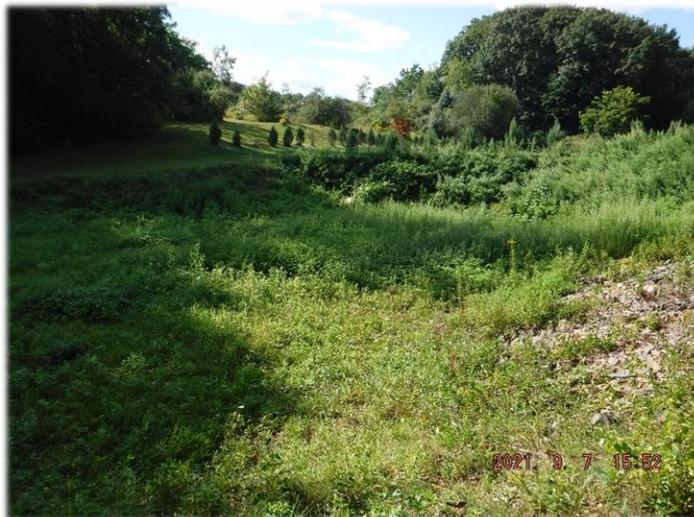
<u>Structures</u>	<u>Vegetation</u>	<u>Site Conditions</u>
Catch basin _____ Vac	Grass _____ A	Animals _____ N/O
Inlet Condition _____ A	Trees _____ A	Debris _____ N/O
Outfall Condition _____ A	Brush _____ A	Erosion _____ N/O
Overflow _____ A		Sink holes _____ N/O
Fences _____ NA		Trespassing _____ N/O
Riprap _____ A		Other _____ NA
Course pool _____ A

Photo 1: Empire Way basin, looking SW

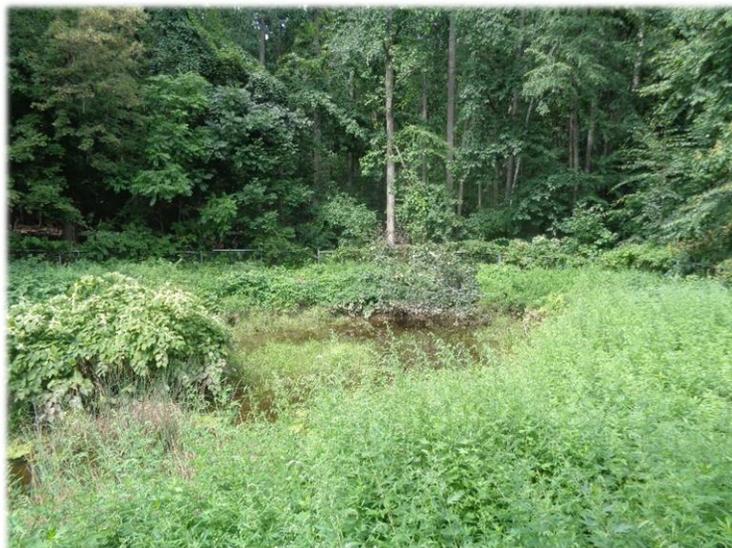
<u>Structures</u>	<u>Vegetation</u>	<u>Site Conditions</u>
Catch basin _____ Vac	Grass _____ V	Animals _____ N/O
Inlet Condition _____ e	Wetland plants _____ (1)	Debris _____ N/O
Outfall Condition _____ e	Trees _____ A	Erosion _____ N/O
Overflow _____ e	Brush _____ G	Sink holes _____ N/O
Fences _____ (2)		Trespassing _____ N/O
Berms _____ e		Other _____ (3)
Riprap _____ e

Photo 1: Medford St pond, looking north

(1) Seed Yard at access point

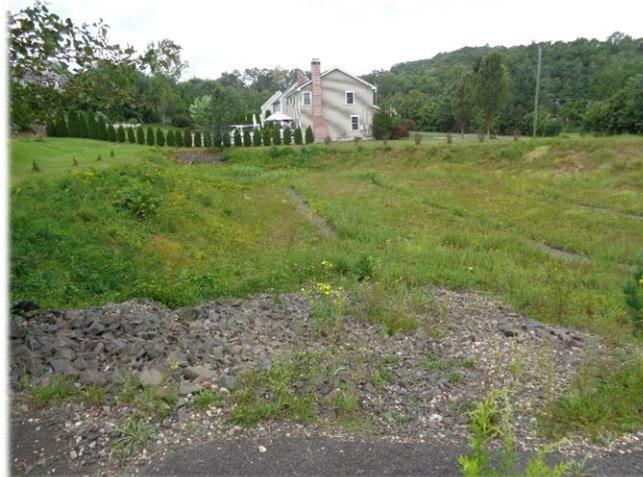
Structures		Vegetation		Site Conditions	
Catch basin _____	A	Grass _____	A	Animals _____	N/O
Inlet Condition _____	A	Brush _____	A	Debris _____	N/O
Outfall Condition _____	(1)			Erosion _____	N/O
Overflow _____	A			Sink holes _____	N/O
Berms _____	A			Trespassing _____	N/O
Riprap _____	A			Other _____	NA
Legend: A=Adequate, G=Good, M=Minor, N/O = None Observed, NA=None or Not applicable					
V=Vegetation control to be scheduled, AV=Aquatic Vegetation control to be scheduled					
Vac=Schedule vac truck, f/l=fenced and locked, e=evaluate after maintenance					
(1) Minor vegetation control at control structure

Photo 1: Warner St basin, looking northwest

(1) Gate lock missing **(2)** Clean minor litter

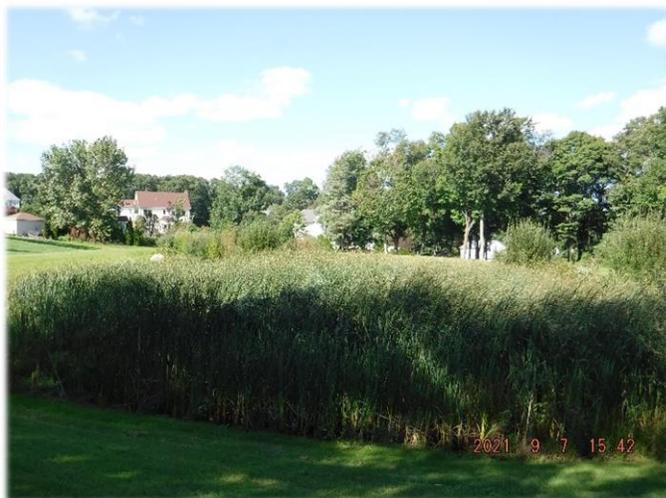
<u>Structures</u>	<u>Vegetation</u>	<u>Site Conditions</u>
Sediment Chamber _____ A	Grass _____ A	Animals _____ NO
Catch basin _____ A	Wetland Plants _____ (2)	Debris _____ A
Inlet Condition _____ (1)	Trees _____ A	Erosion _____ N/O
Outfall Condition _____ A	Brush _____ A	Sink holes _____ N/O
Overflow _____ (2)		Trespassing _____ N/O
Berms _____ A		Other _____ NA

Photo 1: Belgian Circle pond, looking north

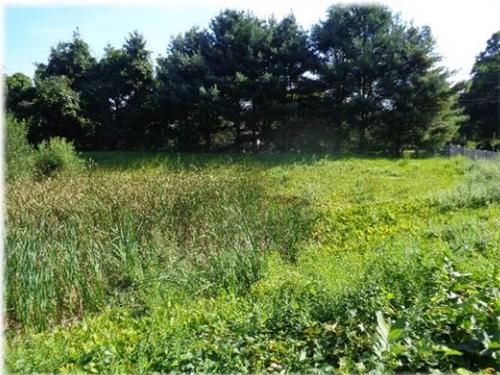
<u>Structures</u>	<u>Vegetation</u>	<u>Site Conditions</u>
Sediment Chamber ____ Vac	Grass _____ V	Animals _____ N/O
Catch basin _____ Vac	Wetland Plants _____ (3)	Debris _____ N/O
Inlet Condition _____ (1)	Trees _____ (3)	Erosion _____ N/O
Outfall Condition _____ A	Brush _____ (3)	Sink holes _____ N/O
Overflow _____ A		Trespassing _____ N/O
Berms _____ A		Other _____ N/A
Fences _____ (2)

Photo 1: Witches Rock pond, looking northeast

(1) Remove fallen tree limbs in back left corner

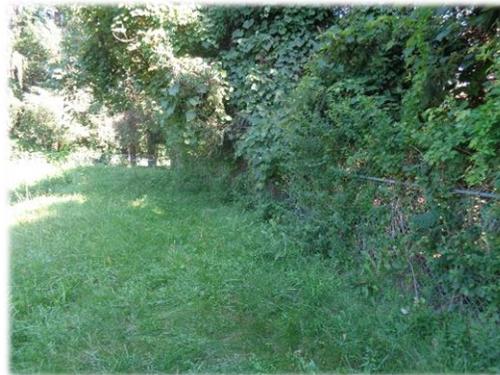
Photo 2: Looking north along east fence line

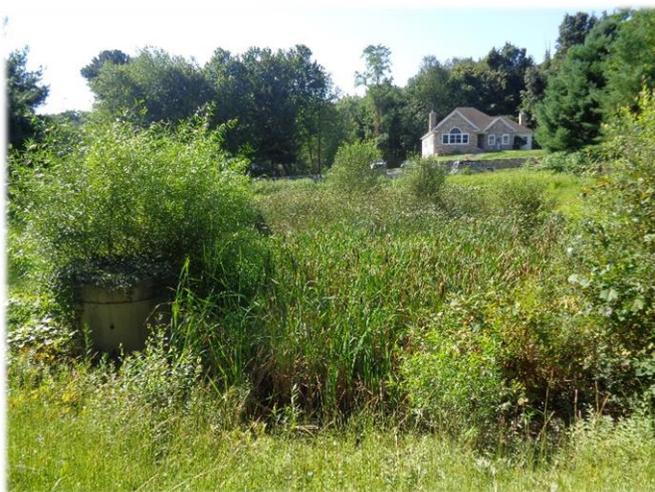
<u>Structures</u>	<u>Vegetation</u>	<u>Site Conditions</u>
Sediment Chamber _____ (1)	Grass _____ A	Animals _____ N/O
Catch basin _____ (1)	Wetland Plans _____ (4)	Debris _____ N/O
Inlet Condition _____ (2)(3)	Trees _____ A	Erosion _____ N/O
Outfall Condition _____ M	Brush _____ A	Sink holes _____ N/O
Overflow _____ A		Trespassing _____ N/O
Berms _____ A		Other _____ N/A
Fences _____ (5)

Photo 1: Old Orchard pond, looking south

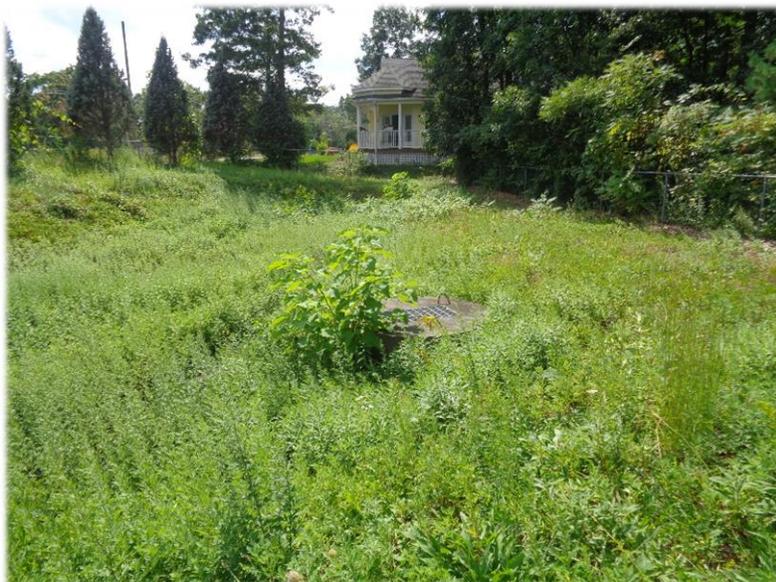
<u>Structures</u>	<u>Vegetation</u>	<u>Site Conditions</u>
Catch basin _____ Vac	Grass _____ V	Animals _____ N/O
Inlet Condition _____ e	Trees _____ A	Debris _____ N/O
Outfall Condition _____ A	Brush _____ A	Erosion _____ N/O
Overflow _____ A		Sink holes _____ N/O
Berms _____ A		Trespassing _____ f/l
Fences _____ A		Other _____ (1)

Photo 1: Bird Road pond, looking south

(1) Remove vegetation from fence

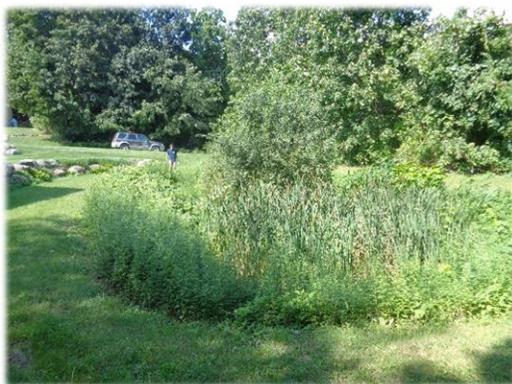
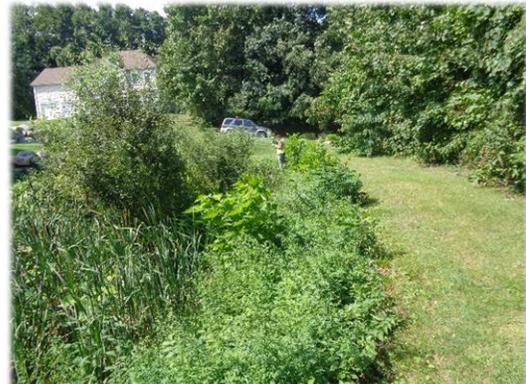
<u>Structures</u>	<u>Vegetation</u>	<u>Site Conditions</u>
Catch basin _____ Vac	Grass _____ V	Animals _____ N/O
Inlet Condition _____ e	Trees _____ V	Debris _____ N/O
Pond condition _____ (1)	Brush _____ AV	Erosion _____ N/O
Outfall Condition _____ (2)		Sink holes _____ N/O
Overflow _____ A		Trespassing _____ N/O
Berms _____ A		Other _____ None

Photos 1 and 2: Margaret Way pond, looking west

(1) Invasives/vegetation removal needed (2) Repair/replace control structure top,

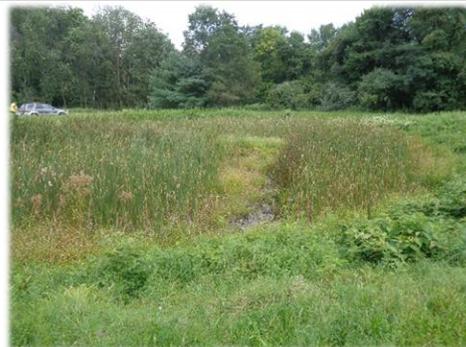
Structures	Vegetation	Site Conditions
Sediment Chamber ___ Vac	Grass _____ A	Animals _____ N/O
Catch basin _____ (1)	Wetland Plants _____ (2)	Debris _____ N/O
Inlet Condition _____ e	Trees _____ A	Erosion _____ N/O
Pond condition _____ (2)	Brush _____ A	Sink holes _____ N/O
Outfall Condition _____ A		Trespassing _____ N/O
Overflow _____ A		Other _____ NA
Berms _____ A

Photo 1: Valmore Road pond, looking north

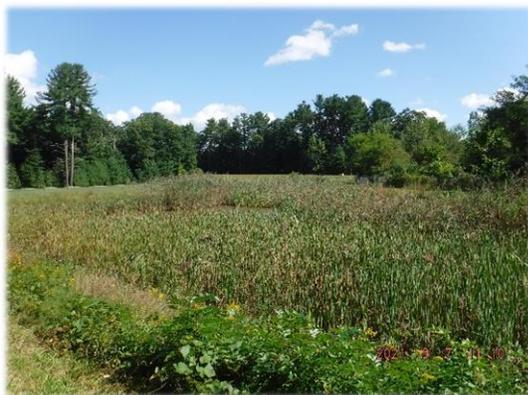
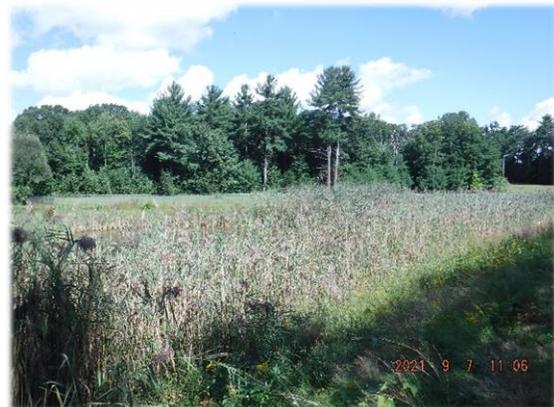
<u>Structures</u>	<u>Vegetation</u>	<u>Site Conditions</u>
Sediment Chamber ____ (e)	Grass _____ A	Animals _____ N/O
Catch basin _____ Vac	Wetland Plants _____ AV	Debris _____ N/O
Inlet Condition _____ (e)	Trees _____ V	Erosion _____ N/O
Pond condition _____ (e)	Brush _____ V	Sink holes _____ N/O
Outfall Condition _____ A		Trespassing _____ N/O
Overflow _____ A		Other _____ NA
Berms _____ A

Photos 1 and 2: SE Business Park pond, looking east and north

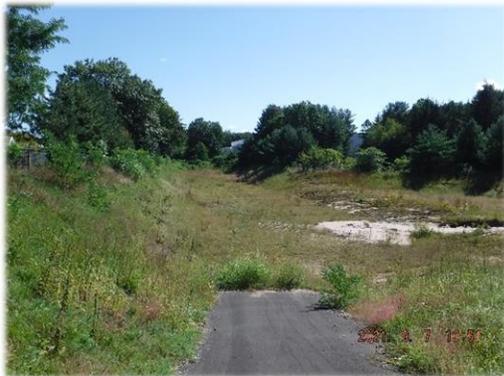
Structures	Vegetation	Site Conditions
Sediment Chamber _____ A	Grass _____ V	Animals _____ burrow
Catch basin _____ A	Trees _____ A	Debris _____ (2)
Inlet Condition _____ A	Brush _____ A	Erosion _____ (1)
Pond condition _____ A		Sink holes _____ N/O
Outfall Condition _____ A		Trespassing _____ yes (litter)
Berms _____ (1)		Other _____ NA

Photo 1: Middle St pond looking east

(1) minor litter

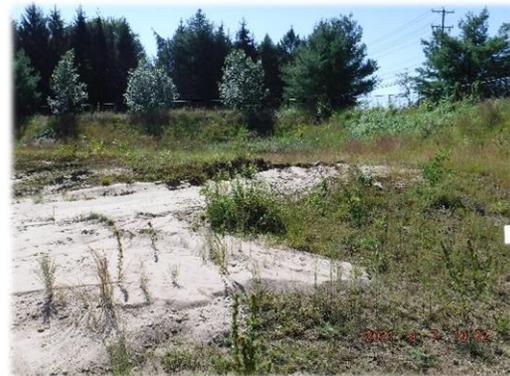
Photo 2: Berm wash-out
