PRELIMINARY ENGINEERING REPORT

**REPLACEMENT OF BRIDGE NO. 017041
FIELD STREET
OVER UNNAMED STREAM
BRISTOL, CONNECTICUT**

CITY OF BRISTOL

MAY 10, 2022

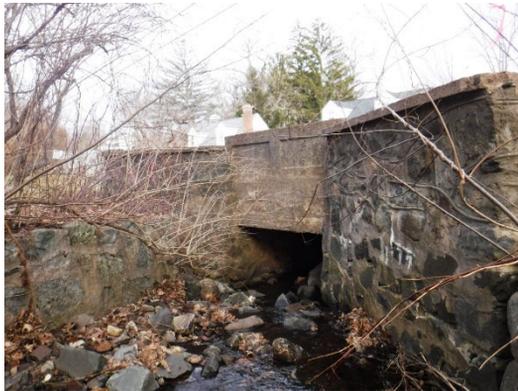
Upstream Elevation

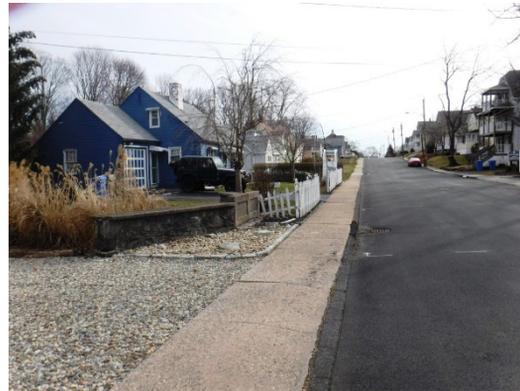
West Roadway Approach –Looking East

- The bituminous concrete roadway approaches have been recently resurfaced are in good condition.
- There are no approach guiderails.

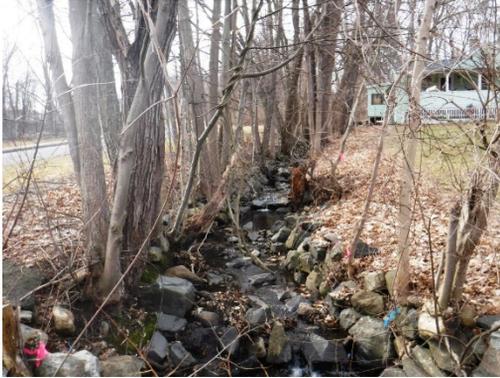
- Upstream channel alignment is poor with moderate vegetation along the streambanks. Downstream channel is narrow with vertical masonry walls.

Channel – Looking Upstream

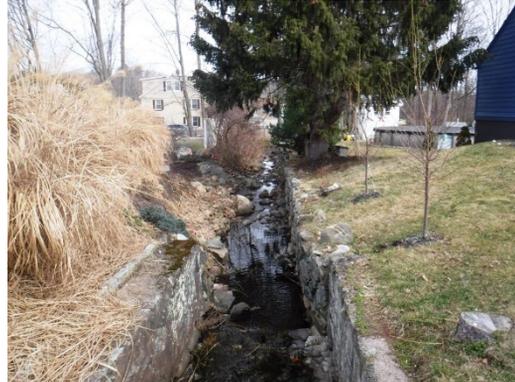
Channel – Looking Downstream

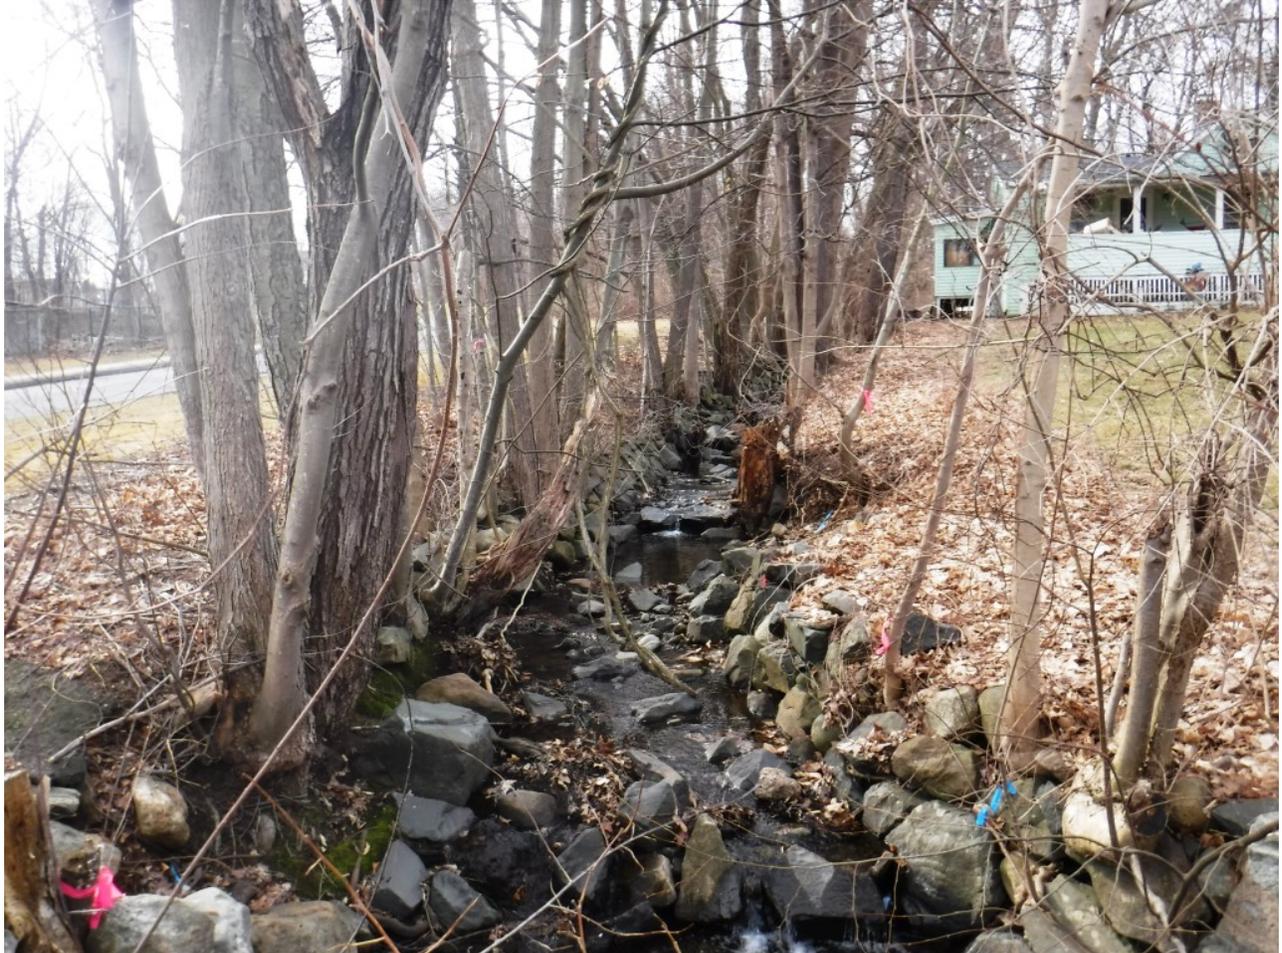
Photo Number: 2

Upstream Channel

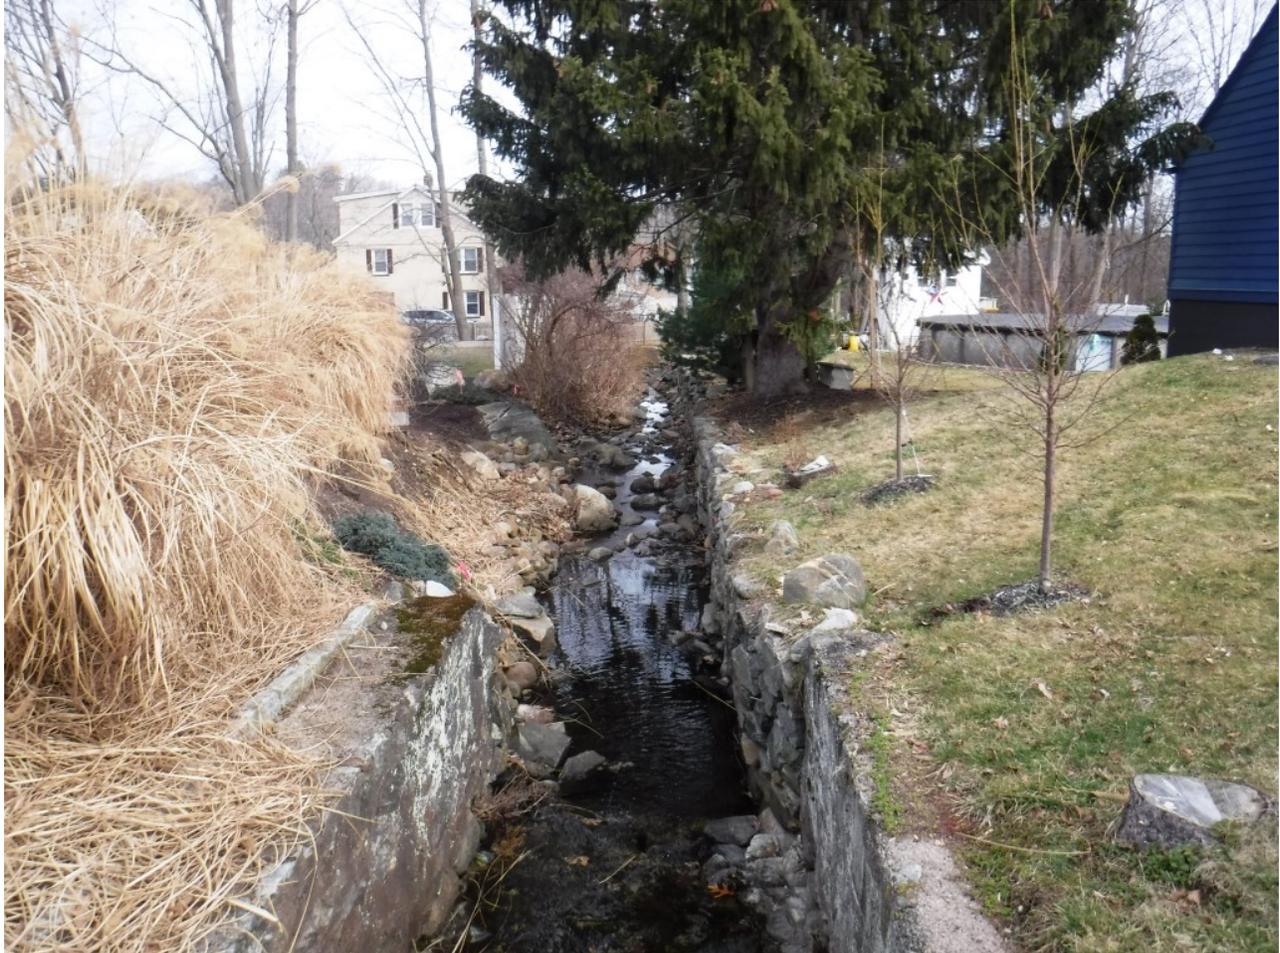
Photo Number: 3

Downstream Channel

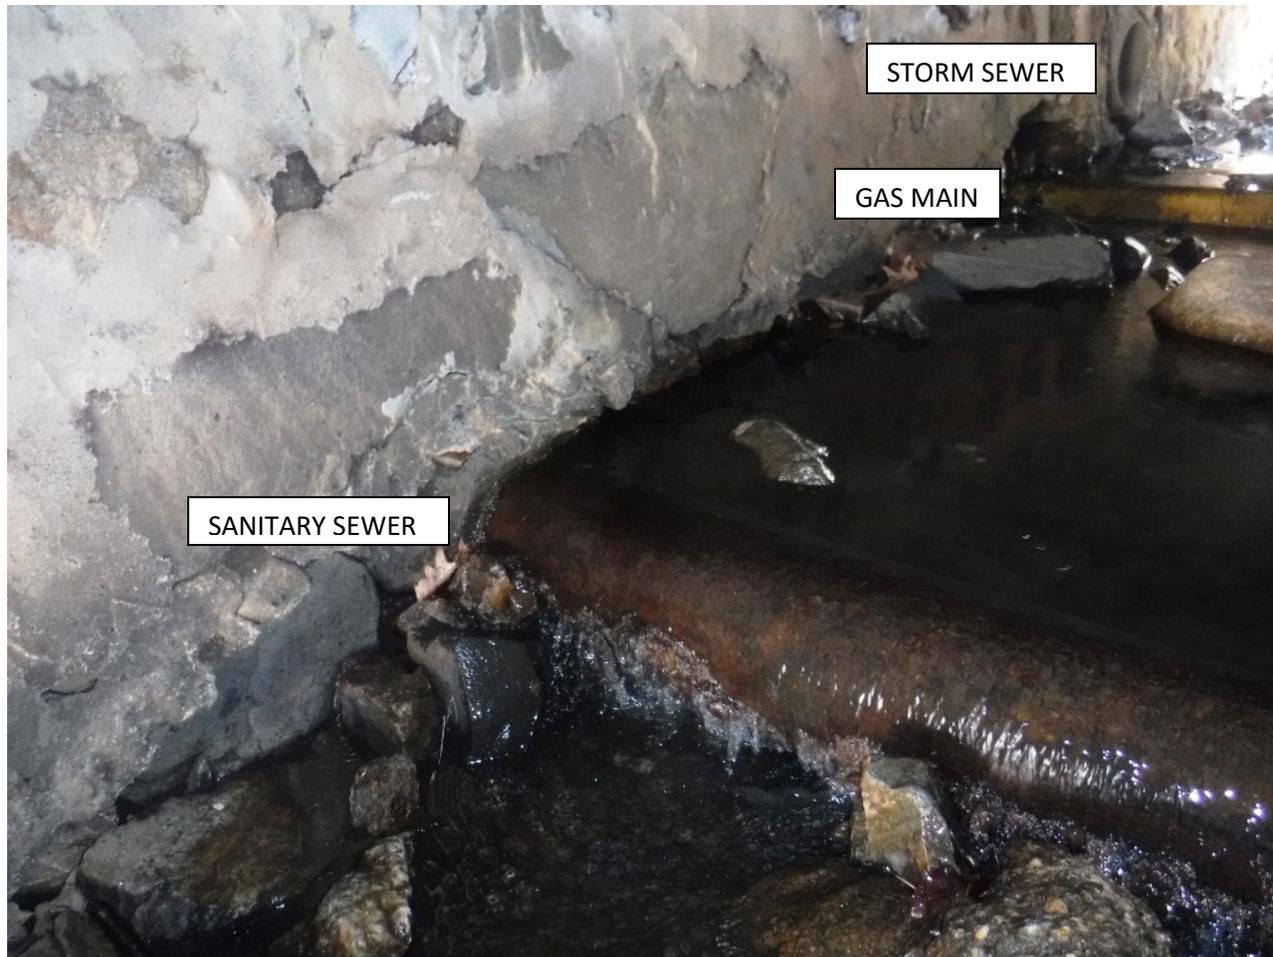
Photo Number: 7

61. CHANNEL PROTECTION	<input type="text" value="Average water depth at time of inspection 0.5 to 1.5 feet."/>	OVERALL RATING 5
	RATING	
CHANNEL SCOUR	5	Exposed gas main and sanitary sewer in bottom of channel with scour (approximately 1 foot deep) downstream of sanitary sewer.
EMBANKMENT EROSION	5	Downstream channel walls have some areas of missing mortar between stones.
DEBRIS	5	Minor debris accumulation at structure inlet
VEGETATION	5	Brush and trees along channel banks upstream of structure.
CHANNEL CHANGE	5	Upstream channel not aligned with structure.
FENDER SYSTEM	N	
SPUR DIKES & JETTIES	N	
RIP RAP	N

Interior Showing Exposed Utilities

Underground utilities in the project vicinity include a gas main and an 8" sanitary sewer. Both of these utilities are exposed in the channel disrupting flow and will likely require relocation, both temporarily during construction and permanently to move them under the proposed culvert.

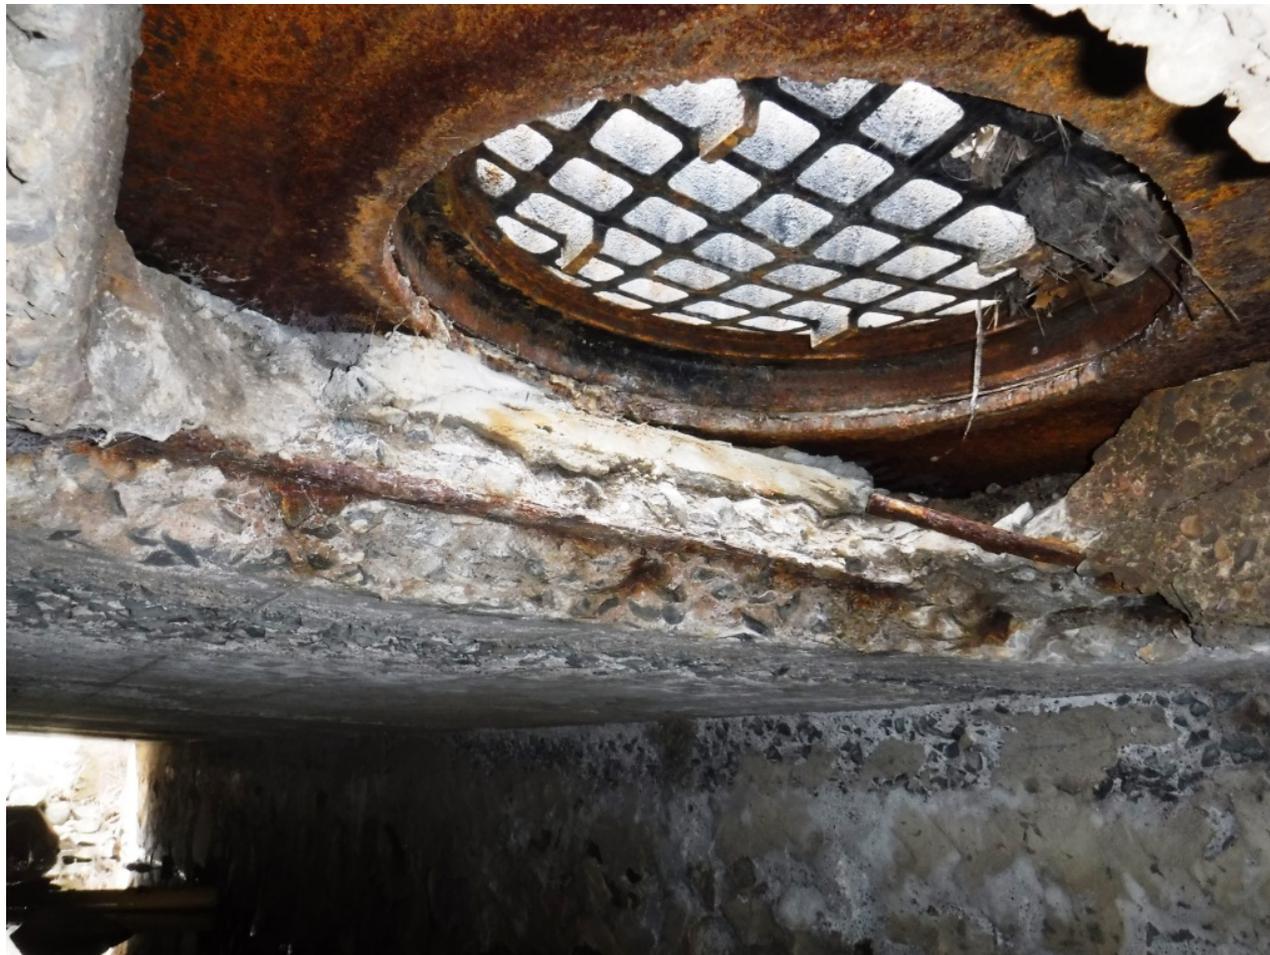
Photo Number: 8

BEARING DEVICES	N	
STRINGERS	N	
GIRDERS	N	
FLOOR BEAMS	3	Areas of spalled concrete with exposed rebar around drain openings. Advanced section loss on exposed rebar. Widespread areas of scaling of concrete on underside of superstructure.
TRUSSES-GENERAL	N	
TRUSSES-PORTALS	N	
TRUSSES-BRACING	N	
PAINT	N	
RUST	N	
MACHINERY MOV SPAN	N	
RIVETS & BOLTS	N	
WELDS & CRACKS	N	
TIMBER DECAY	N	
CONCRETE CRACKING	N	
COLLISION DAMAGE	N	
MEMBER ALIGNMENT	N	
DEFLECT. UNDER LOAD	N	
VIBR. UNDER LOAD	N	
STAND PIPES	N	
BARREL LADDERS	N

Drain Opening in Top Slab with Spalled Concrete and Corroded Rebar

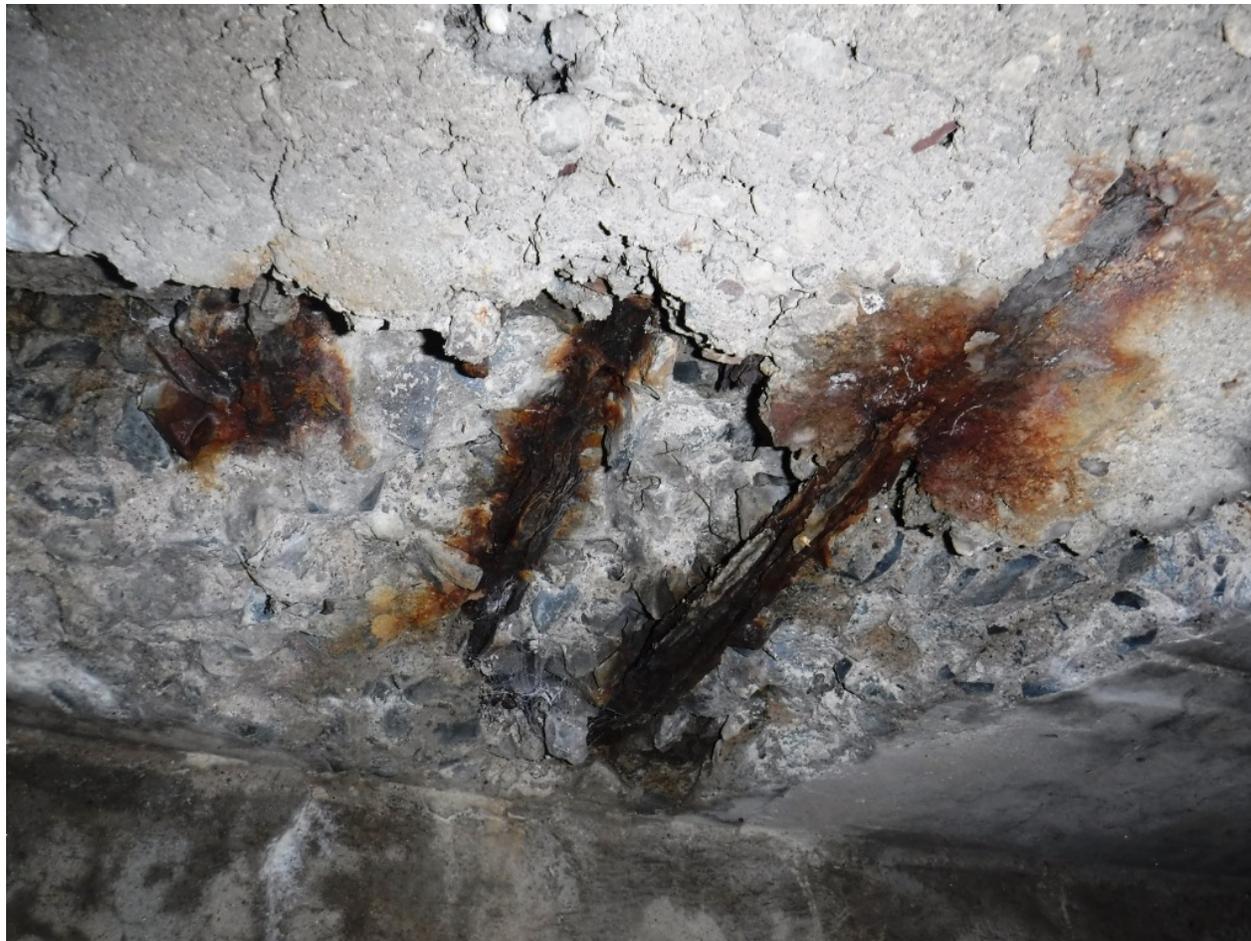
Photo Number: 9

- Deck slab underside exhibits widespread scaling with some spalled areas and exposed rusted rebar.
- Deterioration is greatest around the drain openings in the slab

Spalled Concrete and Corroded Rebar in Bottom of Slab

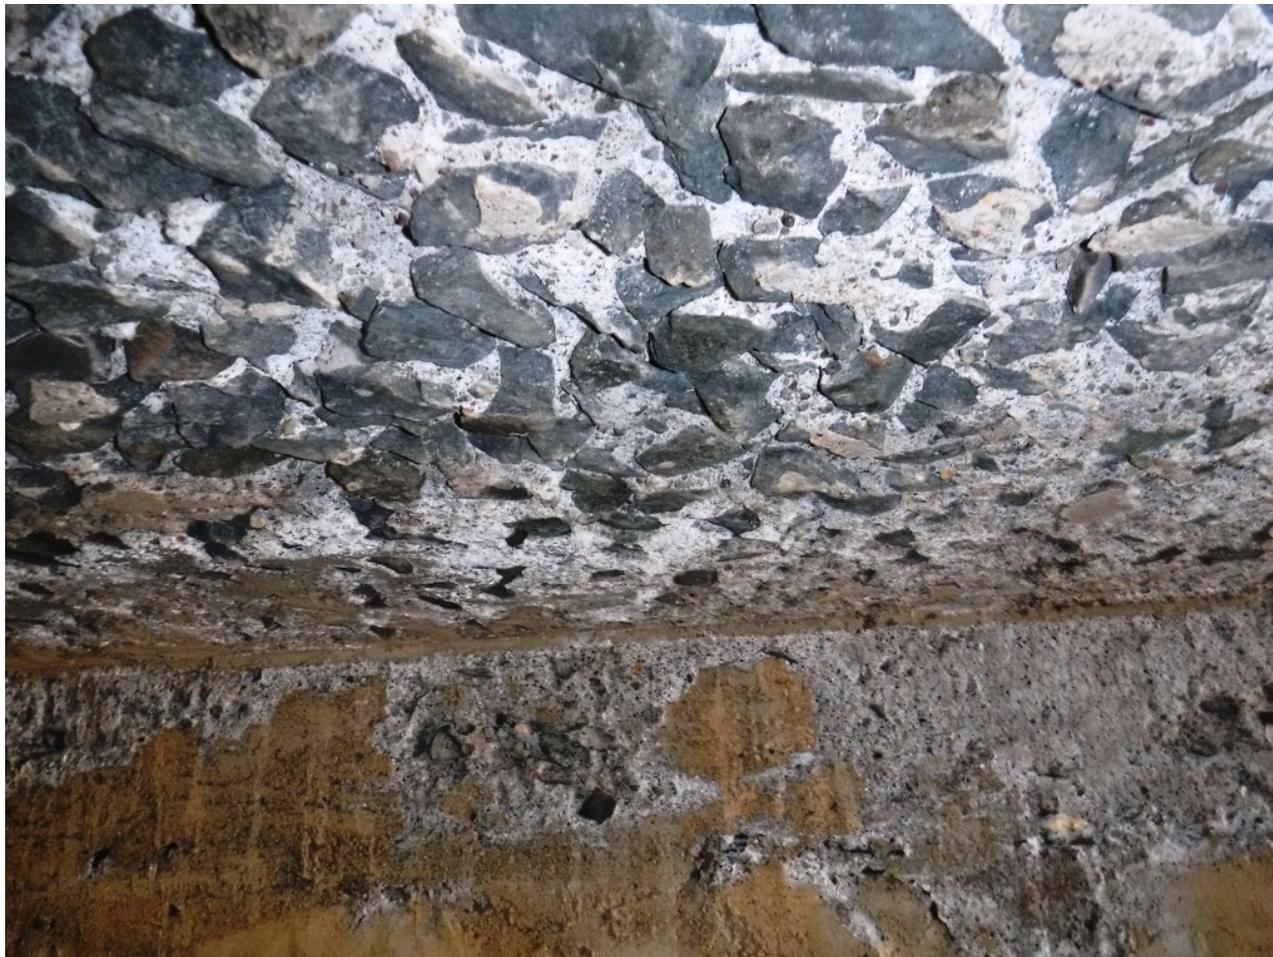
Photo Number: 10

Top Slab with Deteriorated Concrete

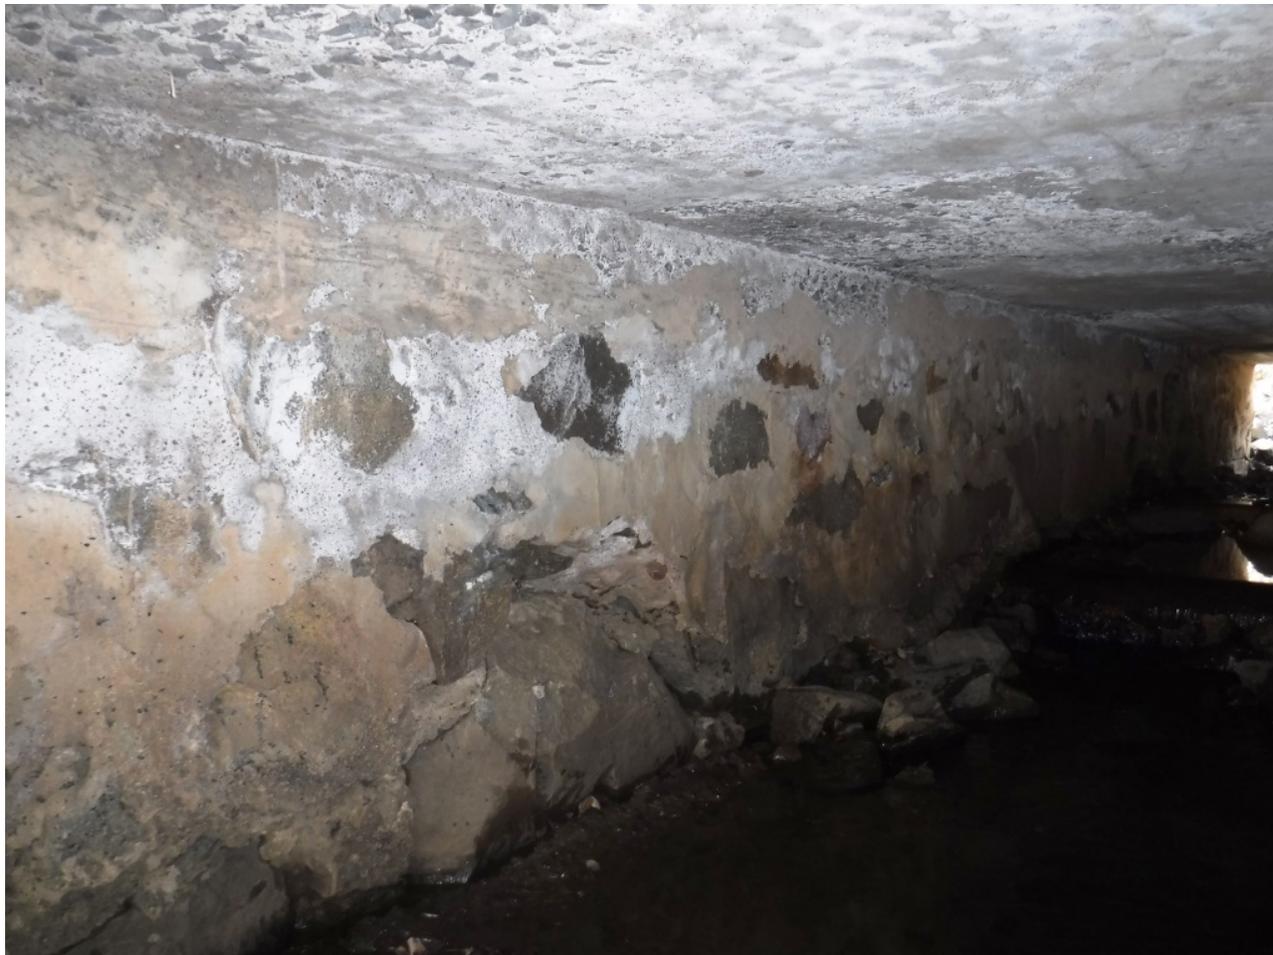
Photo Number: 11

ABUTMENTS-STEM	5	Missing mortar between stones with some displaced stones.
ABUTMENTS-BACKWALL	N	
ABUTMENTS-FOOTINGS	6	No apparent undermining of footing.
ABUT.-SETTLEMENT	N	
ABUTMENTS-WINGWALLS	5	Cracks in both northern wingwalls Concrete cap is heavily scaled on all wingwalls with some damage at corners.
PIERS/BENTS-CAPS	N	
PIERS/BENTS-PILE BENT	N	
PIERS/BENTS-COLUMN	N	
PIERS/BENTS-FOOTINGS	N	
PIERS/BENTS-SETTLEMENT	N	
EROSION-SCOUR	5	Portions of the original stone masonry channel floor are missing exposing the natural channel bottom. There is an area of minor scour (about 1 foot deep) downstream of the exposed sanitary sewer pipe.
CONCRETE CRACK-SPALL	N	
STEEL CORROSION	N	
PAINT	N	
TIMBER DECAY	N	
COLLISION DAMAGE	N	
DEBRIS	N

Masonry Abutment with Missing Mortar

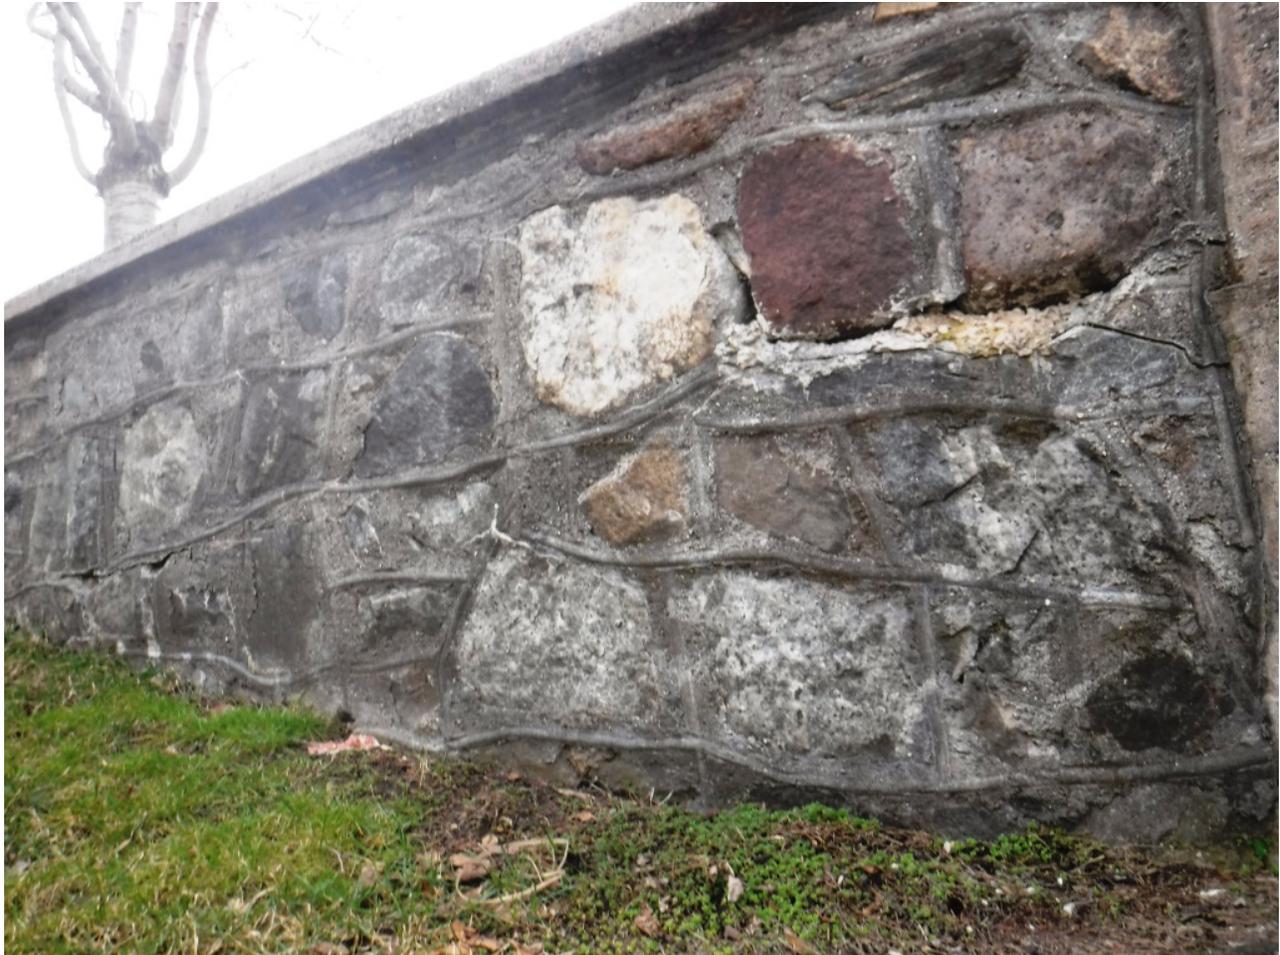
Photo Number: 12

- Abutments and wingwalls exhibit numerous areas of missing mortar with some cracks and damage to the wingwalls.

Northeast Wingwall – Note Cracks and Missing Mortar between Stones

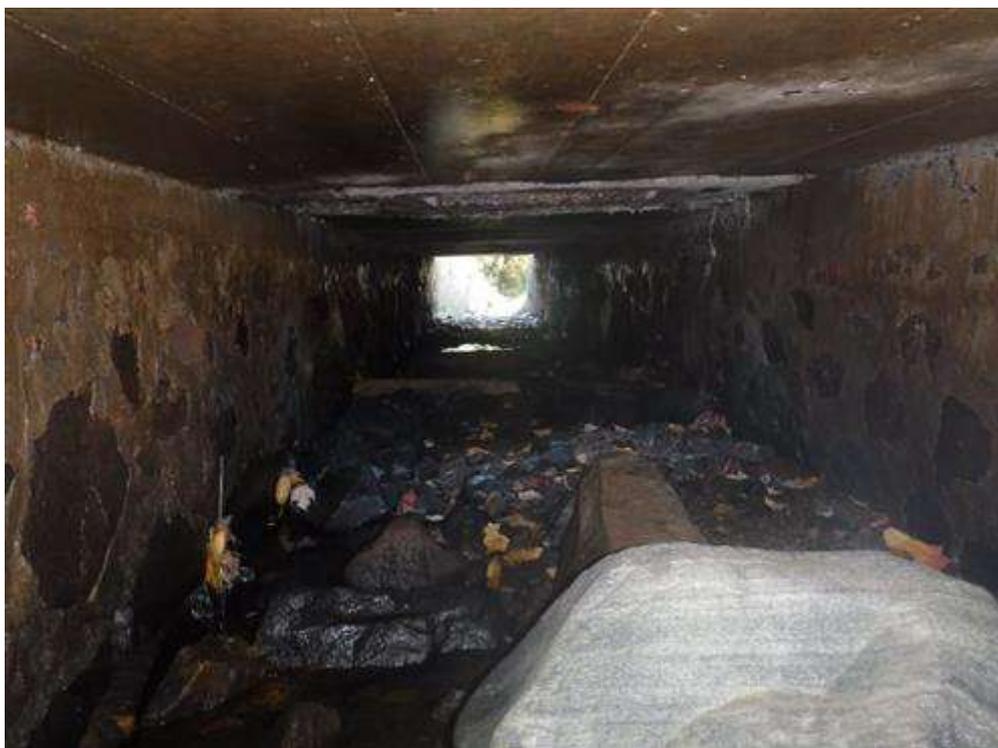
Photo Number: 3

Underside of deck looking downstream from inlet
