Space Needs Analysis Bristol Municipal Buildings

Beals Senior Community Center

240 Stafford Avenue

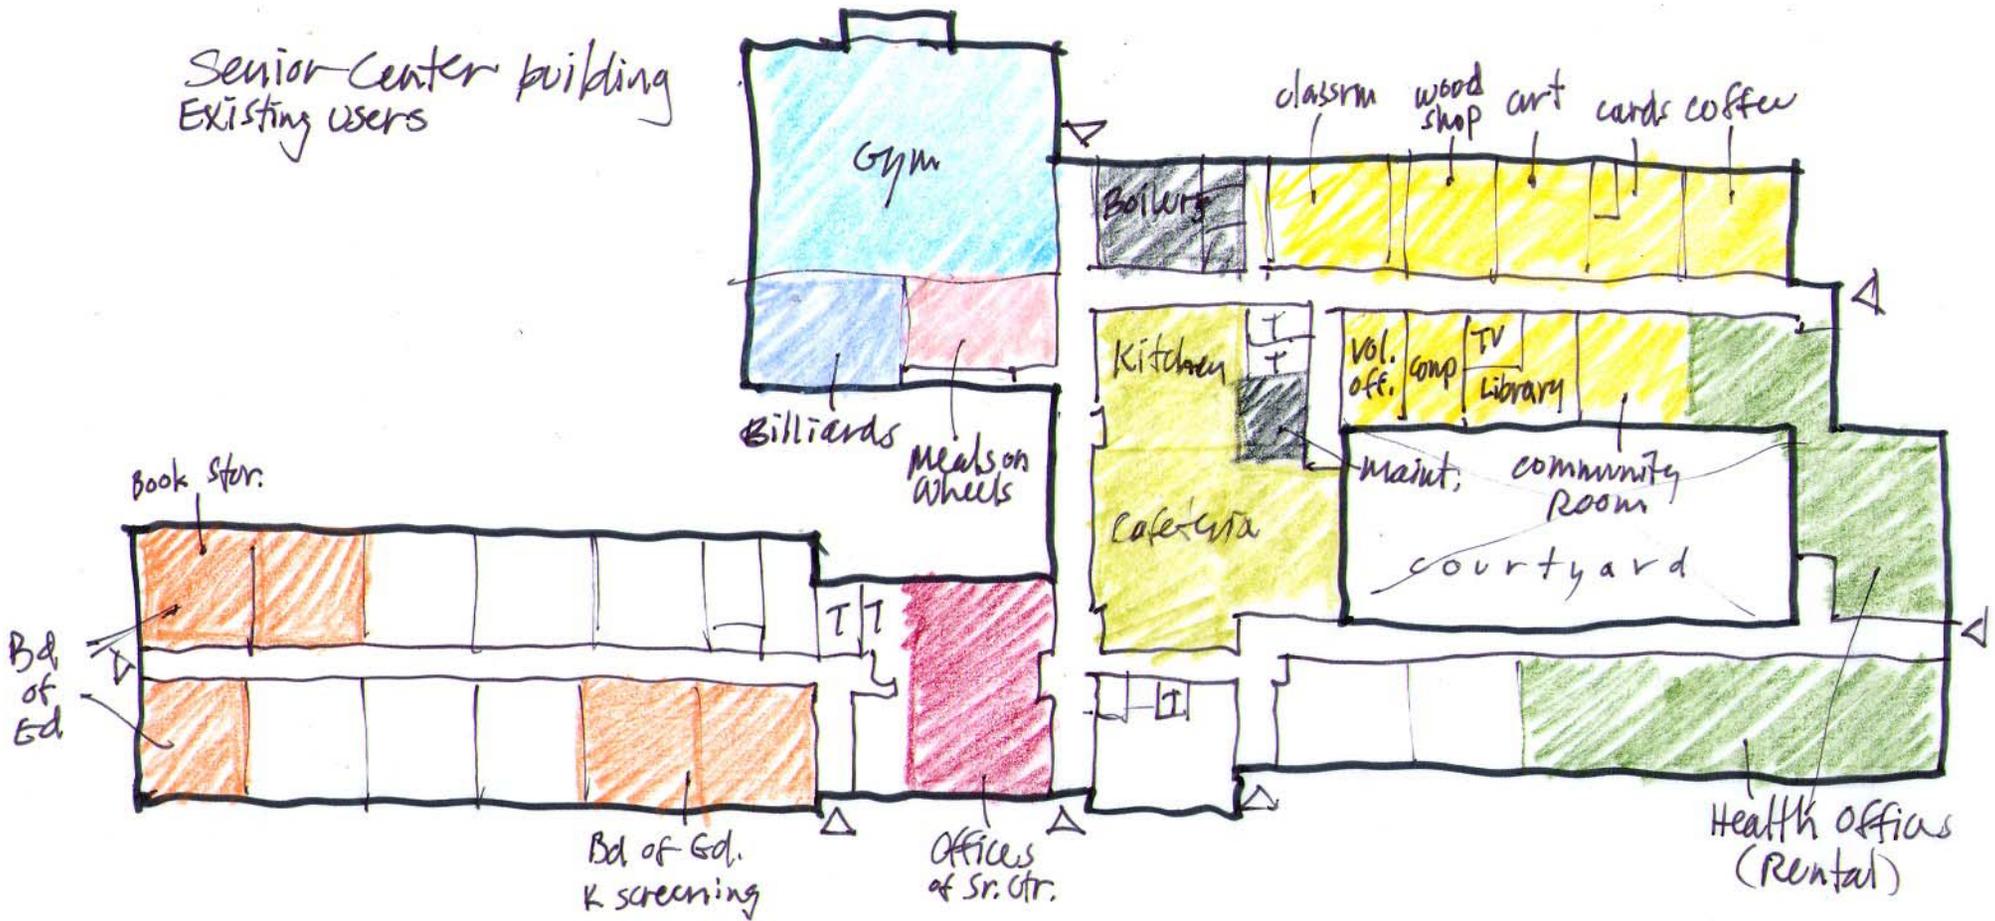
DRA Architects - Existing Utilization Diagram, Beals Senior Community Center

Senior Center building
Existing users

10 open bays
~860 sf each = 8600 ^{net} sf available
