Space Needs Analysis Bristol Municipal Buildings

Clarence A. Bingham Elementary School

3 North Street

Mechanical and Electrical Systems
Existing Conditions Narrative

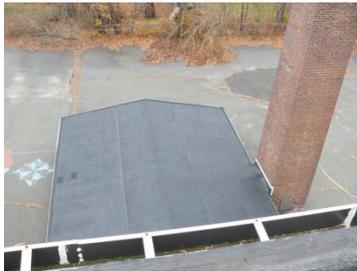
Roof access is good via a narrow staircase up to the roof surface. The enclosure at the roof level should be re-sided and a metal door installed.

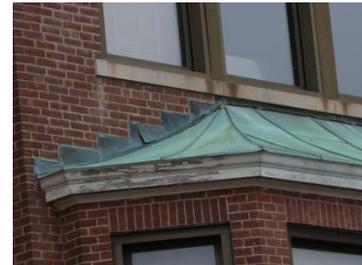
The bay window on the east side of the building has a copper roof that appears to be in good condition despite its age.

The boiler room wing has a relatively new EPDM roof that appears to be functioning well.

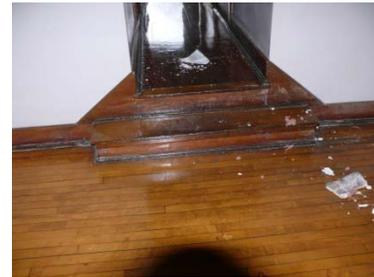
- Accessible toilet rooms will be required for the entire building.
- Door knobs will need to be changed to levers.
- With the removal of the lockers door clearances will be adequate.
- Current Teacher's workroom above main entrance should be used for storage only as it is not universally accessible (see photo of steps).

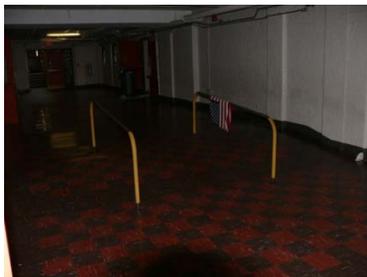
- Stairs are not compliant and will require the elimination of nosings and new continuous handrails.

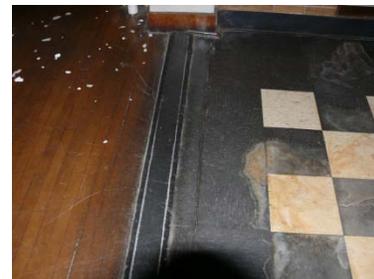
A raised floor cover is present between the original building and the rear wing. It exceeds ½ inch in height and should be replaced.

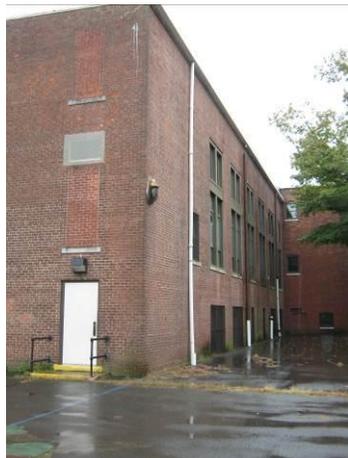
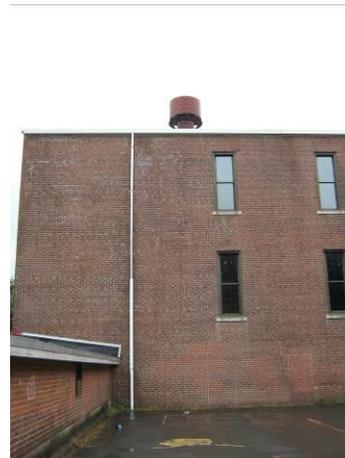
4. Storm:
 - a. The storm piping is primarily downspouts that drain to an underground piping system and drains to the municipal storm water system. There are no secondary roof drains. Some of the original piping has been replaced with PVC pipe either in its entirety or in sections. This piping is in fair condition.

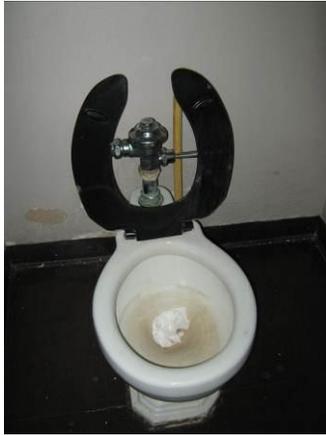
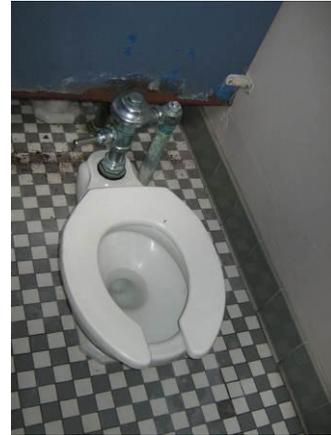
- Water closets are wall and floor mounted in the standard toilet rooms and small 10" bowl size, floor mounted in the classrooms. Both styles are flush valve, vitreous china. The fixtures are original to the facility in fair condition. The original fixtures are non-water conserving type and non-ADA compliant.

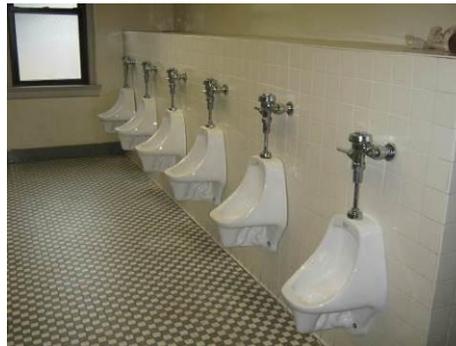
- Urinals are wall hung, vitreous china, with flush valves. The fixtures are original to the facility in fair condition. The original fixtures are non-water conserving type and non-ADA compliant.

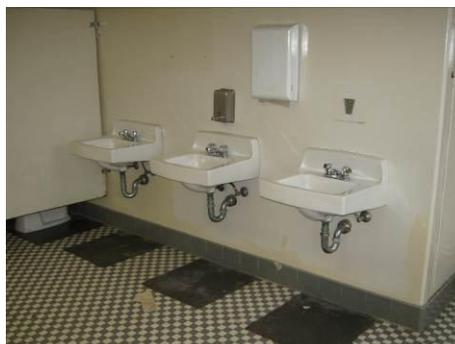
- Lavatories are wall hung vitreous china with two twist or lever style faucets. Some of the faucets have been replaced with single lever operated faucets. The fixtures range from original to the facility in fair condition to ones with new faucets in good condition. The original fixtures are non-water conserving type and the faucets and drains are non-ADA compliant.

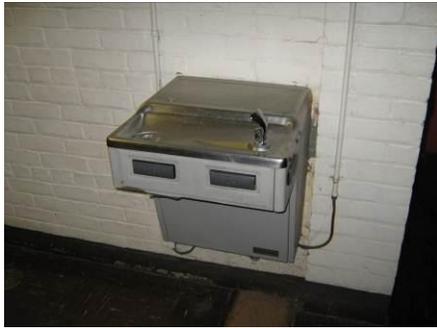
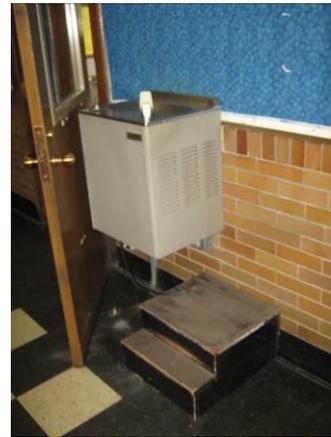
- Drinking fountains are wall mounted stainless steel units in fair condition. One of the single units may be ADA compliant with respect to controls however there are other units that do not have ADA compliant controls. The distance these units protrude into the path of travel should be reviewed for compliance with current ADA requirements.

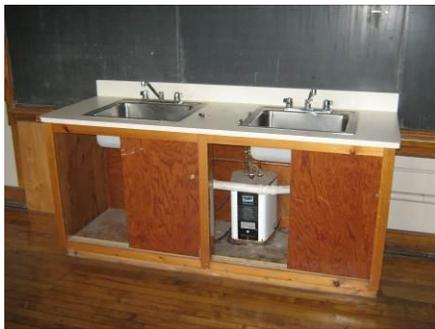
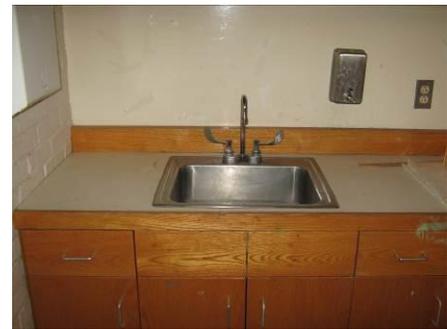
- Stainless steel sinks with two lever gooseneck type faucets are present in various areas of the facility. These sinks are non-ADA compliant and in fair condition.

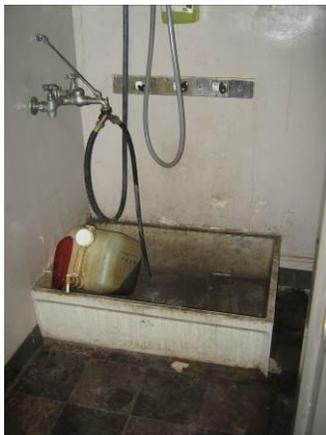
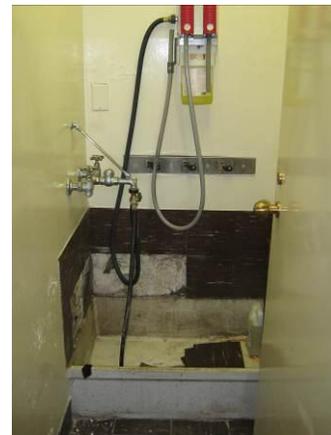
- Janitor sinks are a combination of wall mounted cast iron units with two lever faucets or floor mounted molded stone units with two lever faucets. There are no vacuum breakers present at these sinks. The sinks are original to the building and in poor condition.

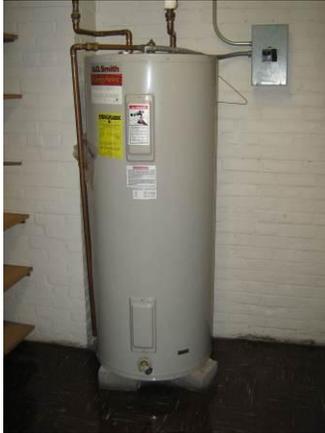
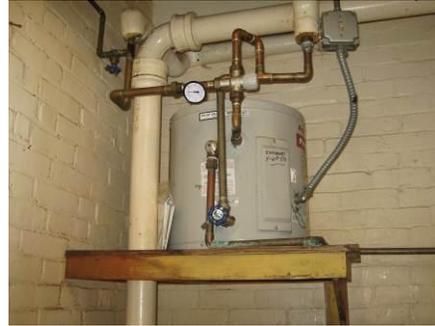
1. The existing domestic hot water system includes an A.O. Smith Model ELSC10 917 electric water heater as the primary source of domestic hot water, (1) A.O. Smith Model EES-80 electric water heater to serve the kitchen, (1) small shelf mounted electric water heater, and (1) ISE Model W152 instantaneous hot water heater in one of the class rooms. All of this equipment is in fair to good condition.

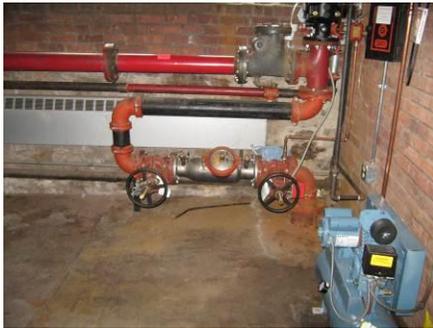
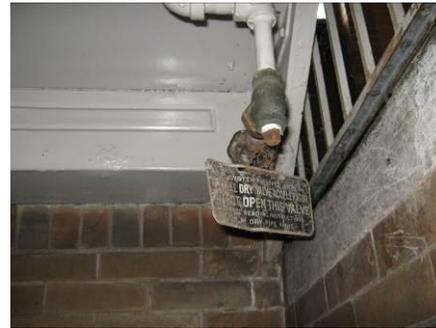
1. The building is served by a 6" fire protection service fed from a fire main in North Main Street. This fire service includes a shut-off valve and Watts Model 774 double check valve. This fire protection service feeds sprinklers throughout the building. There is also a dry sprinkler system. The dry system has a new air compressor installed to maintain system pressure. This fire service equipment has been recently installed and is in good condition, however, the sprinkler piping and sprinkler heads are an older installation, more than 30 years old, and should be replaced.

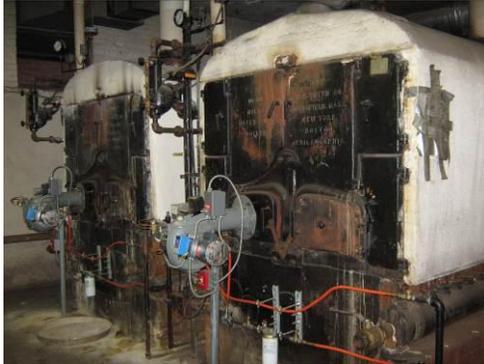
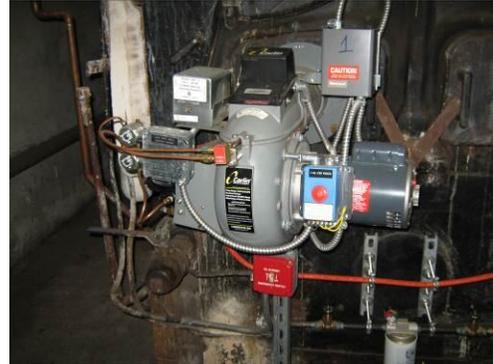
1. The existing building is heated by (2) HB Smith Mills 44 18-section cast iron steam boilers with Carlin Model 1050FFD-20 oil burners. The boilers and breeching are original to the building and in poor condition. The oil burners have recently been replaced and are in very good condition.

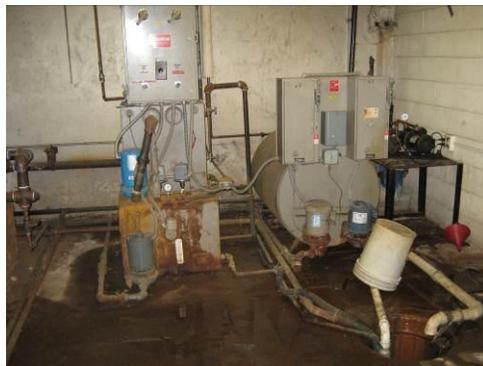
2. The heating plant also includes a condensate receiver and boiler feed system. There were visible leaks in both these systems at the site visit. Both of these systems are in very poor condition.

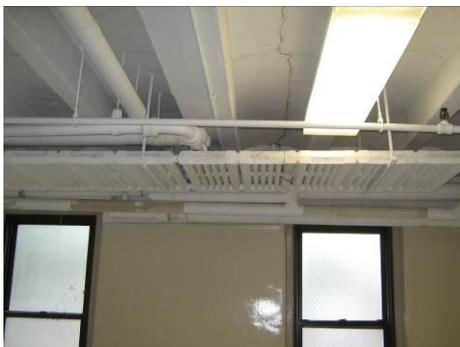
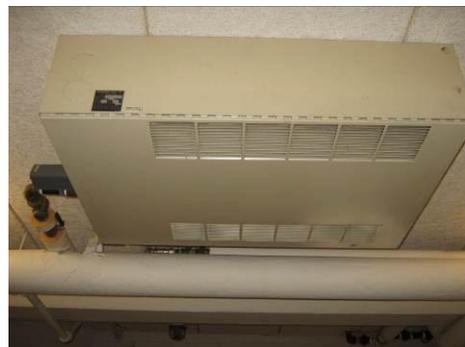
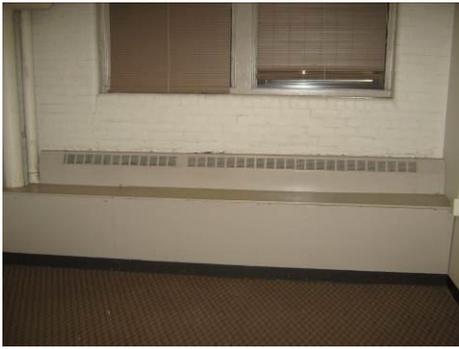
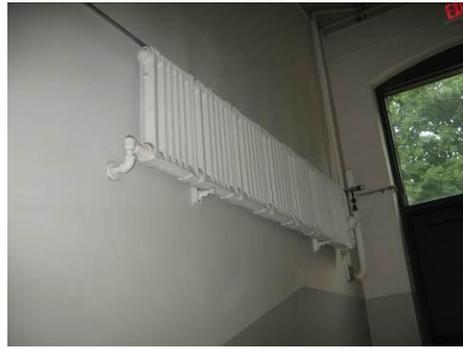
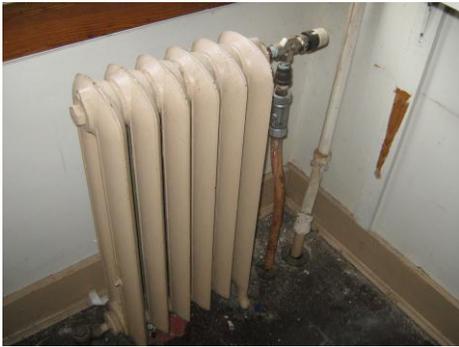
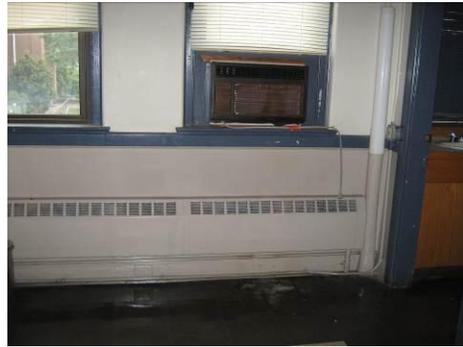
3. The present heating system also includes cabinet unit heaters, ceiling mounted unit heaters, cast iron radiators and baseboard radiation. This equipment is original to the building and in good to very poor condition.

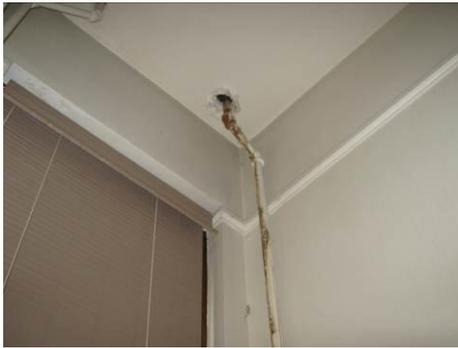
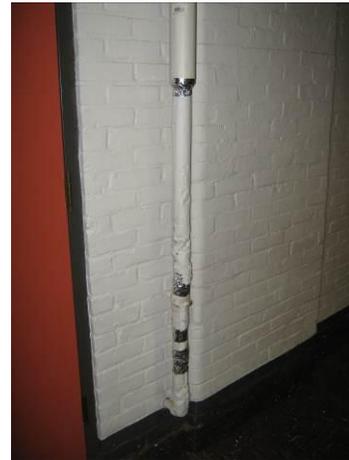
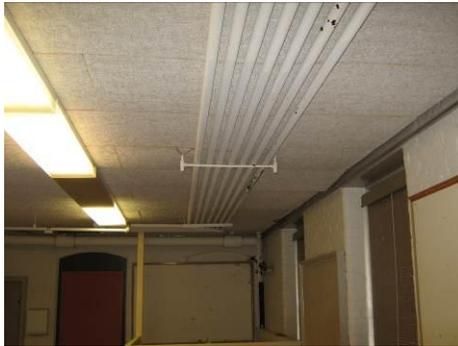
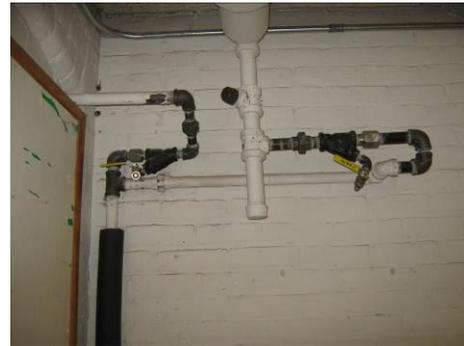
5. The steam piping consists of iron supply and condensate return piping. Some of this piping is missing insulation or the insulation has failed and replaced. There also have been areas where leaks are evident and repairs have been made to this piping.

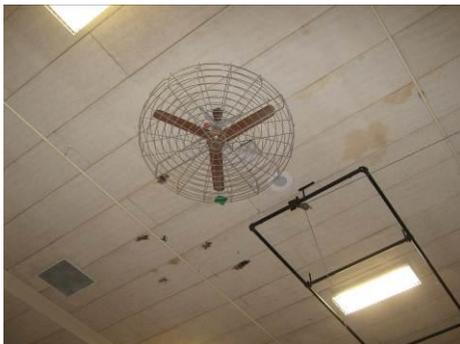
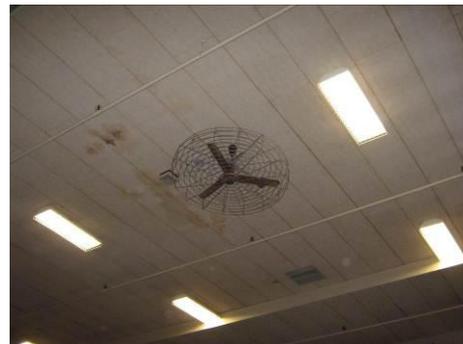
6. The Gymnasium has paddle fans installed to help with air circulation in the space.

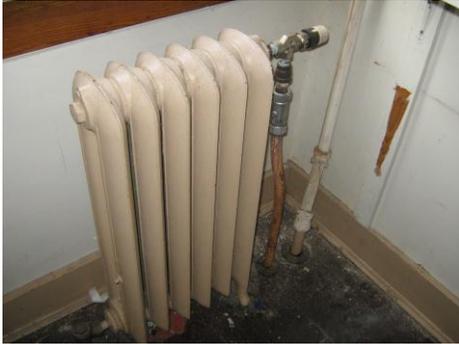
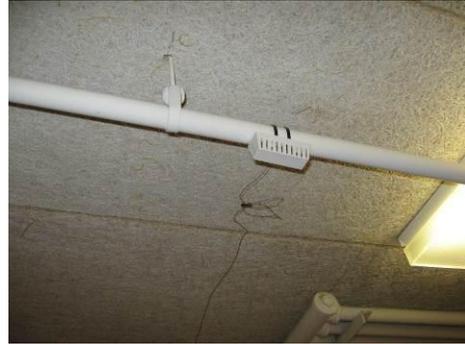
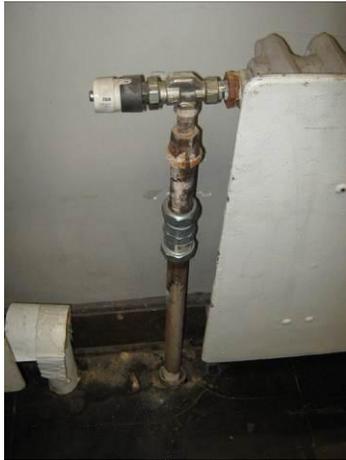
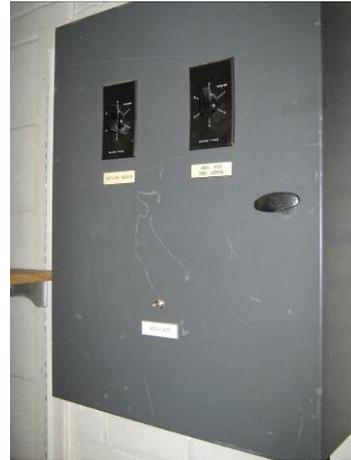
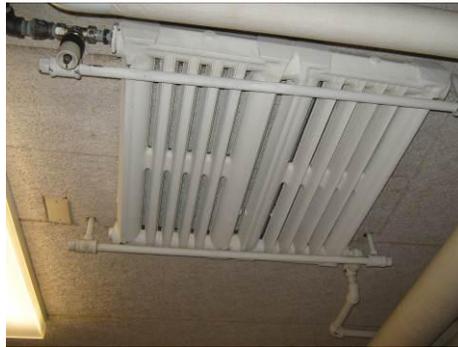
7. The existing temperature control system consists of local controls mounted at the individual radiators, cabinet unit heaters, etc. and some additional sensors throughout the building. The exhaust fans in the gymnasium operate via a local selector switch. This control method is antiquated and does not offer the opportunity for maximum energy savings.

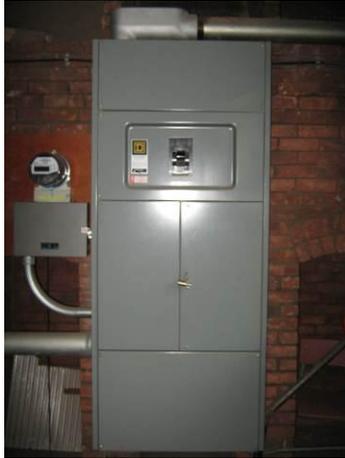
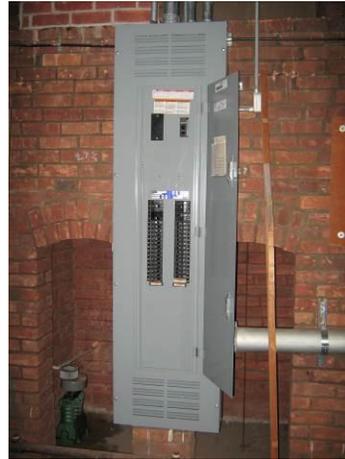
1. The building is served by a single electrical service rated 400amperes, 208Y/120volts, 3-phase, 4-wire. This service equipment consists of a 400amp main disconnect switch, distribution and metering per utility company requirements. The service equipment has been recently replaced and is in very good condition.

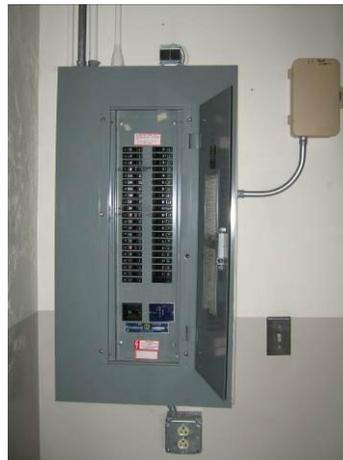
2. There are a number of electrical panels located throughout the facility. These panelboards have been recently installed with the electrical service equipment. The condition of these panelboards is very good. The majority of the panelboards do not have spare circuit breakers available for new circuits to be added, or have space to add new circuit breakers.

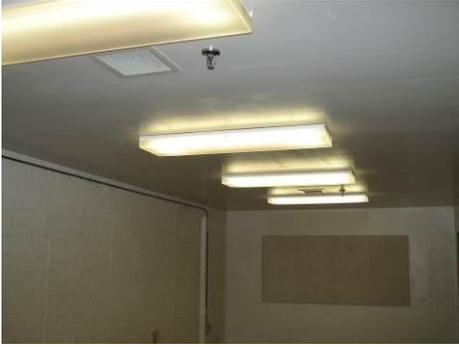
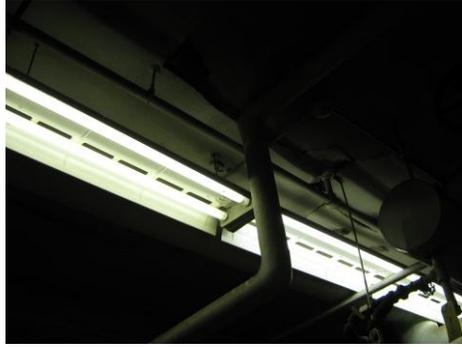
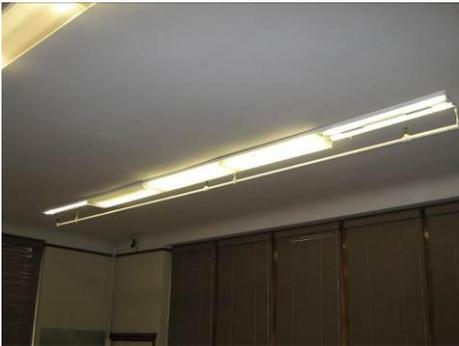
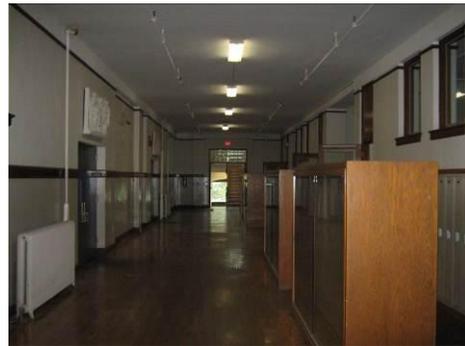
3. The lighting throughout the facility consists primarily of surface mounted acrylic lensed wraparound style fluorescent fixtures throughout the facility. Some areas such as storage rooms, mechanical rooms have industrial fluorescent fixtures. Most of the lighting has been upgraded to newer T8 technology, however, there are other fixtures using older T12 technology or incandescent lamps. Some of the fixtures have been damaged and are missing lenses. The lighting ranges from good to poor condition.

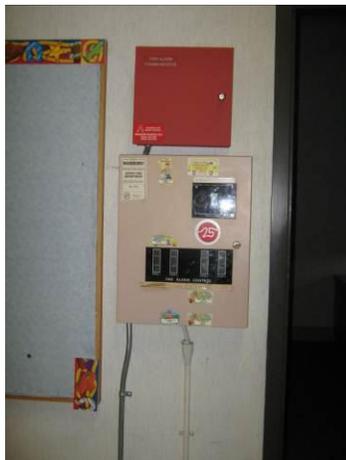
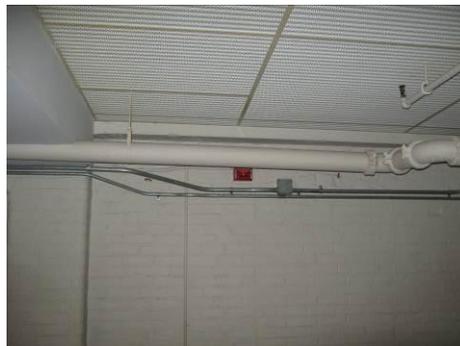
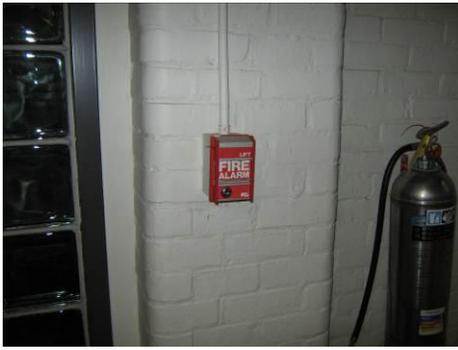
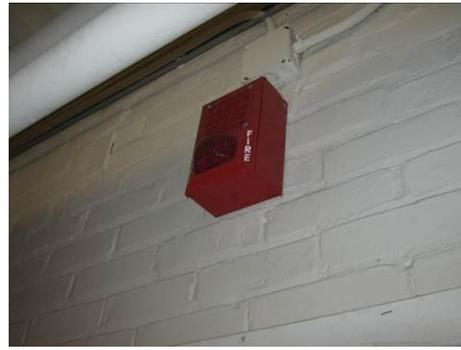
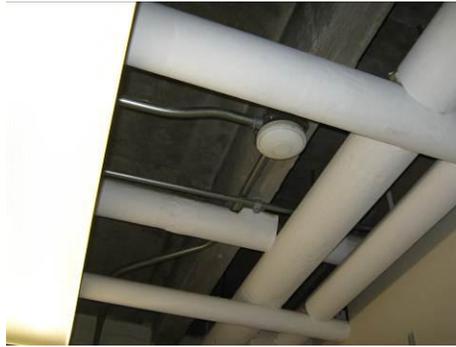
4. The fire alarm system is manufactured by FCI. The system includes manual pull stations, horn strobes, and ceiling mounted heat detectors. Some of the horn/strobe units are partially blocked by piping. This system is in fair condition and non-ADA compliant. Smoke detectors and additional audio visual devices should be added to the building.

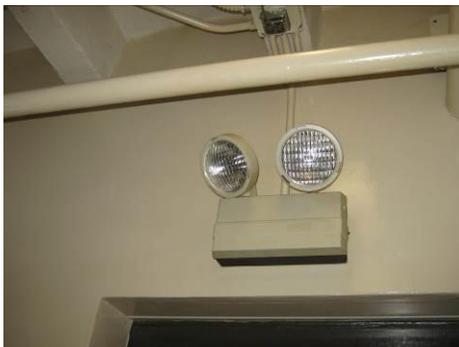
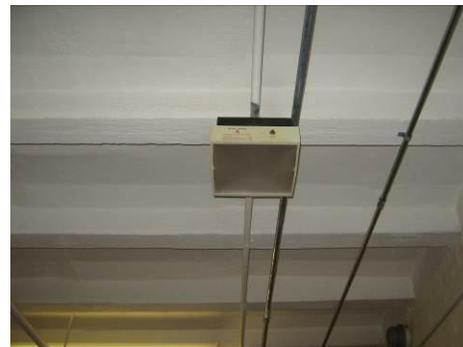
5. The emergency lighting is provided by two-head self-contained emergency fixtures with batteries or a surface mounted 9"x9" self-contained emergency fixture. This system is operational however the equipment is in poor condition. Additional lighting fixtures are required to meet current requirements for emergency lighting.

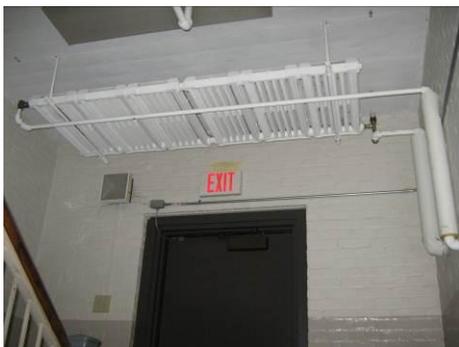
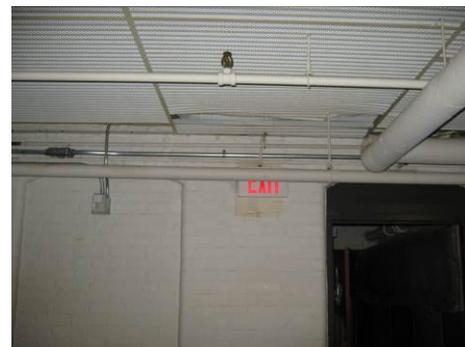
6. The exit signs consist of fluorescent exit signs with batteries. This equipment is in good condition. It was noticed that some exit signs are covered by piping reducing their visibility. Additional exit signs are required to meet current requirements for exit signs.

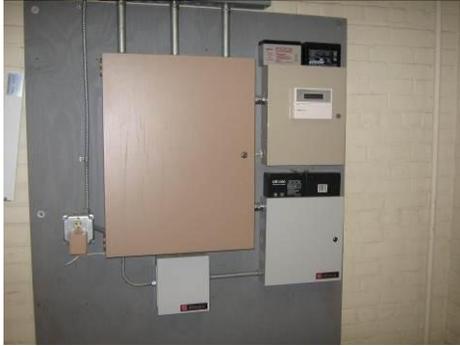
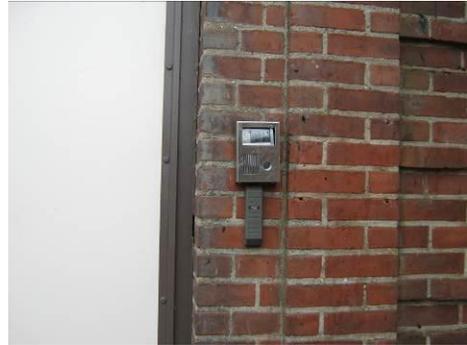
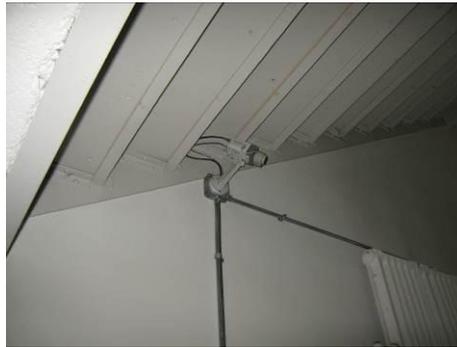
7. The facility does have a limited security system consisting of a control panel, limited cameras, door contacts, motion detectors, and a door entry intercom with camera. This system is in fair condition. Additional devices may be considered for enhanced security.

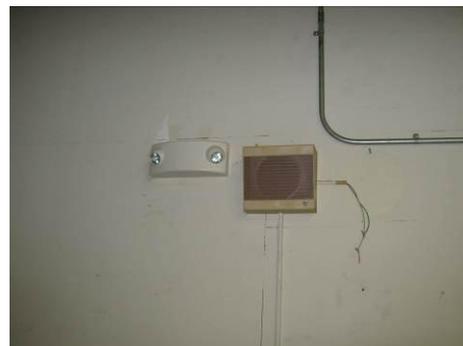
8. The existing PA system consists of wall mounted speakers. Some of this equipment does not appear to be operational as it is disconnected. There is no central clock

system as it appears that all of the clocks have been removed.
