## **2024 ANNUAL MONITORING REPORT**

CITY OF BRISTOL SOLID WASTE MANAGEMENT UNIT  
BRISTOL LANDFILL, BRISTOL, CONNECTICUT  
EPA ID NO. CTD000790725  
PERMIT NO. DEEP/REM/SP/2023/10588

FEBRUARY 2025

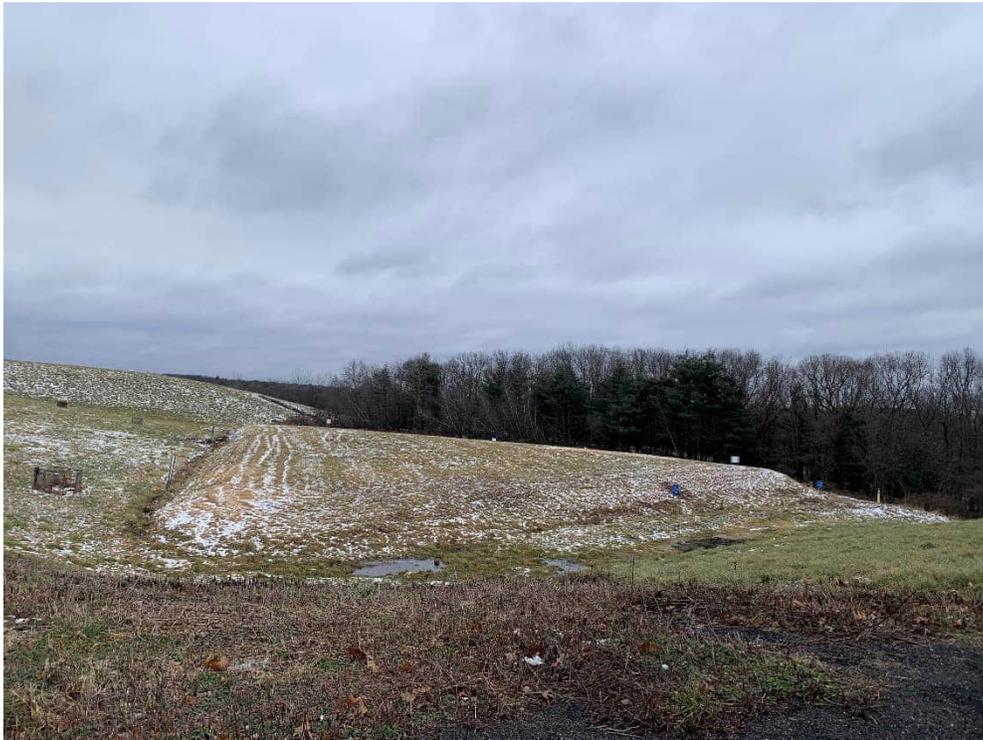
**Photograph 1 – Cell (Facing Southeast)**

The general condition of the MHSL surface at the time of inspection was acceptable. Run-on/run-off controls were found in satisfactory conditions. The surface completions for all groundwater-monitoring wells located around the perimeter of the MHSL were found in good condition and secured with locks. Posted signs were legible and clear of vegetation. Most surfaces of the MHSL were dry; standing water was observed in the northeast swale. Overall conditions on the MHSL were good. The three corners of the cell did exhibit yellow grass. Photographs of the MHSL are attached.

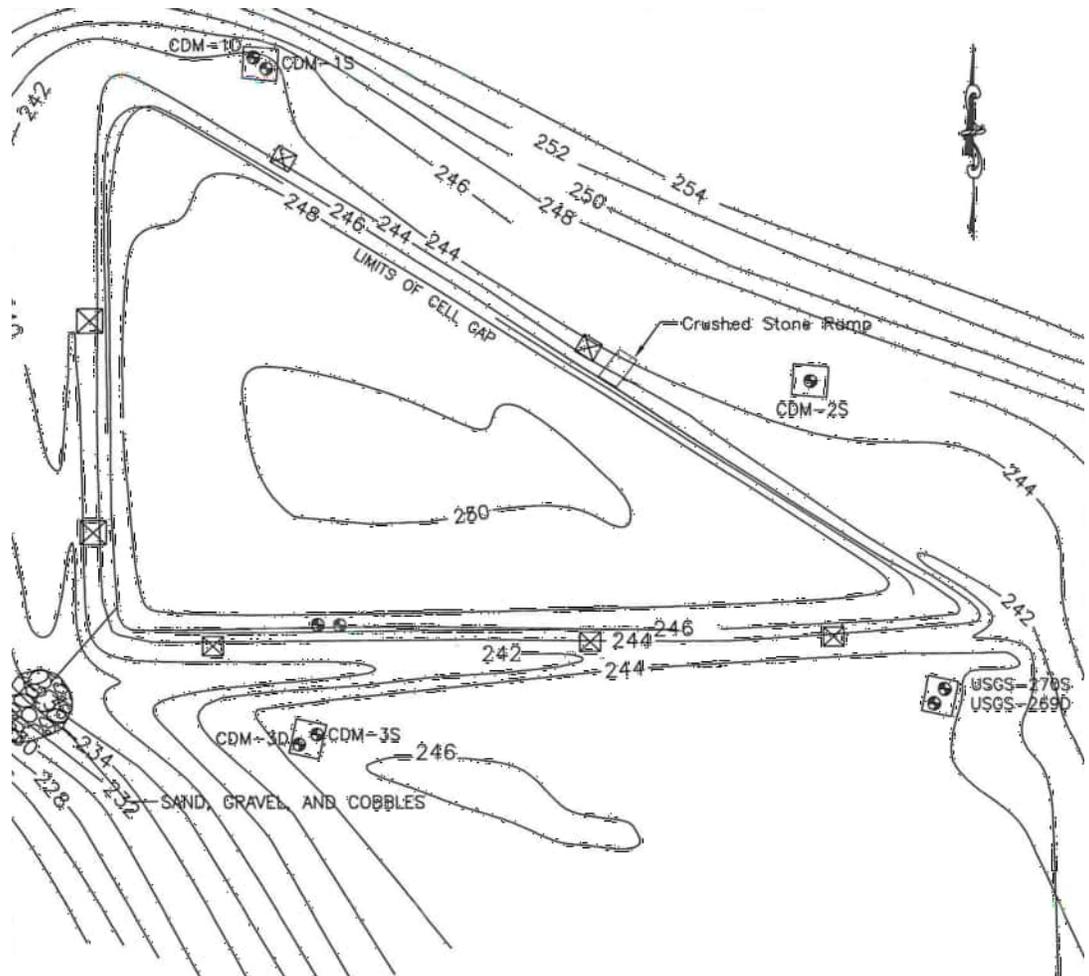
Inspection Notes: \*B3- (3) Corners of MHSL cell exhibit yellowed grass

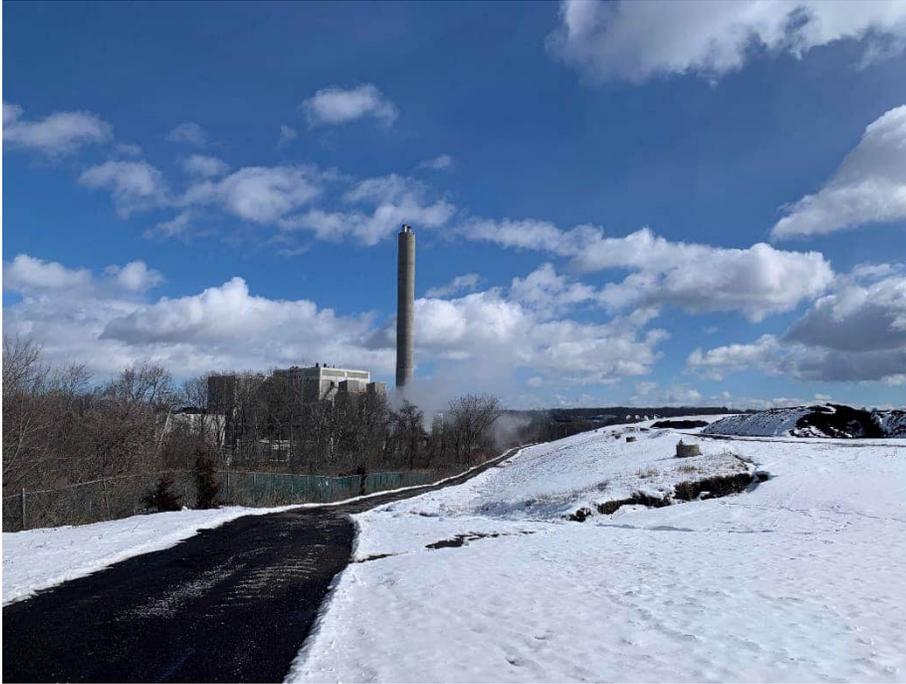
**Photograph 3 – Landfill Access Road (Facing East). Evidence of soil erosion observed to the right of the photograph.**

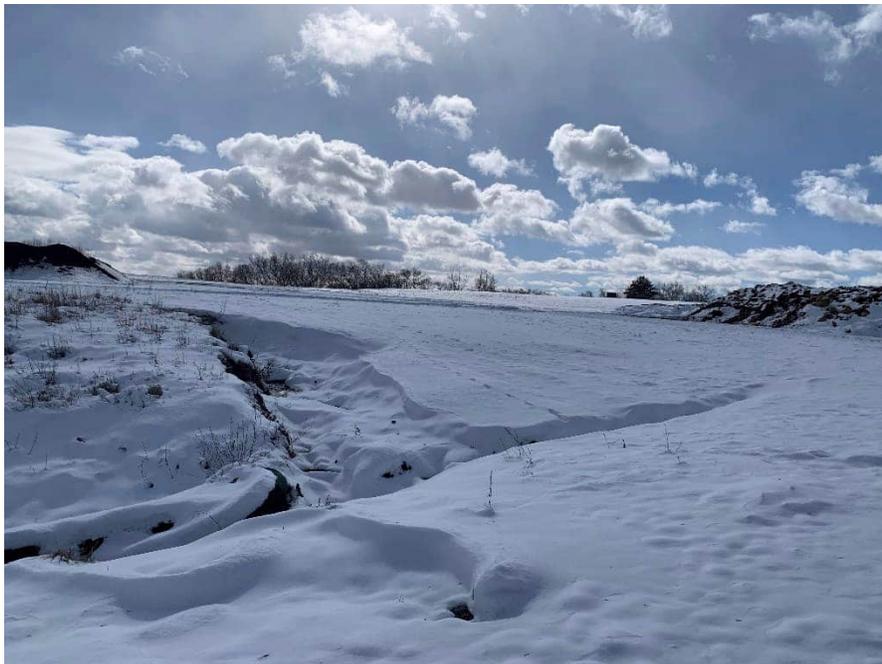
The general condition of the capped landfill was not acceptable at the time of the first quarter inspection with the following noted observations: soil erosion, approximately 6 inches to 2 feet deep, likely caused by uncontrolled stormwater runoff was observed at the top of the landfill access road; excessive vegetative growth was observed in stormwater channels; stormwater run-off/run-on controls at discrete locations were not in good condition; and subsidence and erosion on the northwestern side of the MSW was noted. Subsequent repairs to these deficiencies were completed in May 2024 by Yield Industries.

**Photograph 4: Observed Soil Erosion (~6''-2' deep) of cover soil possibly caused by uncontrolled stormwater runoff.**

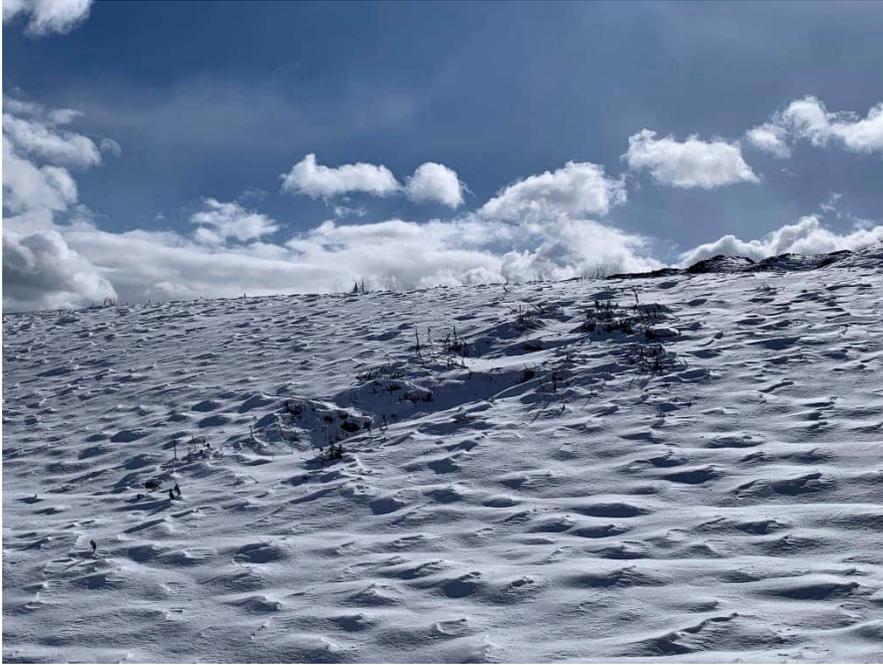
**Photograph 5: Image of land subsidence North slope of Landfill (Subsidence is noted along the North slope at multiple locations)**

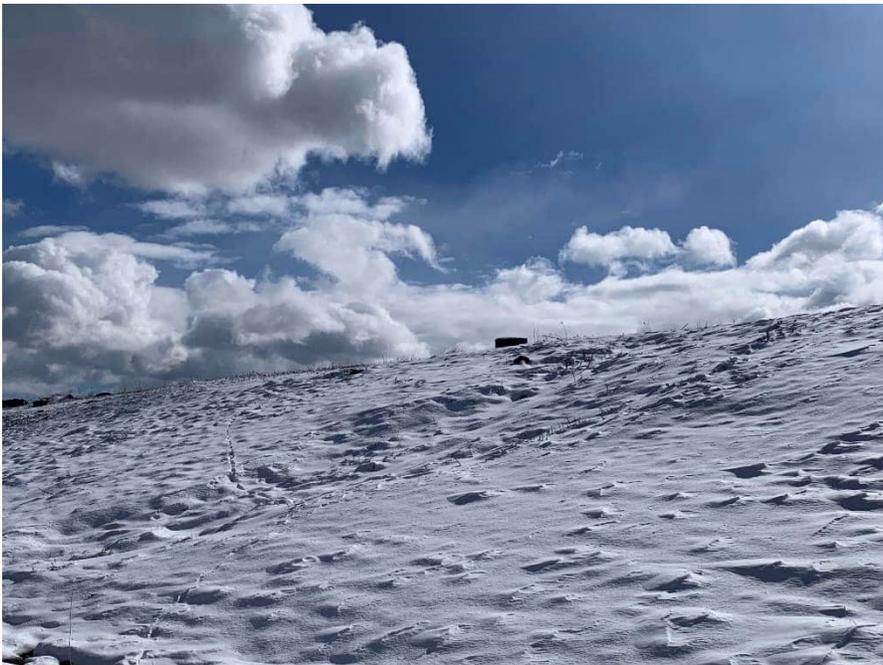
**Photograph 6: Image of land subsidence North slope of Landfill (Subsidence is noted along the North slope at multiple locations)**

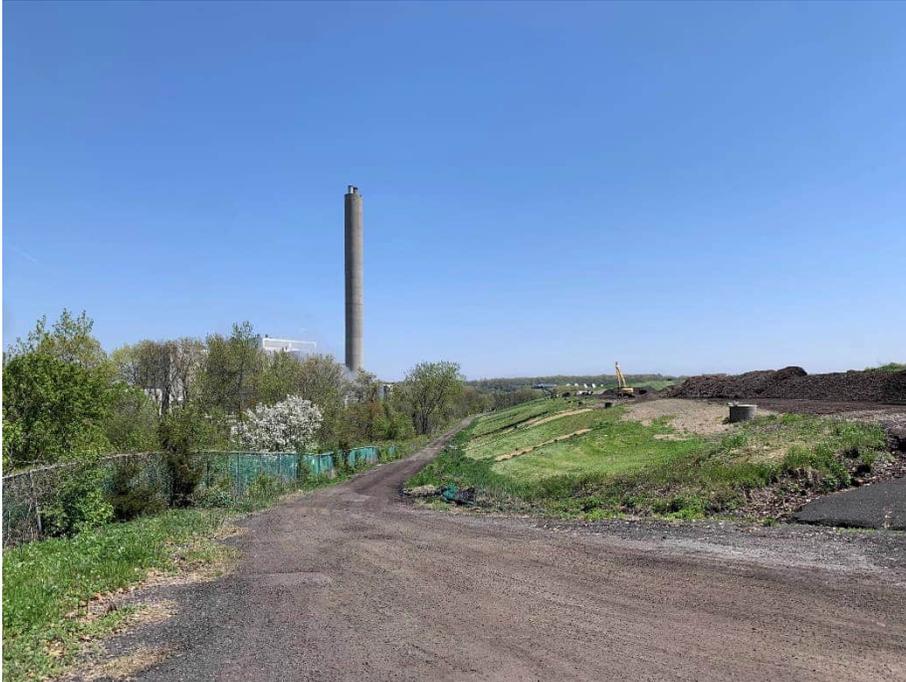
**Photograph 3: Landfill Access Road (facing east). Evidence of soil erosion observed to the right of the photograph.**

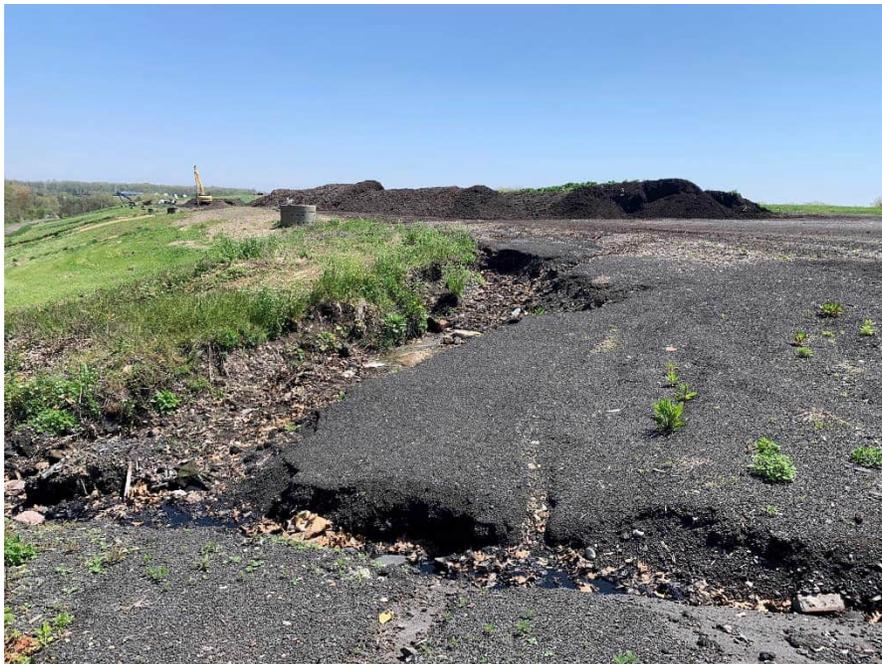
**Photograph 4: Observed Soil Erosion (~6''-2' deep) of cover soil possibly caused by uncontrolled stormwater runoff.**

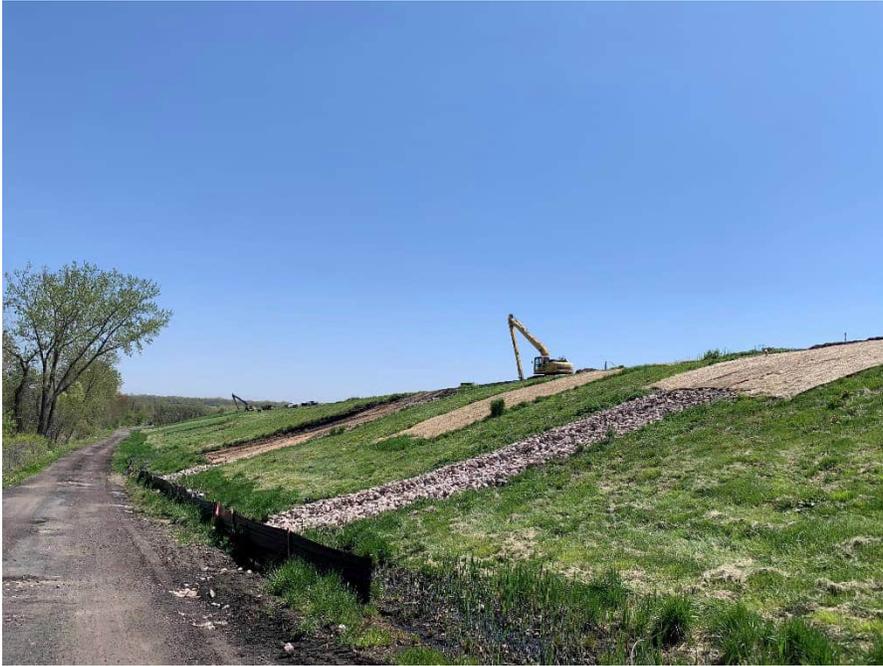
**Photograph 5: Ongoing repairs on the north slope of landfill of land subsidence at multiple locations.**

The general condition of the MHSL were generally acceptable at the time of the inspections with the exception of erosion observed at the top of the landfill, as well as previously areas identified in late 2023 with settling/subsidence. The City awarded a contract to Yield Industries to repair erosion on the landfill. The construction was scheduled to start in April 2024 and the repairs were completed in May 2024.

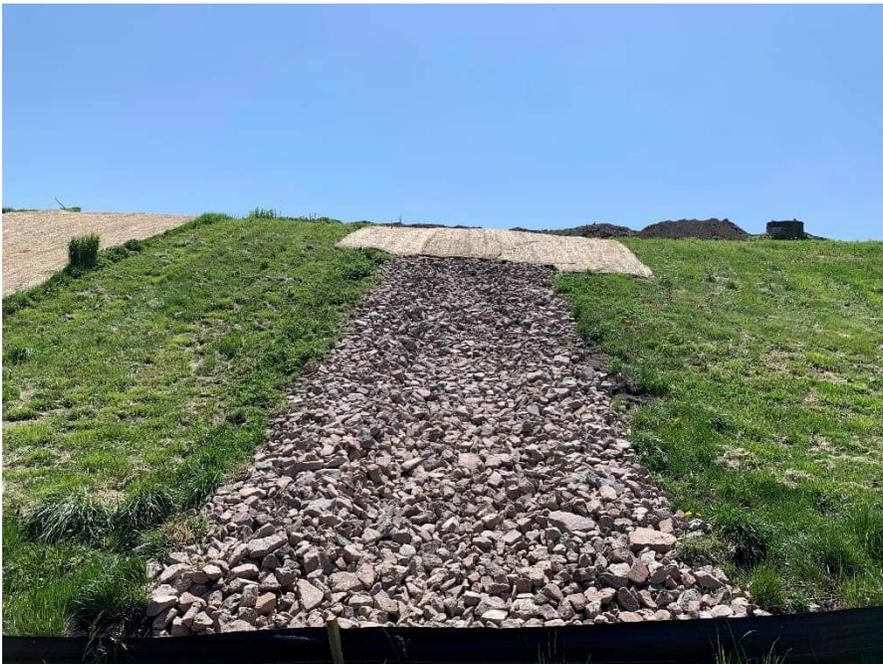
**Photograph 6: Close up of ongoing repairs on the north slope of the landfill.**

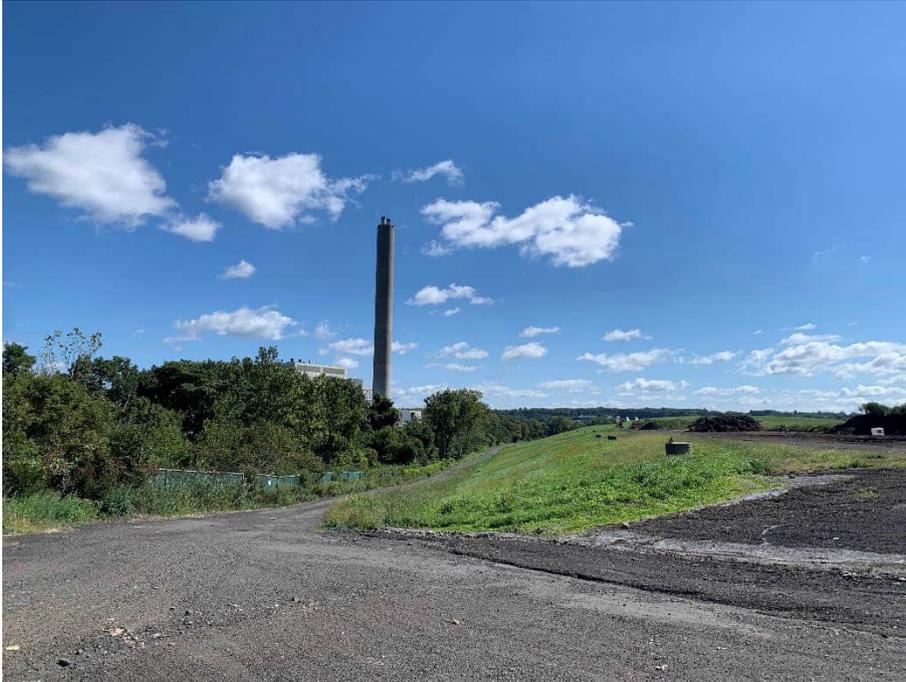
**Photograph 3 – Landfill Access Road (Facing East). Evidence of soil erosion observed to the right of the photograph.**
