**COPPERMINE BROOK DRAINAGE EVALUATION**

**BRISTOL, CONNECTICUT**

August 14, 2008

MMI #2235-19

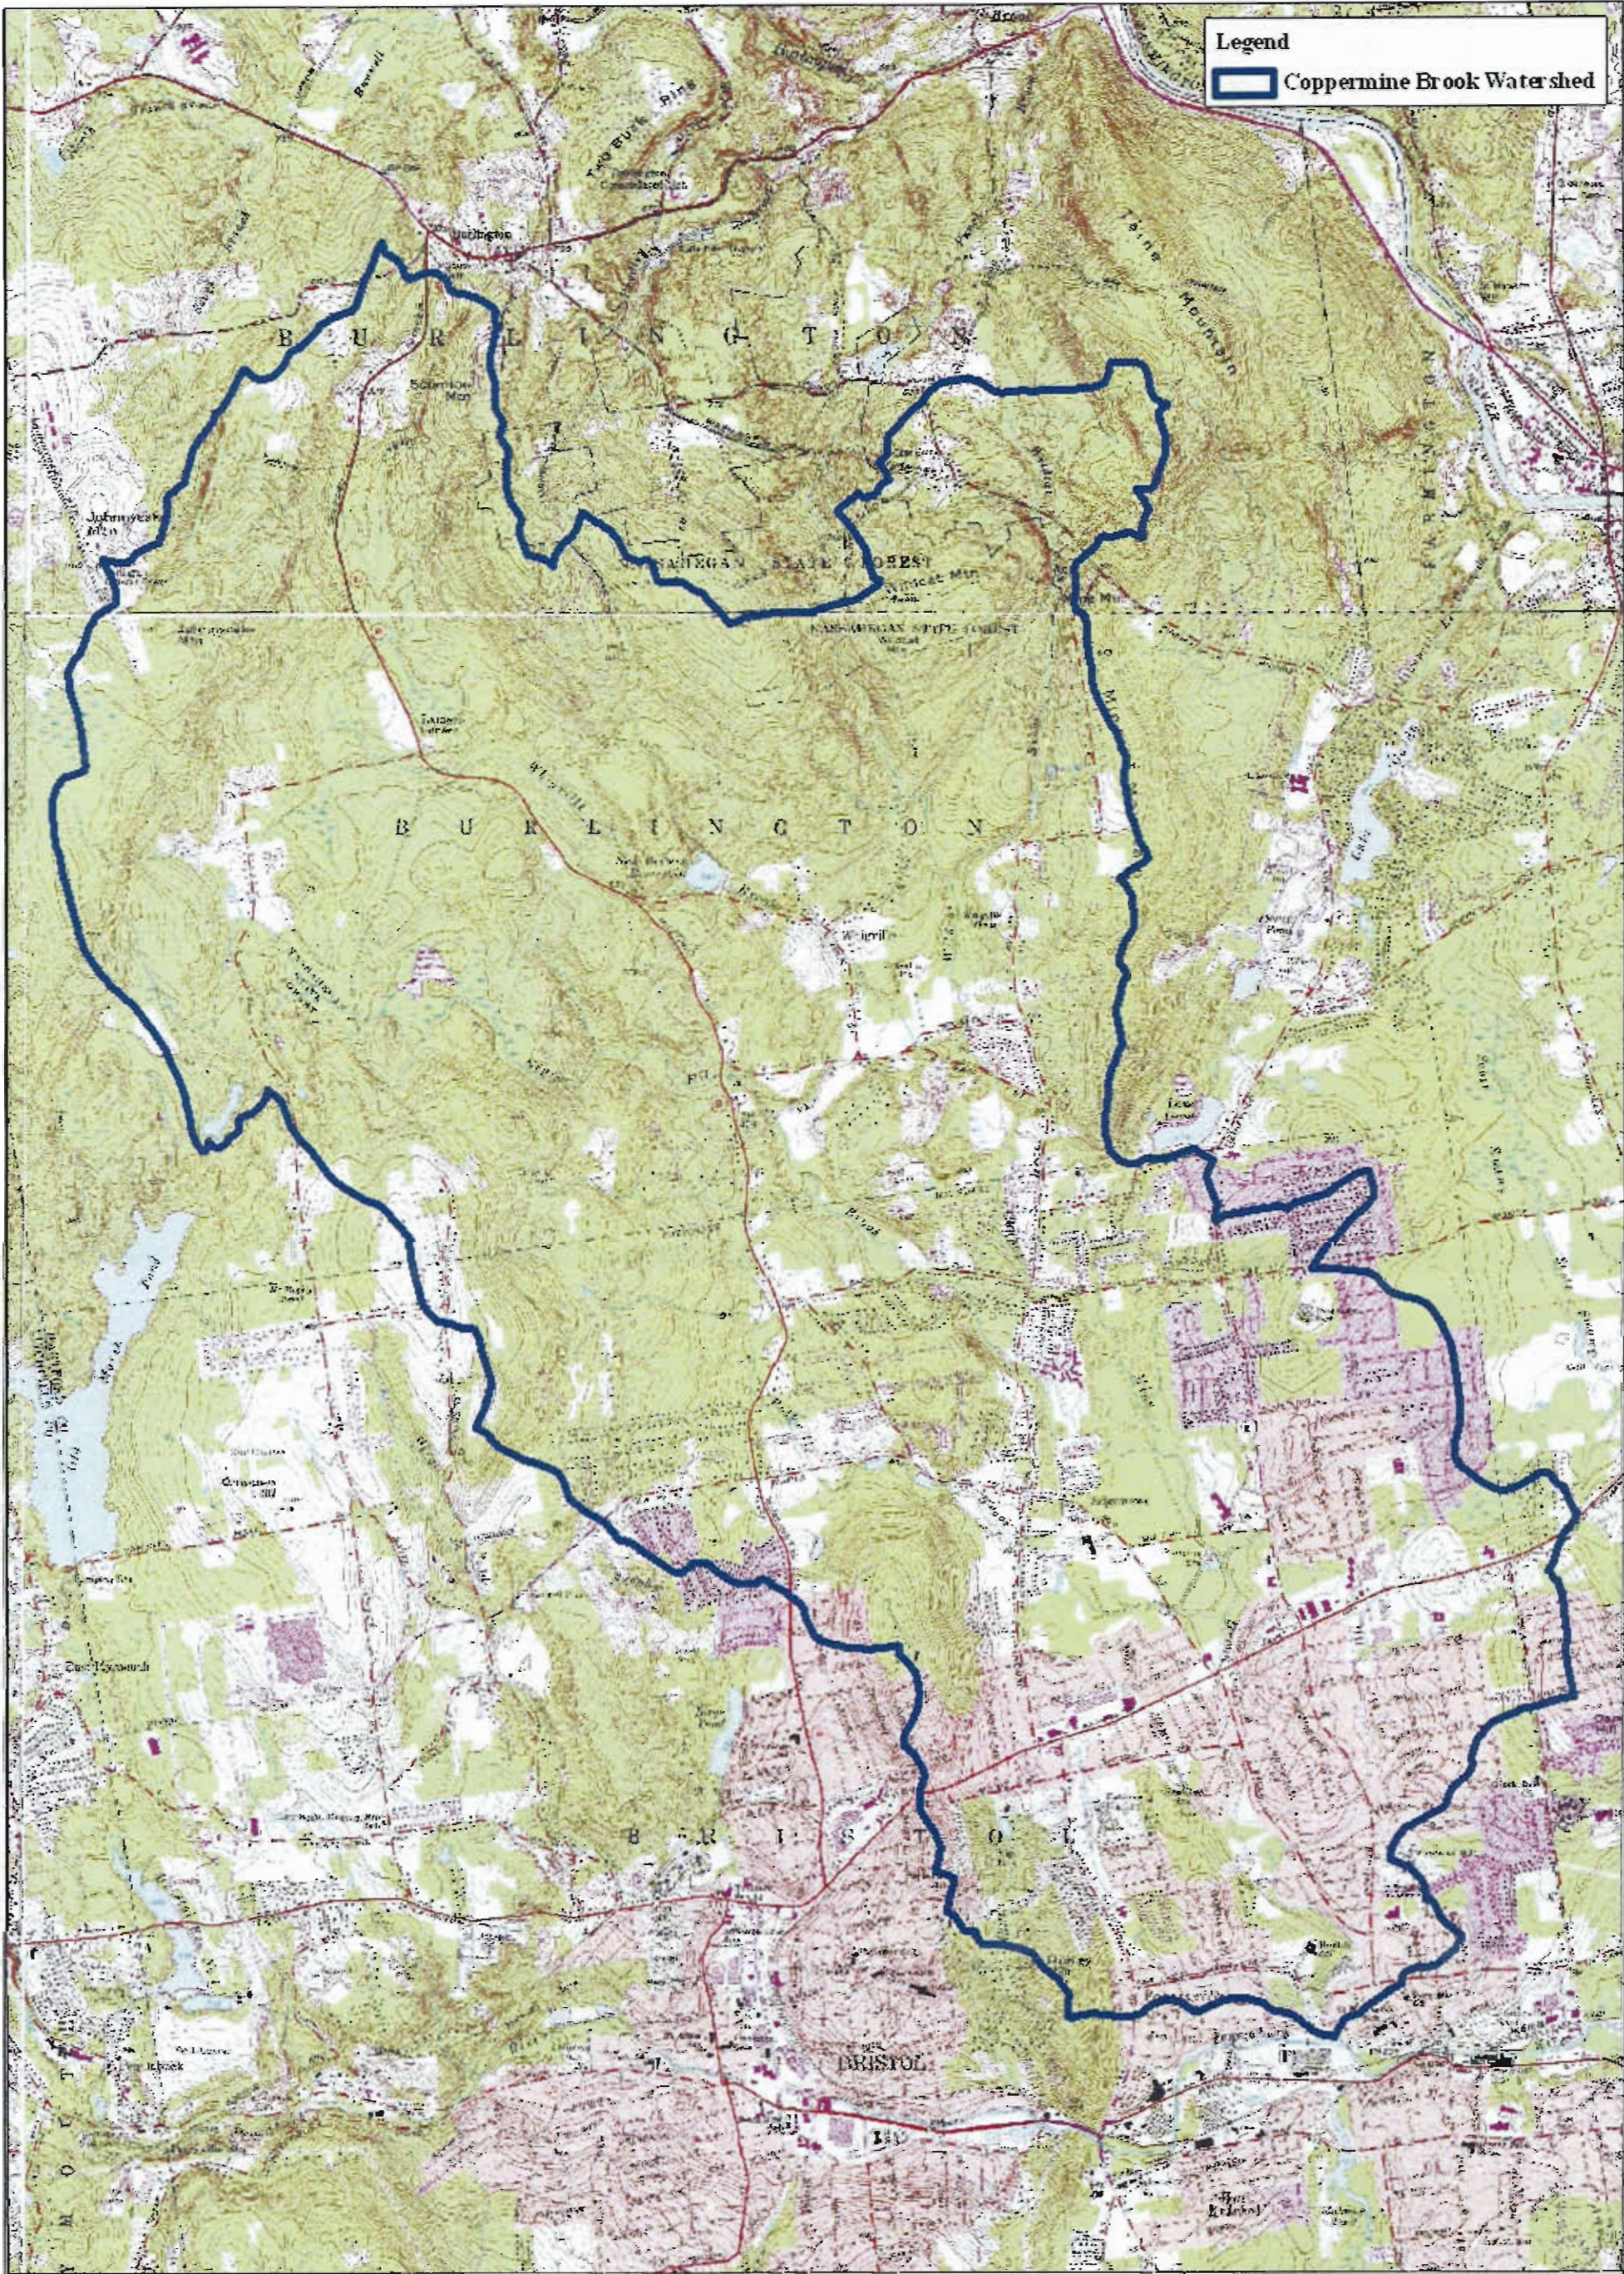
This evaluation is intended to identify the causes of and evaluate potential solutions to reduce flooding along the main stem of Coppermine Brook in the City of Bristol. Hydrologic analyses consider the full watershed area including those areas within Burlington, while hydraulic modeling of the channel extends from the Pequabuck River upstream to the corporate boundary of Bristol and Burlington. Coppermine Brook has a significant watershed area, measuring over 18 square miles (11,520 acres). For comparison, the watershed of the Pequabuck River is approximately 45 square miles in area. Figure 2-1 is a watershed map of Coppermine Brook.

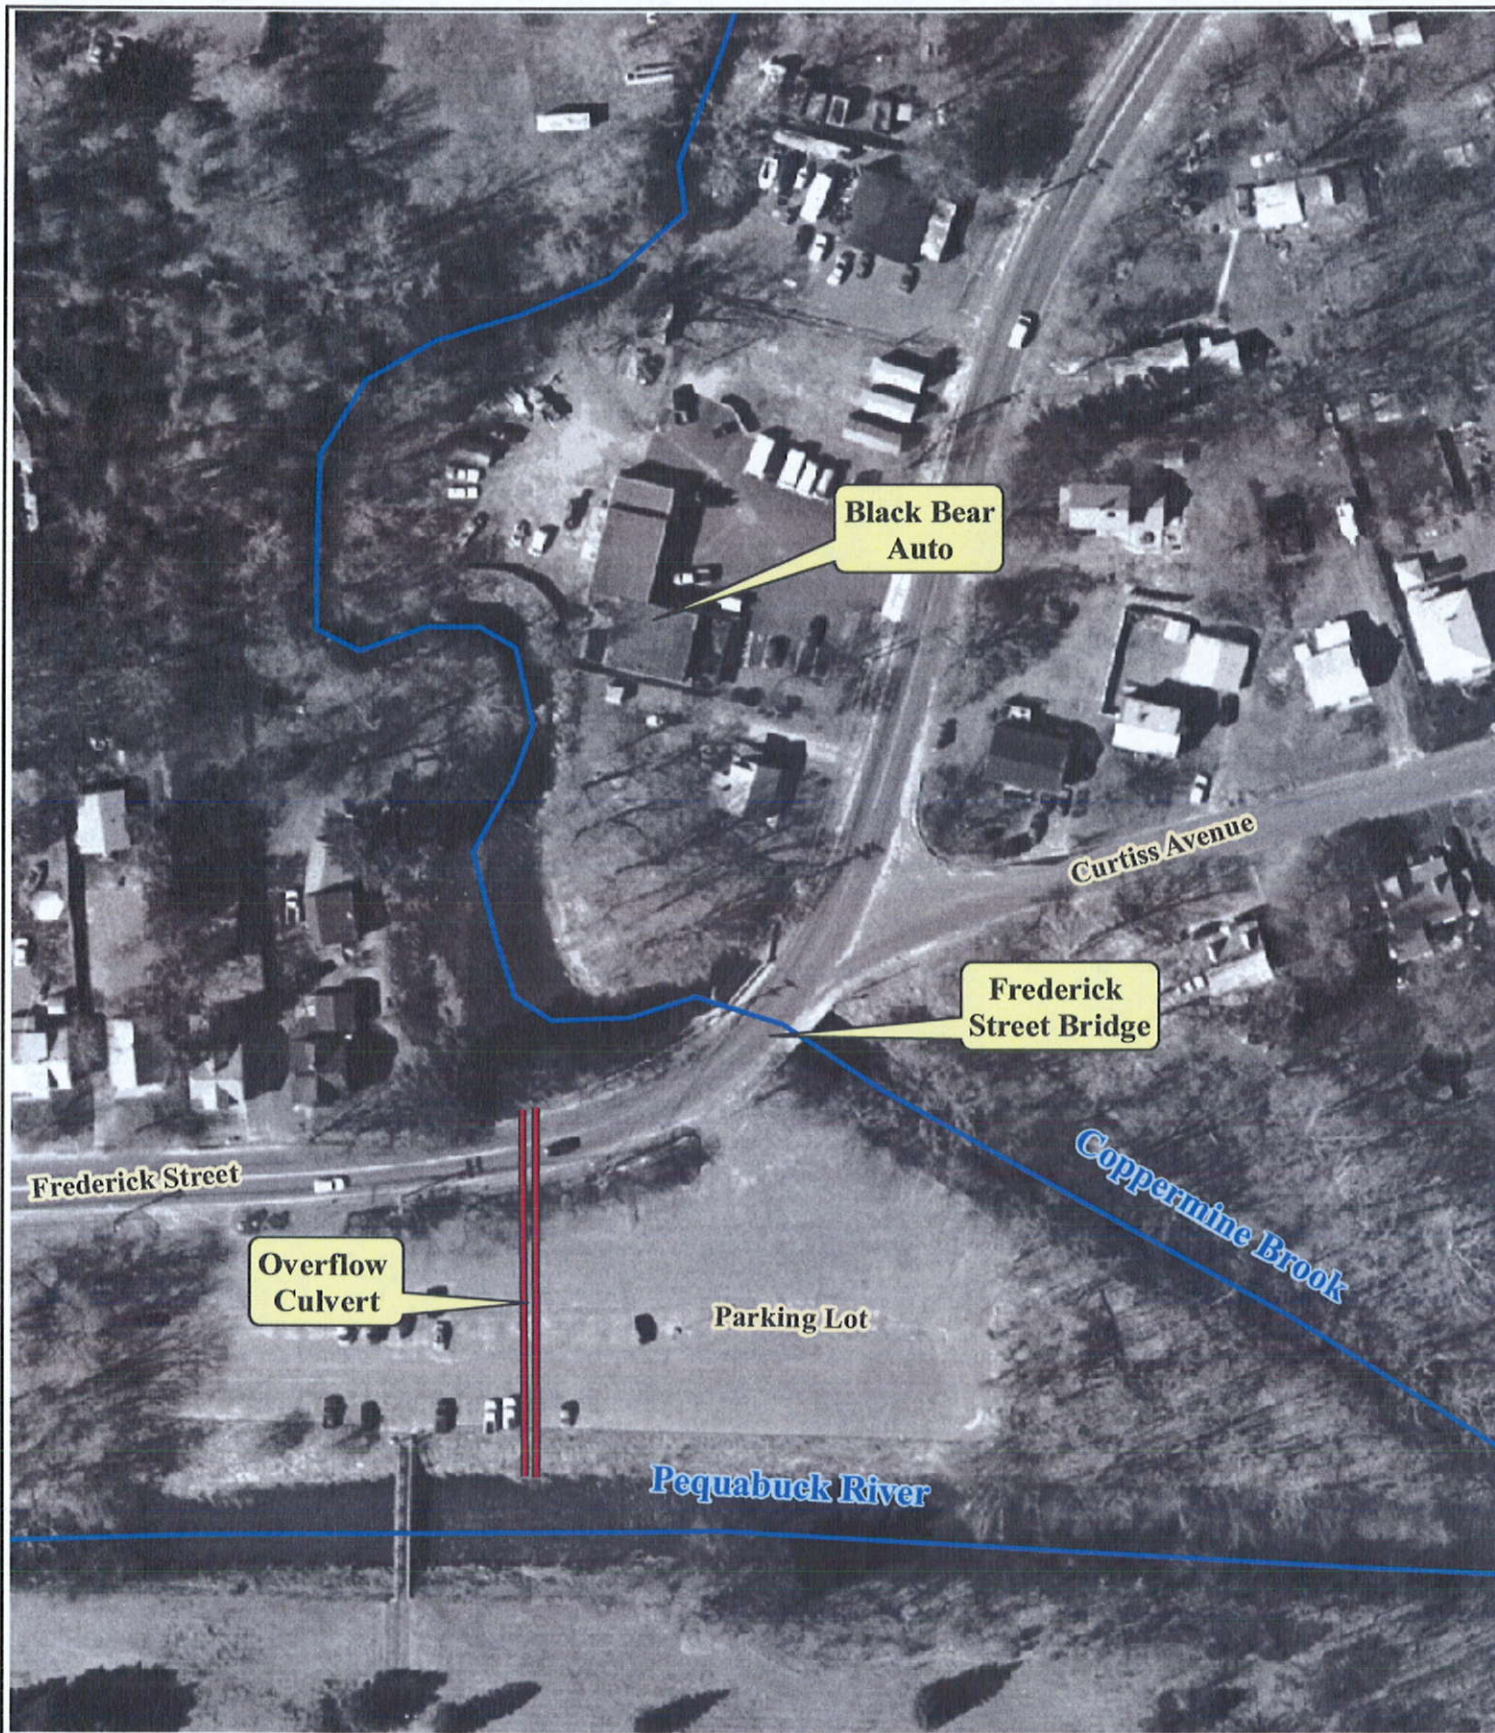
The intention of this alternative is to increase the capacity of the Frederick Street crossing without completing a full bridge replacement. Twin concrete box culverts with dimensions six feet wide by eight feet high are proposed to be installed at the low point of Frederick Street, extending across the parking lot of Theis Steel and discharging in the Pequabuck River upstream of Coppermine Brook. The existing Frederick Street crossing and the channel downstream will be retained. Figure 4-5 is a conceptual sketch of this alternative.

The intent of this culvert is to convey flows during flood events only and, as such, the elevation of these culverts was set 1.15 feet above the current channel bed. During periods of mean flow in the channel, all of the water would continue on its current course.
