# Space Needs Analysis Bristol Municipal Buildings

## Police Department

131 North Main

**Mechanical and Electrical Systems**  
**Existing Conditions Narrative**

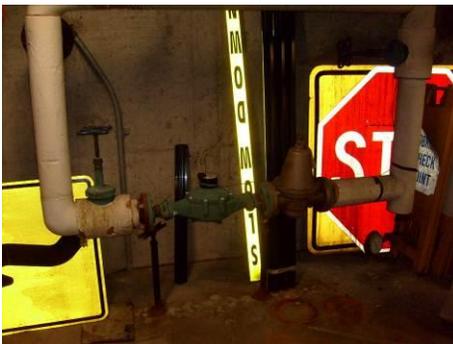
- a. Existing Domestic Water Service: The existing building is currently served by a 4 inch domestic water service. The domestic water service equipment includes a 2 inch water meter, pressure reducing valve, and isolation valves. This water service currently serves all of the building's domestic water needs and has adequate pressure. The water distribution system is original to the building.

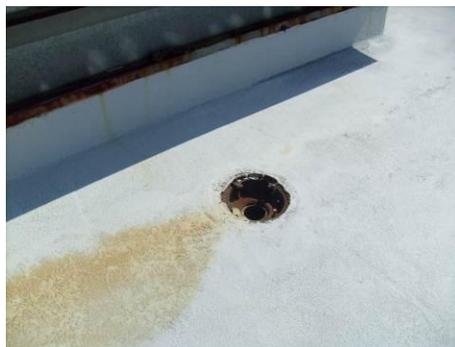
- a. The storm piping is primarily cast iron and drains to the municipal storm water system. Some of the original piping has been replaced with PVC piping. There are no secondary roof drains or strainers on the existing roof drains. Domed strainers should be added to the roof drains to keep debris out of the storm water system.

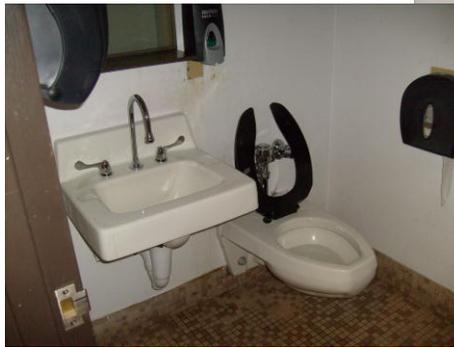
- Water closets are floor or wall mounted; flush valve, vitreous china. Some of the fixtures have been replaced with water conserving fixtures with sensor operated flush valves. The fixtures range from original to the facility in fair condition to new in very good condition. The original fixtures are non-water conserving type and non-ADA compliant.

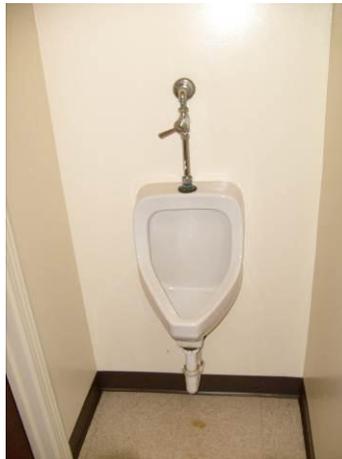
- Urinals are wall hung, vitreous china, with flush valves. The fixtures are original to the facility in fair condition, non-water conserving type and non-ADA compliant.

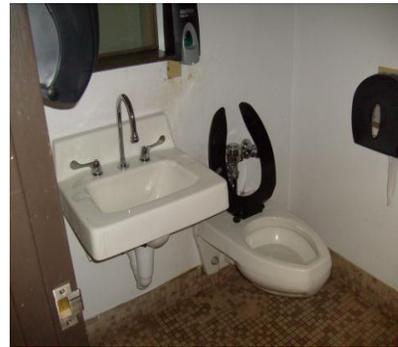
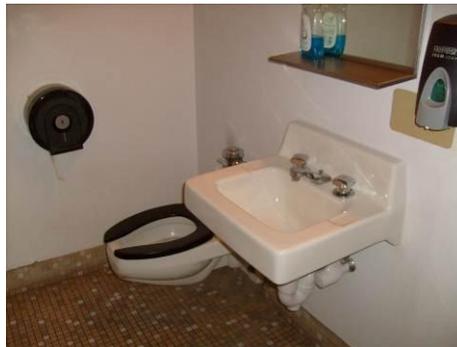
- Lavatories are wall hung vitreous china. Some of the fixtures have been replaced with water conserving fixtures with sensor operated faucets. The original fixtures have two lever handle faucets. The fixtures range from original to the facility in fair condition to new in very good condition. The original fixtures are non-water conserving type and the faucets and drains are non-ADA compliant.

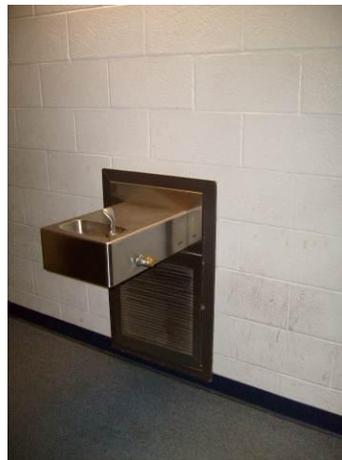
- Drinking fountains are wall mounted stainless steel units in good condition. The amount these units protrude into the path of travel should be reviewed for compliance with current ADA requirements.

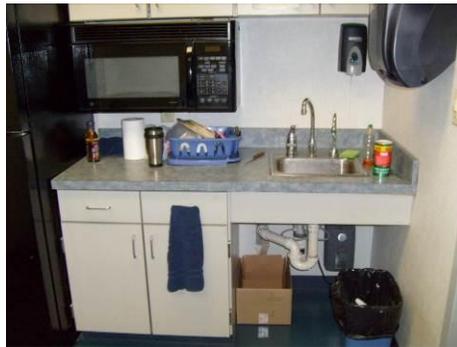
- Stainless steel sink with two lever gooseneck type faucet is present in a work/break room. This sink is ADA compliant and in good condition.

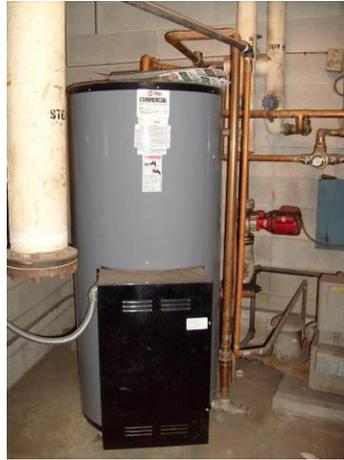
1. The existing domestic hot water system includes a Ruud Model ES120-36-G electric hot water heater. This equipment is in very good condition.

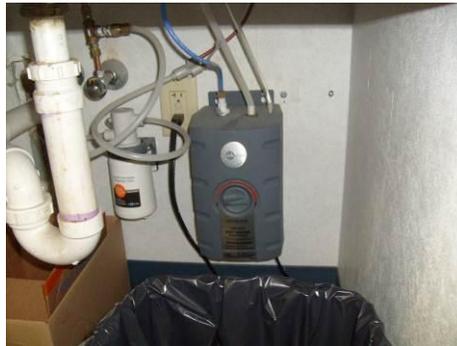
2. A local instantaneous electric water heater has been installed below a sink in a break room in the Police Department. This equipment is in good condition.

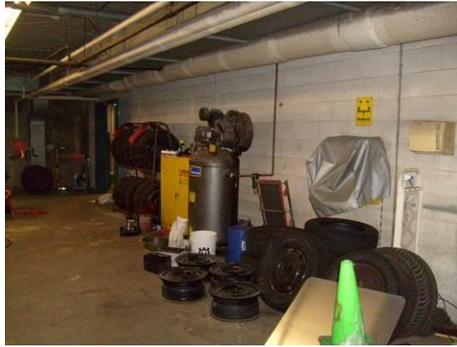
4. There is an air compressor system consisting of a vertical air compressor, piping and outlets located in a maintenance area serving the Police Department. This equipment is in fair condition.

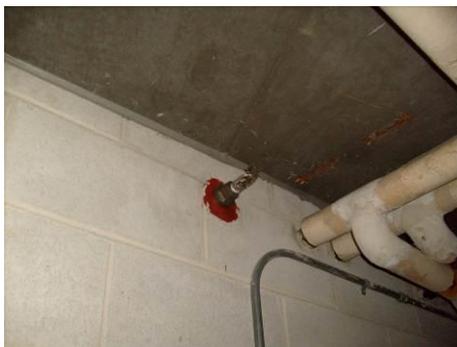
1. The building is served by a 6" fire protection service fed from a fire main in North Main Street. This fire service includes a shut-off valve and Watts Model 774 double check valve. The buildings are protected throughout with a full sprinkler system. There are also standpipes located in the stairs. This backflow preventer equipment has been recently installed and is in good condition. The remainder of the piping and most of the sprinkler heads are original to the building. The sprinkler heads and fire protection piping in the Police Headquarters was modified during the last renovation.

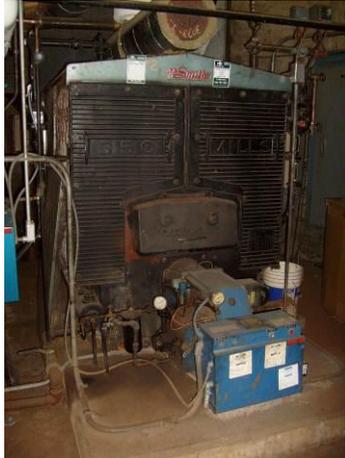
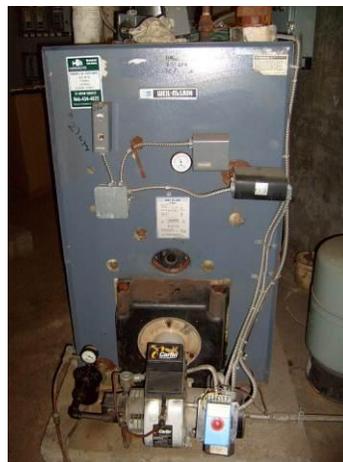
1. The existing building is heated by (2) H.B. Smith 350 Mills, 13-section oil fired steam boilers with Power Flame Model C30-04HBS-10-14 oil burners. There is a separate oil fired boiler that serves the cell block area. It is a Weil McClain Series 78, Model 478 hot water boiler with a Carlin Model 201 CRD-w oil burner. The H.B. Smith boilers, burners, and breeching are original to the building and in poor condition. The Weil McClain equipment is newer and in good condition.

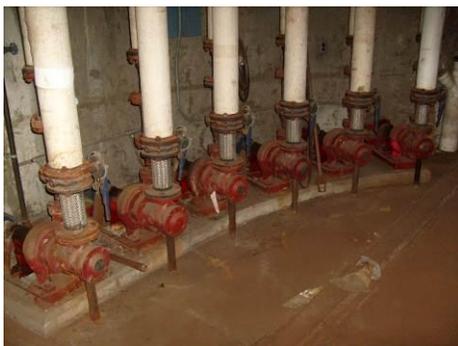
2. The heating plant also includes a condensate receiver, boiler feed system, hot water heat exchanger, condensate receivers, and hot water pumps. All of this equipment is original to the facility and poor condition.

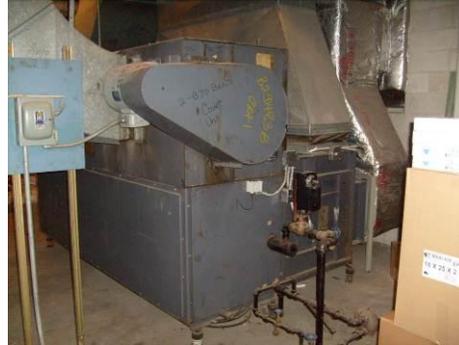
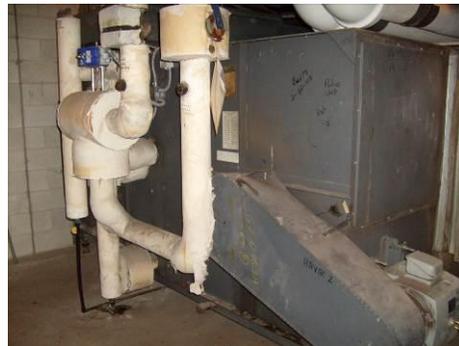
5. The air handling equipment is Trane Climate Changer units that serve as heating and air conditioning units or air conditioning units only. There are also large exhaust/return air fans. This equipment is located in mechanical rooms within the buildings and are original to the facility and in poor condition.

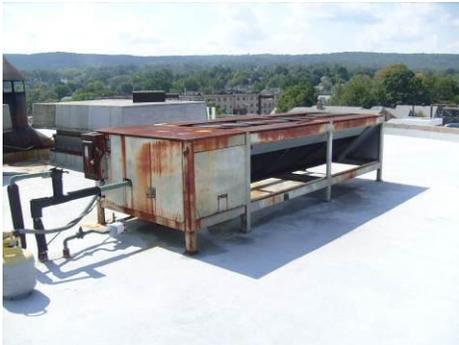
7. The roof mounted equipment consists of exhaust fans, condensing units, etc. This equipment is original to the building and in poor condition.

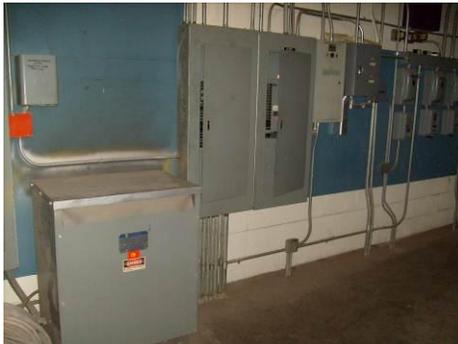
2. There are a number of electrical panels located throughout the facility. Some of these panels are original to the facility and some have been replaced with new. There are a number of panelboards located in storage rooms that have material stored in front of them which is a code violation. In addition, there is one panelboard that has had a significant water leak above it. The conduit, boxes, and panel are showing signs of corrosion. The condition of the panelboards ranges from poor to good.

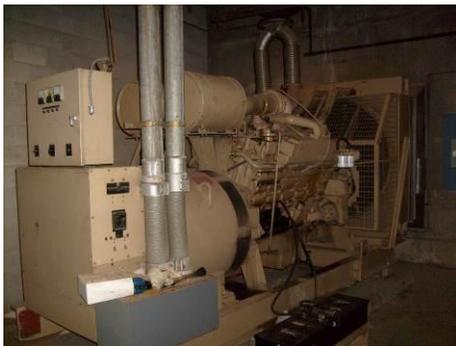
3. The building is served by a Cummings Model 080FDR5057A8W, 410kW, 613kVA diesel generator. The generator is located in the main electrical room. The transfer switch is located in the main electrical switchboard. There is a separate day tank (fuel tank) that pumps fuel oil from the exterior underground tank to feed the emergency generator. To meet current codes, (2) separate automatic transfer switches would be required to separate life safety from other loads in the building. This generator and associated equipment is original to the facility and in good condition.

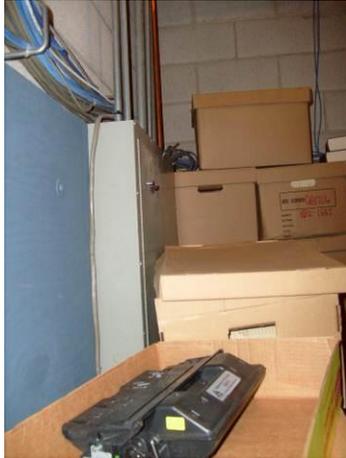
4. In the Main Electrical Room there is a series of (91) wet-cell batteries that serve as back-up power to emergency lighting and other pieces of equipment between when normal utility power is lost and the emergency generator starts. It is controlled by a Dual

Lite Model 120-120-S-791 charger. There is also a number of Dual Lite control panels located throughout the building. Some of these control panels are inaccessible because of items stored in front of them. This equipment is original to the facility and in fair condition. To satisfy current codes, this equipment is required to be in a separate room with adequate ventilation, etc.

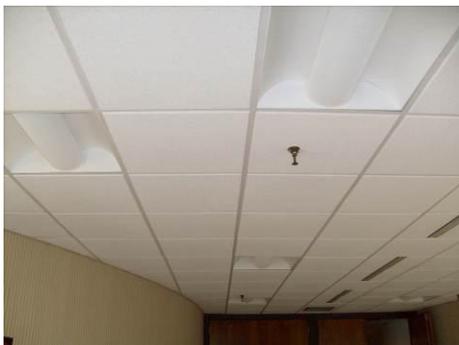
5. The lighting throughout the facility consists of recessed parabolic fixtures, recessed center basket fluorescent fixtures, and recessed mounted acrylic lensed fluorescent fixtures in the office areas, etc. Other fixtures include industrial fluorescent fixtures, wrap around acrylic lensed fixtures, and other miscellaneous fixtures throughout the building. Most of the lighting has been upgraded to newer T8 technology, however, there are other fixtures using older T12 technology or incandescent lamps. The lighting ranges from very good to poor condition.

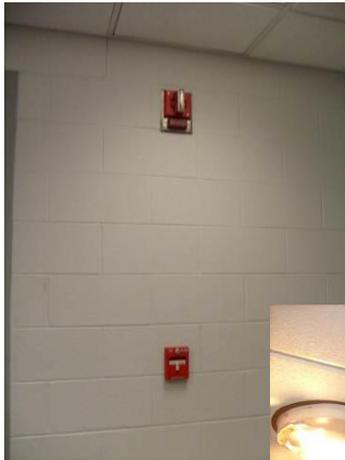
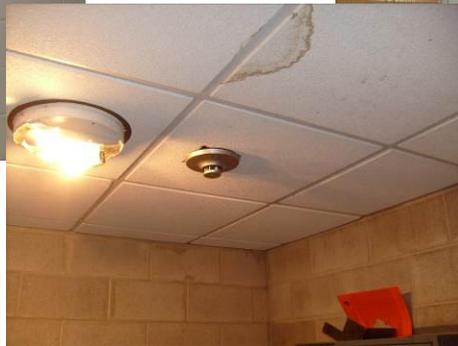
6. The fire alarm system is manufactured by Fire Lite, Model Sensiscan 2000 or Simplex. The system includes control panels, manual pull stations, horn-strobes, and some smoke detectors. This system is in fair condition and portions are non-ADA compliant. Additional audio visual devices should be added to the building as well as upgrading to an addressable ADA-compliant system.

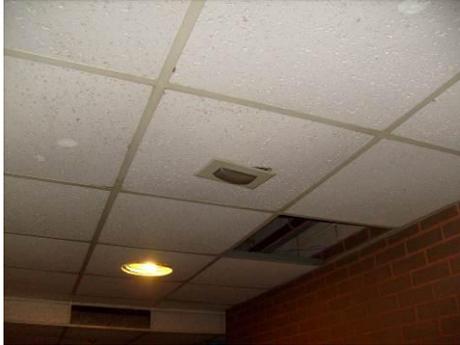
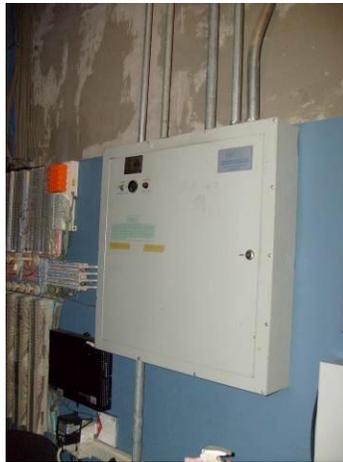
7. The emergency lighting is provided by a Dual Lite Inverter System that includes the inverter, batteries, ceiling mounted remote heads and controls. Although this system is operational, it is in poor condition. Additional lighting fixtures are required to meet current requirements for emergency lighting.
