Space Needs Analysis Bristol Municipal Buildings

Superior Court

131 North Main

Mechanical and Electrical Systems
Existing Conditions Narrative

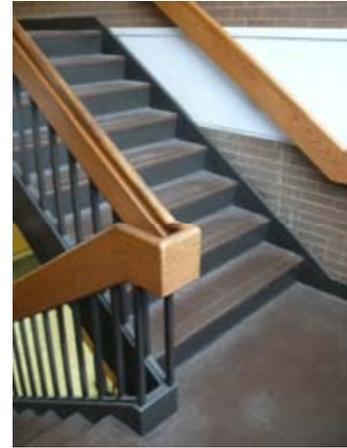
The stairs do not have correct style handrails. Nosings on the stairs project enough to create a catch point that could cause tripping, and should be corrected.
Appropriate room signs are missing from all spaces.

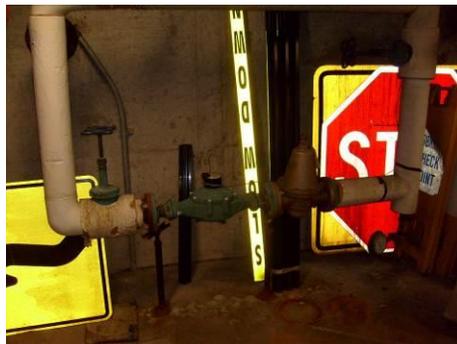
- a. Existing Domestic Water Service: The existing building is currently served by a 4 inch domestic water service. The domestic water service equipment includes a 2 inch water meter, pressure reducing valve, and isolation valves. This water service currently serves all of the building's domestic water needs and has adequate pressure. The water distribution system is original to the building.

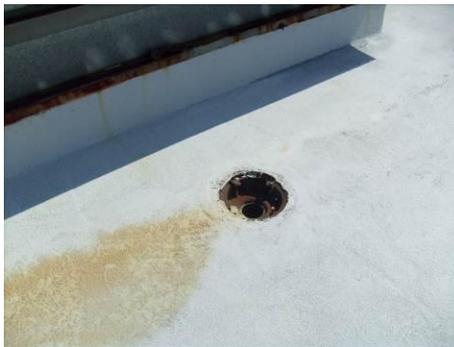
- a. The storm piping is primarily cast iron and drains to the municipal storm water system. Some of the original piping has been replaced with PVC piping. There are no secondary roof drains or strainers on the existing roof drains. Domed strainers should be added to the roof drains to keep debris out of the storm water system.

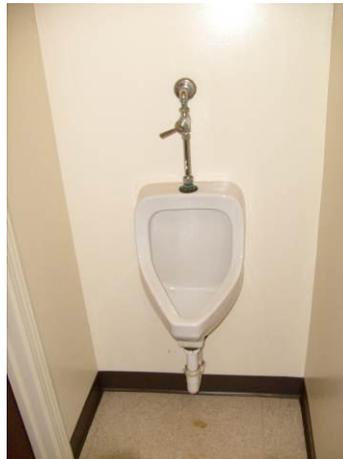
- Urinals are wall hung, vitreous china, with flush valves. The fixtures are original to the facility in fair condition, non-water conserving type and non-ADA compliant.

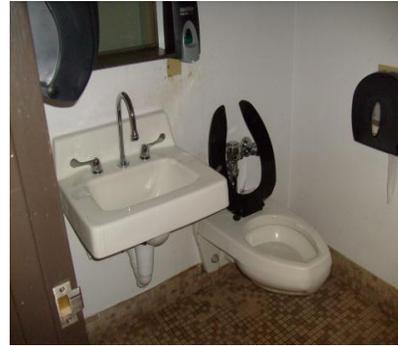
- Lavatories are wall hung vitreous china. Some of the fixtures have been replaced with water conserving fixtures with sensor operated faucets. The original fixtures have two lever handle faucets. The fixtures range from original to the facility in fair condition to new in very good condition. The original fixtures are non-water conserving type and the faucets and drains are non-ADA compliant.

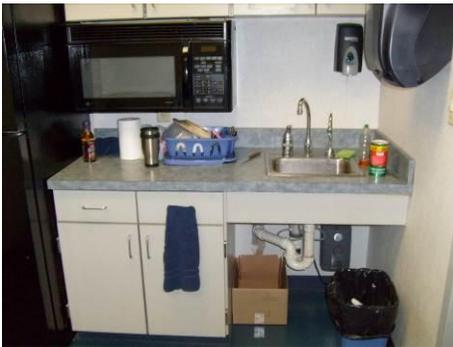
- Stainless steel sink with two lever gooseneck type faucet is present in a work/break room. This sink is ADA compliant and in good condition.

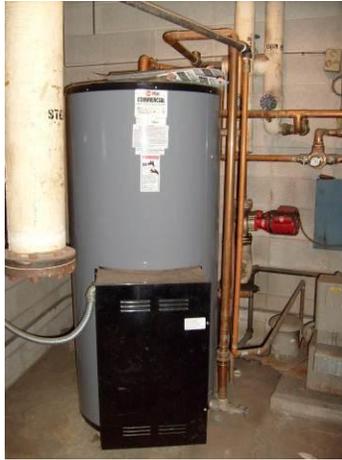
1. The existing domestic hot water system includes a Ruud Model ES120-36-G electric hot water heater. This equipment is in very good condition.

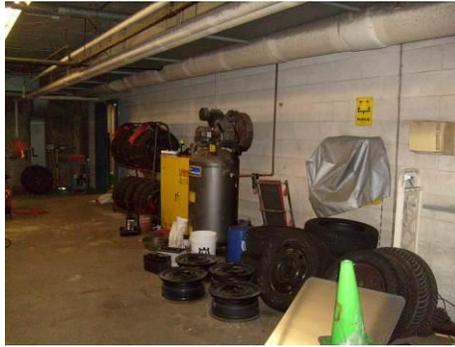
4. There is an air compressor system consisting of a vertical air compressor, piping and outlets located in a maintenance area serving the Police Department. This equipment is in fair condition.

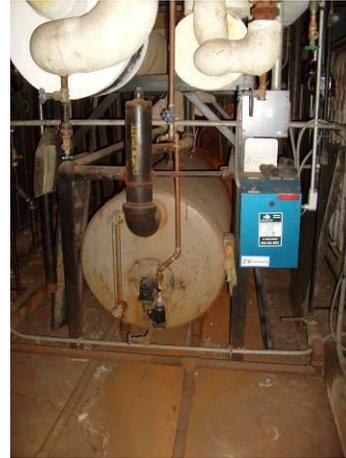
2. The heating plant also includes a condensate receiver, boiler feed system, hot water heat exchanger, condensate receivers, and hot water pumps. All of this equipment is original to the facility and poor condition.

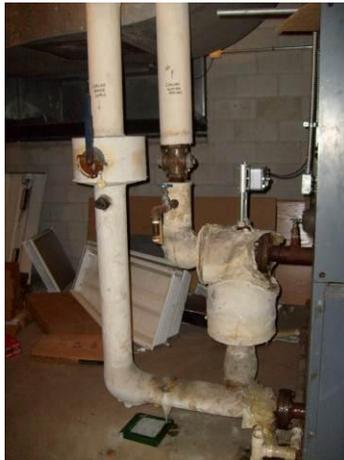
4. The air conditioning system consists of a Trane Series R Centravac chiller, Model RTHB150FMCOONW0000UNN3LF2LF00QU chiller installed in 1996. This chiller is shared between the two buildings. The chiller is in good condition. There is a cooling tower mounted on the roof of the parking facility that is in very poor condition. This piece of equipment has significant corrosion problems and the maintenance staff has made many attempts to repair this sump which has allowed this unit to operate.

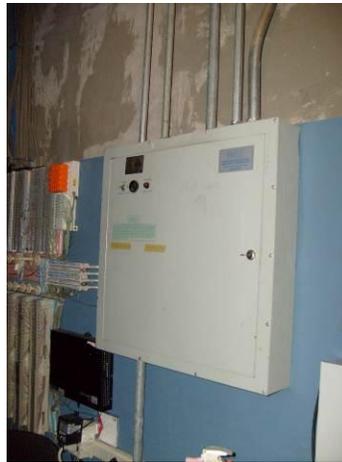
7. The emergency lighting is provided by a Dual Lite Inverter System that includes the inverter, batteries, ceiling mounted remote heads and controls. Although this system is operational, it is in poor condition. Additional lighting fixtures are required to meet current requirements for emergency lighting.

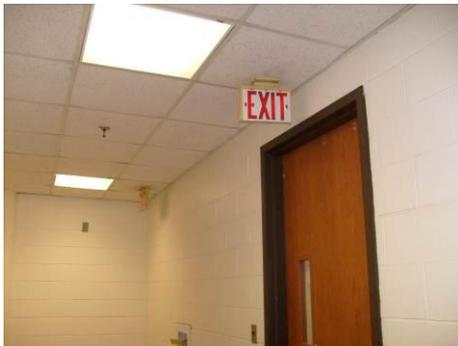
8. The exit signs consist of fluorescent exit signs with batteries. This equipment is in fair condition. Additional exit signs are required to meet current requirements for exit signs.
