Space Needs Analysis Bristol Municipal Buildings

Fire Department Headquarters

111 North Main

Current Facility

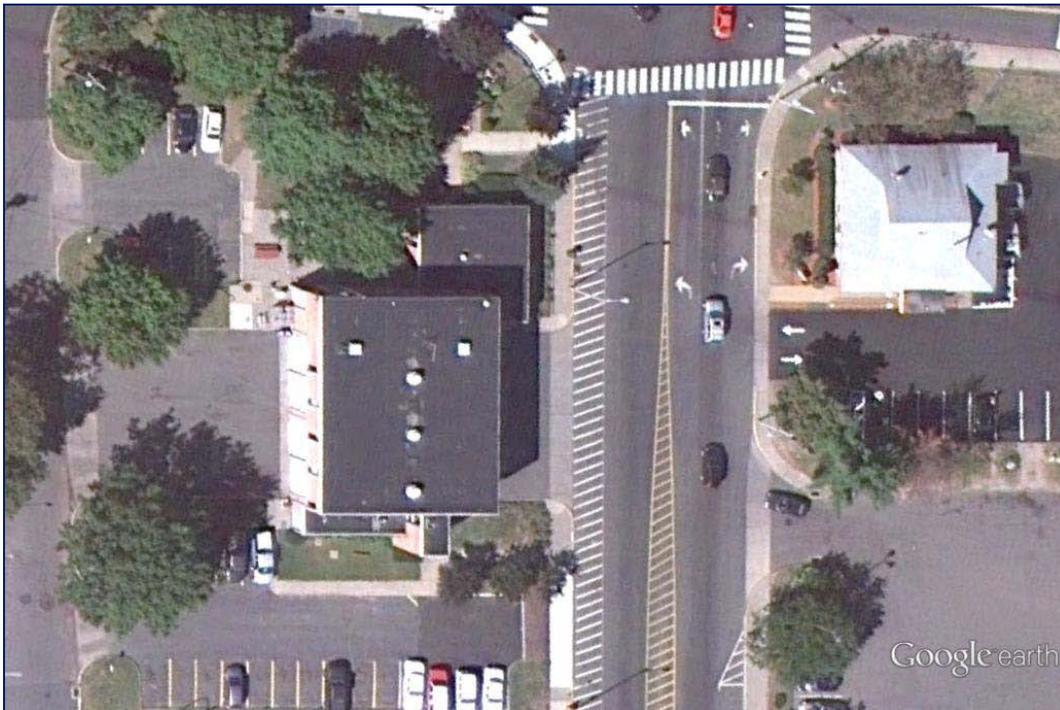
There are currently 27 parking spaces for the building on site with on street parking available. Redesigning the parking would result in 32 spaces. If an expansion occurs on the site the number could be 29 but this assumes the expansion will include an extra bay for fire equipment current located outside.
