Space Needs Analysis Bristol Municipal Buildings

**Clara T. O'Connell
Elementary School
(Formerly Park Street E.S.)**
120 Park Street

Current Facility

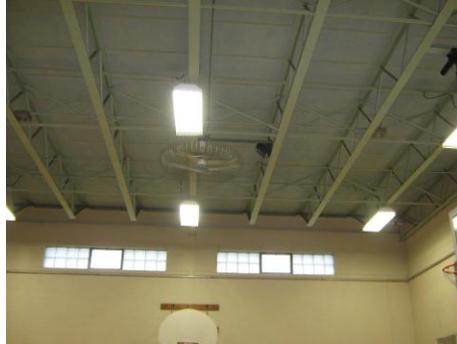
mechanical space has been exposed to flooding and is in poor condition.

6. The Gymnasium has paddle fans installed to help with air circulation in the space.

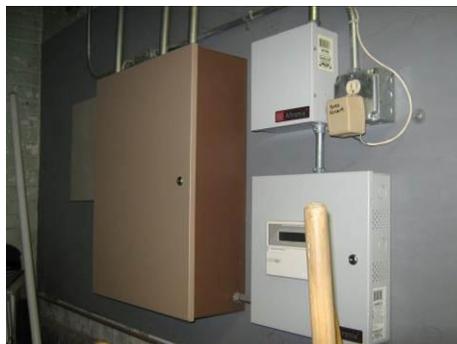
9. There is a security system at the building manufactured by Altronix. There are door contacts and cameras, as well as other equipment. This system is in good condition.
