Space Needs Analysis Bristol Municipal Buildings

Memorial Boulevard School

70 Memorial Boulevard

Current Facility

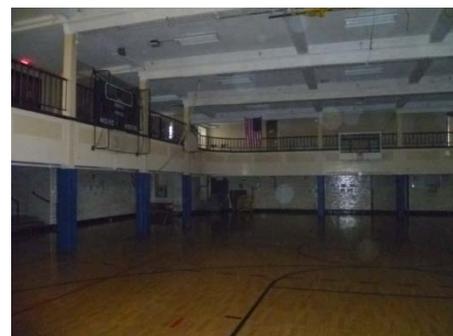
The gymnasium floor is lower than all surrounding spaces making accessibility difficult. One solution might be to raise the floor of the gym to the level of the surrounding areas but headroom is not adequate. If the space is not to be used as a gym then a perimeter corridor at the high level could be created with wheel chair lifts in two locations. One of the lifts would have an additional stop to serve the weight room level (Previous pool level). Waivers should be sought to retain the existing narrow stairs, with winders, between the gym and the weight room.

Non-accessible toilet rooms and showers could be eliminated and smaller accessible toilets could be provided for the new occupancy.

In the weight room a ramp needs to be constructed to the former shower area.

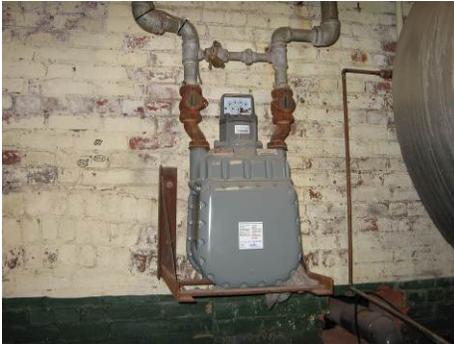
- a. Existing Natural Gas Service: The existing natural gas service enters the building in the tunnels below the school adjacent to the fire protection water service. There is an indoor meter assembly with shut-off valves. This natural gas service feeds the kitchen appliances and the emergency generator.

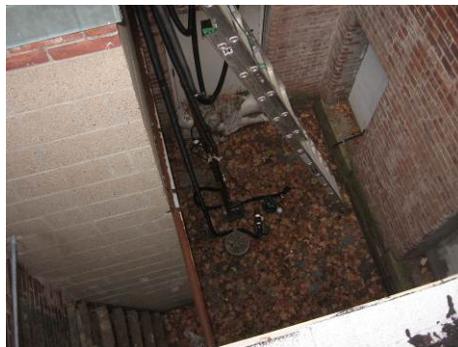
- b. Problems with the storm drainage system were reported in the areas of the light wells. There are storm drains in each light well. In the recent storms, storm water has come up thru these storm drains flooding these light wells causing water to enter the building. Maintenance staff has added sump pumps to help pump out the water at these locations.

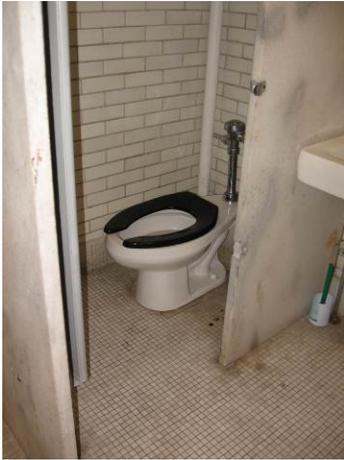
- Water closets are wall and floor mounted vitreous china with flush valves. Most of the fixtures are original to the facility in fair condition. The fixtures are non-water conserving type and non-ADA compliant.

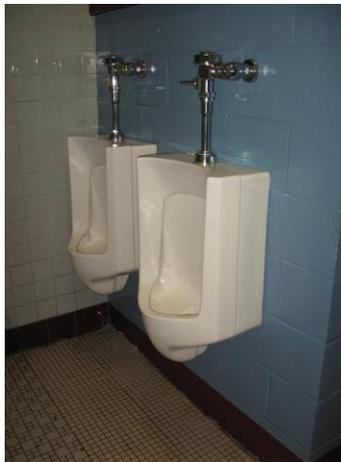
- Urinals are wall hung, vitreous china, with flush valves. The fixtures are original to the facility in fair condition. The original fixtures are non-water conserving type and non-ADA compliant.

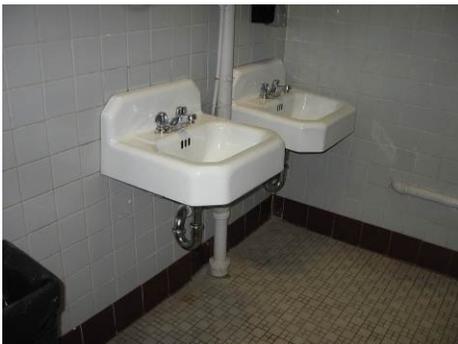
- Lavatories are wall hung vitreous china with two twist or metered style faucets. The fixtures are mainly original to the facility in fair condition. The fixtures are non-water conserving type and the faucets and drains are non-ADA compliant.

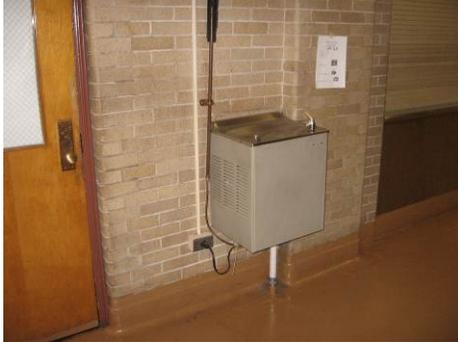
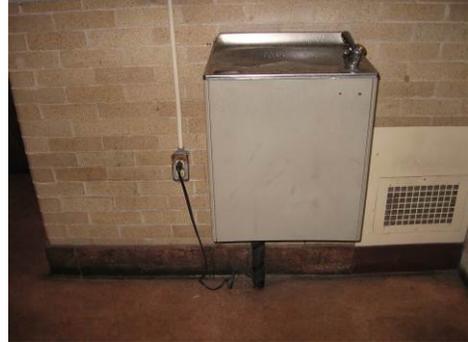
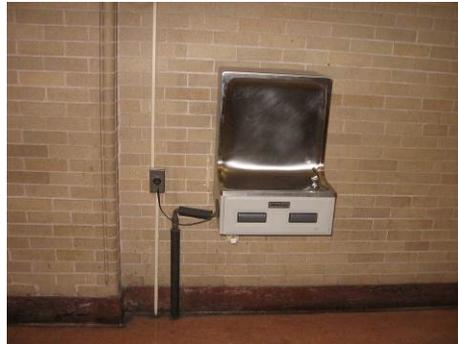
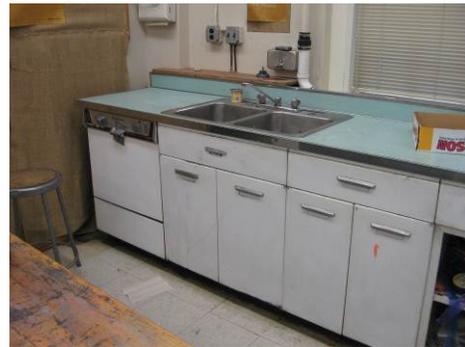
- Drinking fountains are wall mounted stainless steel units in fair condition. One of the single units may be ADA compliant with respect to controls however there are other units that do not have ADA compliant controls. In addition, the receptacles serving these drinking fountains are not GFCI protected.
- Stainless steel sinks with two lever type faucets are present in various areas of the

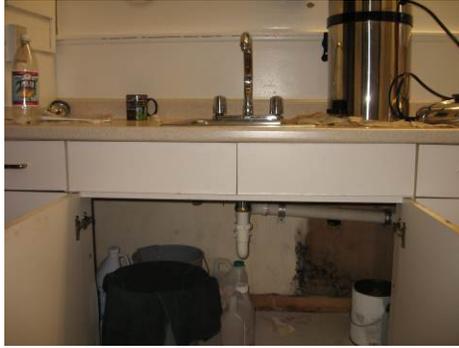
facility. These sinks are non-ADA compliant and in fair condition.

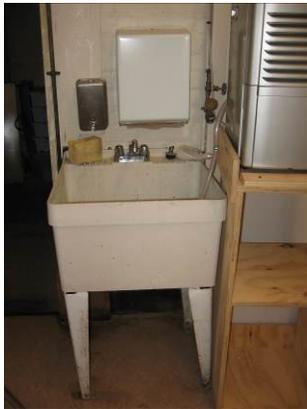
- Classroom sinks consist of pedestal mounted fiberglass units with two-lever faucets. These sinks are in good condition but are not ADA compliant. In the Tech Lab, there is also a wash fountain that is in fair condition.

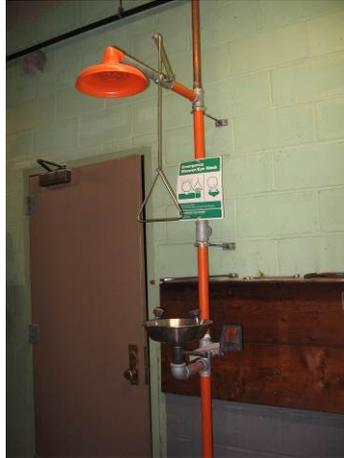
- The Kitchen has a local grease interceptor manufactured by Big Dipper. This equipment is in good condition. There is an original grease trap that once served a dishwashing area that has been abandoned.
- There are emergency eyewash and shower unit located in the lower level that was used when the pool was operational. This unit is in good condition.

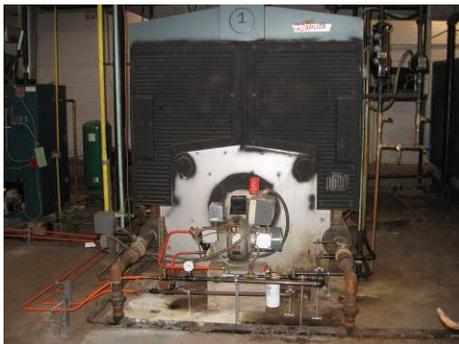
1. The existing building is heated by (2) HB Smith Mills 450 21-section cast iron steam boilers with Carlin oil burners. The boilers and burners were installed in 1974 and are in poor condition. The boilers are showing signs of leaks at the individual sections.

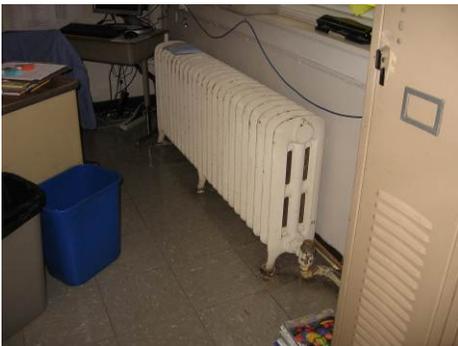
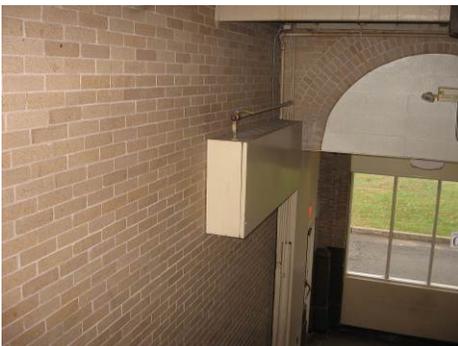
4. The present heating system also includes cabinet unit heaters, ceiling mounted unit heaters, cast iron radiators and baseboard radiation. Most of the heating units within the stairwells have been disconnected. Most of this equipment is original to the building and is in fair to

very poor condition.

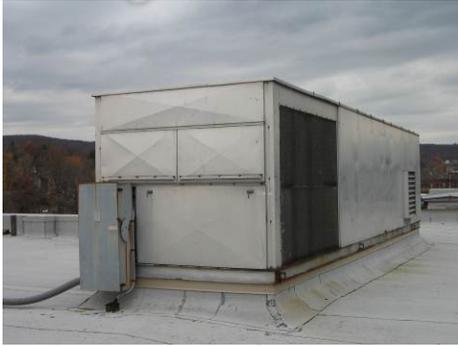
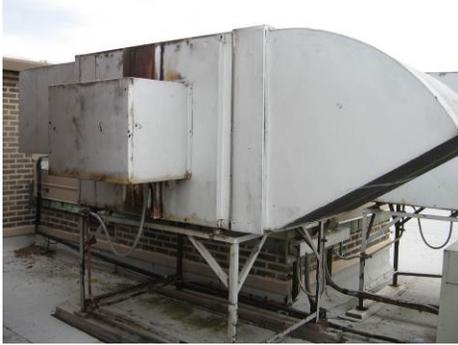
5. There are a number of air handling units that serve various areas of the building. There are (3) Seasons 4 air handling units for heat only. Only (1) of these units is operational. There is

a Herman Nelson Audi-Vent unit that serves the Gymnasium. This unit is in poor condition. There is an Aaon air handling unit that is approximately (10) years old that is not operational. The unit that serves the Auditorium is approximately (20) years old and is used for cooling only. The air handling unit that serves the Administration area is located above the ceiling in the area with a remote condensing unit. The remote condensing unit is over (20) years old and in poor condition.

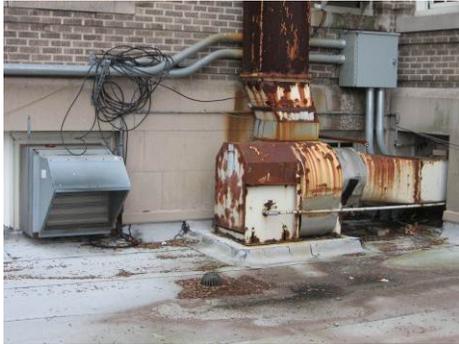
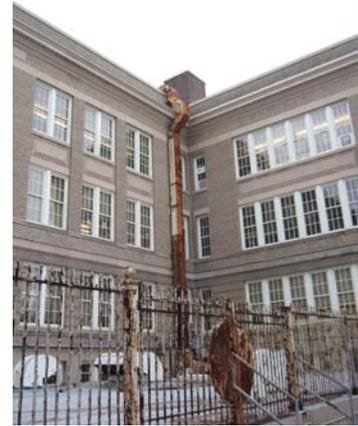
10. The Kitchen includes an exhaust fan that serves the hood over the cooking equipment. The duct work from the hood runs exposed in the Kitchen out to a roof mounted exhaust fan. The ductwork then extends up the side of the building to a discharge on the roof. The exhaust fan and ductwork serving this hood does not comply with current NFPA 96 requirements for a grease-laden exhaust system.

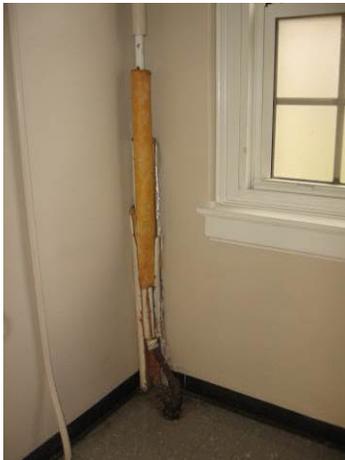
11. The steam piping consists of iron supply and condensate return piping. Some of this piping is missing insulation or the insulation has failed and replaced.

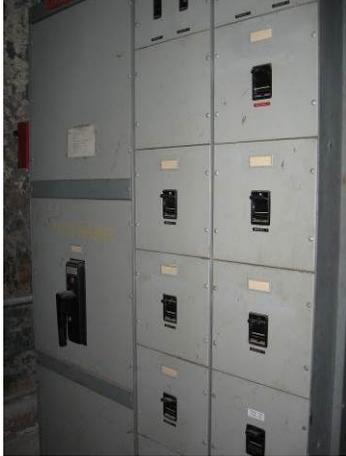
1. The building is served by a single electrical service rated 1600amperes, 208Y/120volts, 3-phase, 4-wire. This service equipment consists of a 1600amp main disconnect switch, distribution section and metering per utility company requirements. The service equipment is approximately 30 years old and in fair condition.

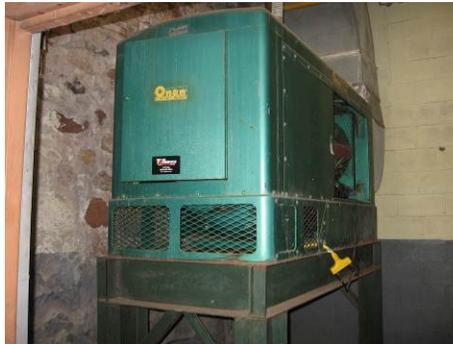
2. There is a 45kW natural gas fired emergency generator located off the boiler room. This equipment is manufactured by Onan. This generator serves the boiler room equipment only. This equipment is in poor condition.

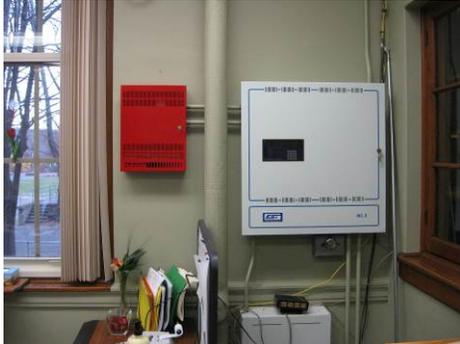
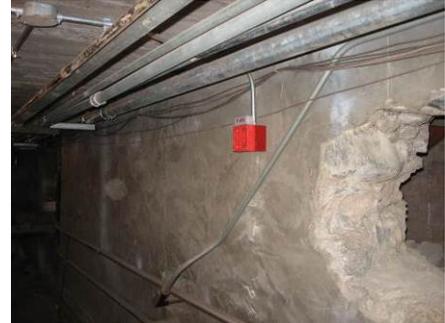
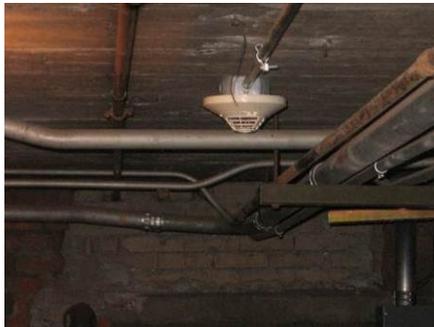
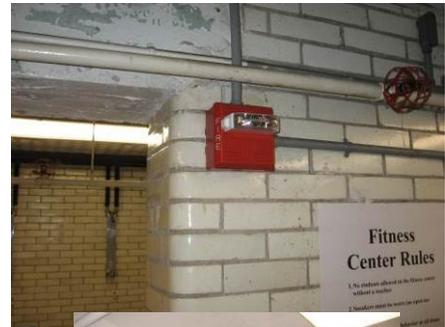
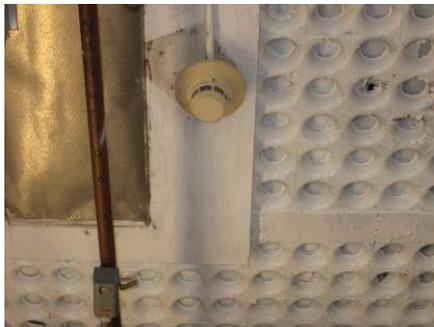
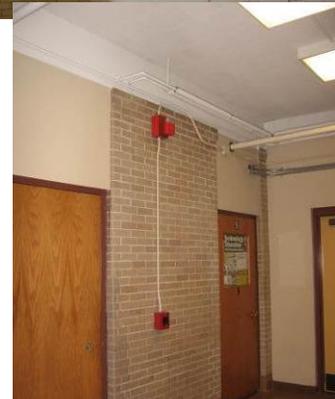
- The fire alarm system is manufactured by EST. The system includes manual pull stations, horn strobes, and ceiling mounted smoke detectors, and graphic annunciator. Some of the horn/strobe units are non-ADA compliant. This system is in fair condition. Additional audio visual devices as well as replacing the non-ADA compliant devices should be added to the building.

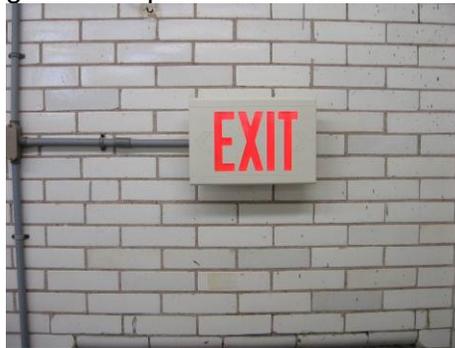
7. The exit signs consist of fluorescent exit signs with batteries. This equipment is in good condition. Additional exit signs are required to meet current requirements for exit signs.

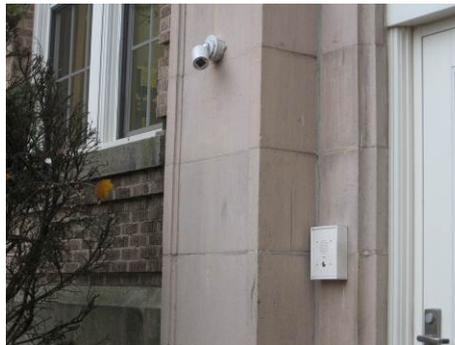
8. The facility does have a limited security system consisting of a control panel, limited cameras, door contacts, motion detectors, and a door entry intercom with camera. This system is in fair condition. Additional devices may be considered for enhanced security.

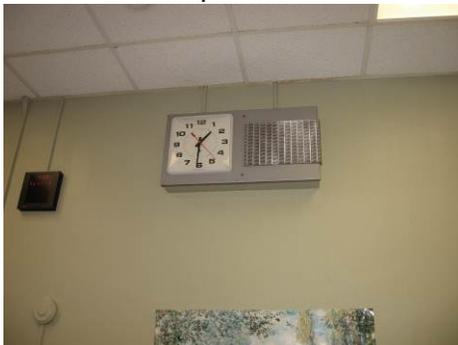
9. The existing PA system consists of wall or ceiling mounted speakers. It is manufactured by Bogen, Model Multicom 2000. The head end equipment is located in the main office. This head end equipment is in very good condition. Some of the speakers show signs of damage and should be replaced.

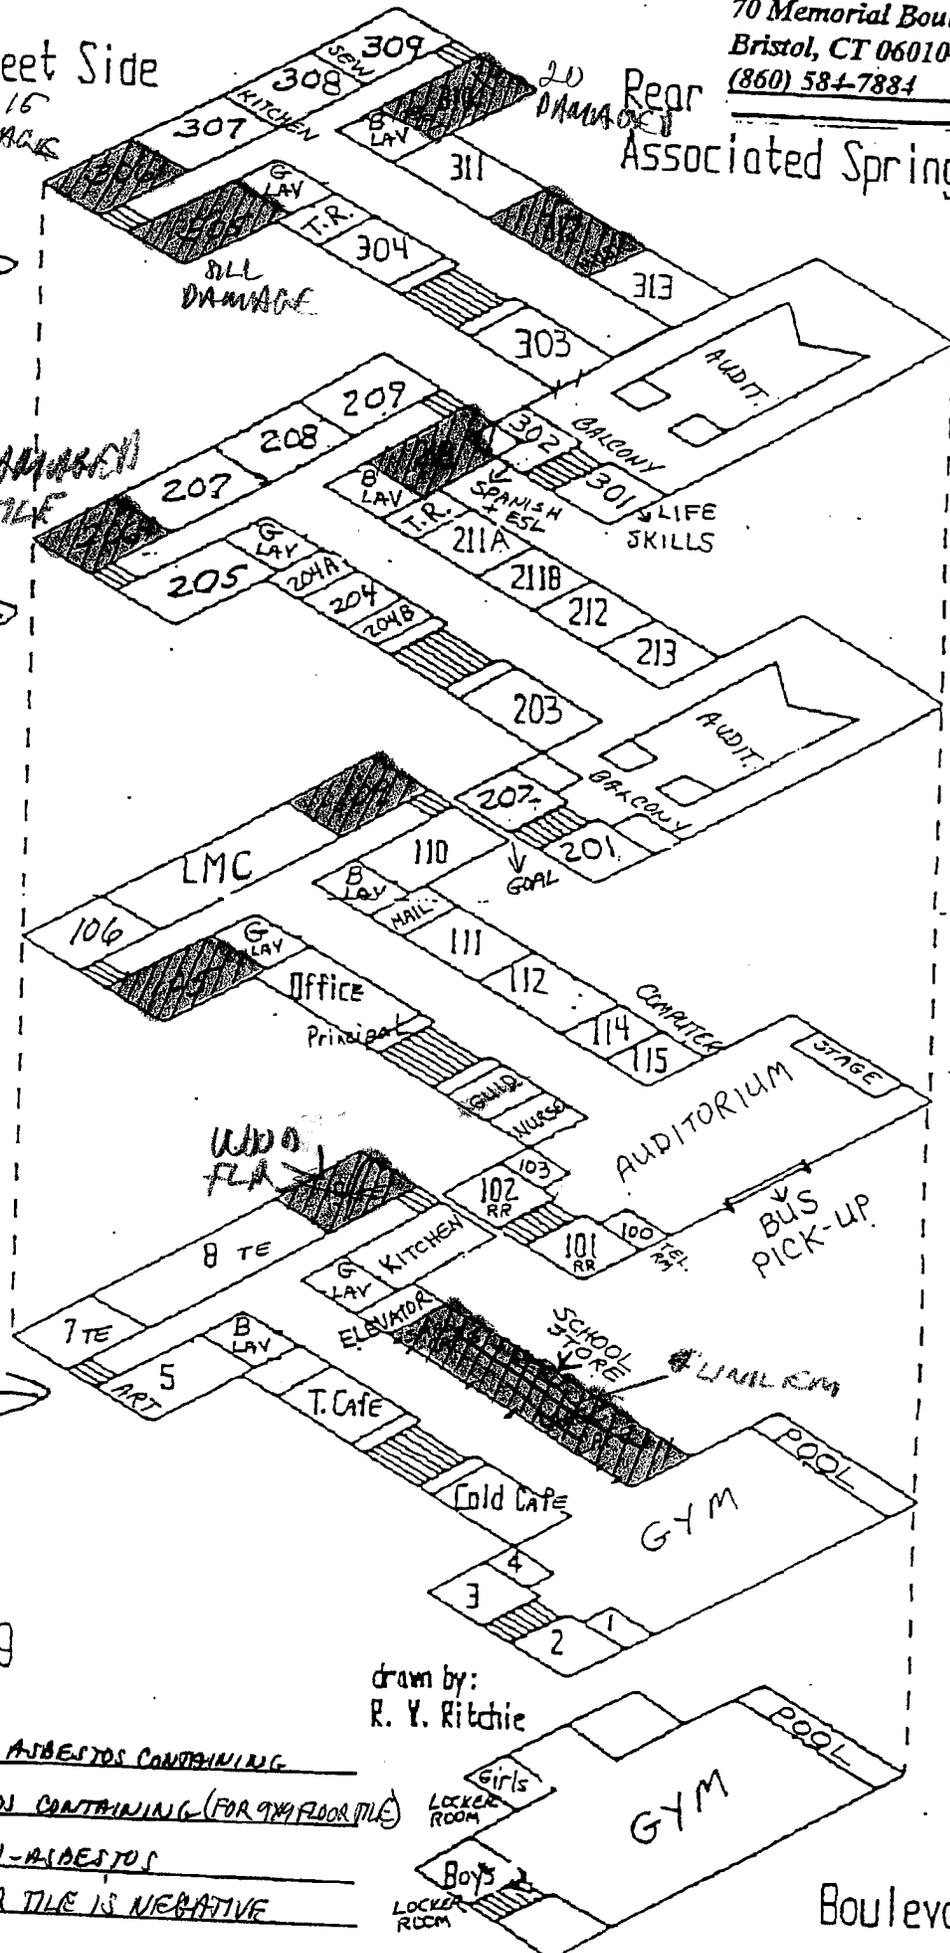
- ALL 9x9 FLOOR TILE IS ASBESTOS CONTAINING
- ALL MASTIC IS ASBESTOS CONTAINING (FOR 9x9 FLOOR TILE)
- ALL LINOLEUM IS NON-ASBESTOS
- MASTIC FOR 12x12 FLOOR TILE IS NEGATIVE
