Storm Water Control Trust
Annual Inspection Report

March 2023

RE: Storm Water Detention Pond Report – March 3, 2023

DETENTION POND INVENTORY REPORT

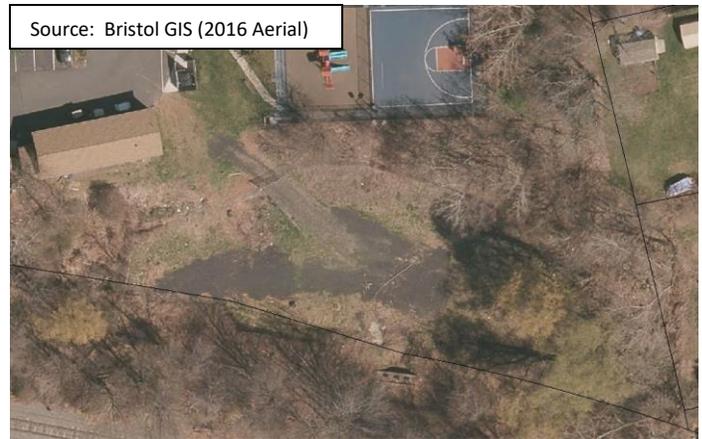
Huntington Woods

<u>Structures</u>	<u>Vegetation</u>	<u>Site Conditions</u>
Manholes _____ A	Grass _____ V	Animals _____ N/O
Catch basin _____ NA	Trees _____ G	Debris _____ M
Pipes _____ (1)	Brush _____ (4)	Erosion _____ (1)
Inlet condition _____ (1)		Sink holes _____ N/O
Outlet structure _____ A		Trespassing _____ N/O
Pond condition _____ A		Other _____ (3)
Fences _____ (2)

- (1) Pipe replacement is scheduled to be replaced (CIP funded), include rip rap check dam and spreader swale to eliminate short circuiting and grading and removal of sediments and excessive millings DPW scheduled to start work in March. Pipe and structure ordered.
- (2) Vegetation control needed, Fence post at west inlet is undermined
- (3) Invasives control needed

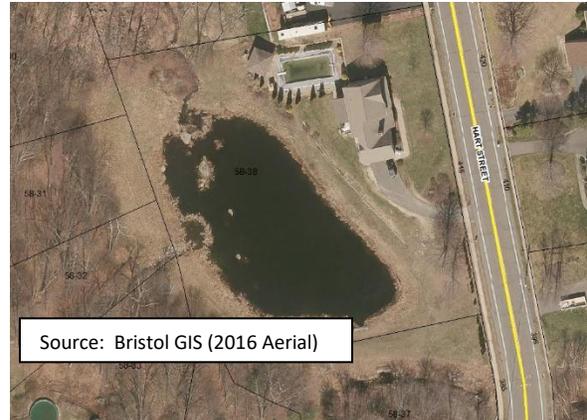
Eastview Farms (Hart Street)

<u>Structures</u>	<u>Vegetation</u>	<u>Site Conditions</u>
Pipes _____ G	Grass _____ V	Animals _____ N/O
Inlet condition _____ (1)	Trees _____ A	Debris _____ M(4)
Outfall condition _____ (2)	Brush _____ na	Erosion _____ M(5)
Overflow _____ A		Sink holes _____ N/O
Fences _____ (3)		Trespassing _____ N/O
Dam _____ A		Other _____ NA
Course pool (n) _____ A		
Course pool (w) _____ A

- (1) Clear vegetation at outlet
- (2) Clear vegetation from fence

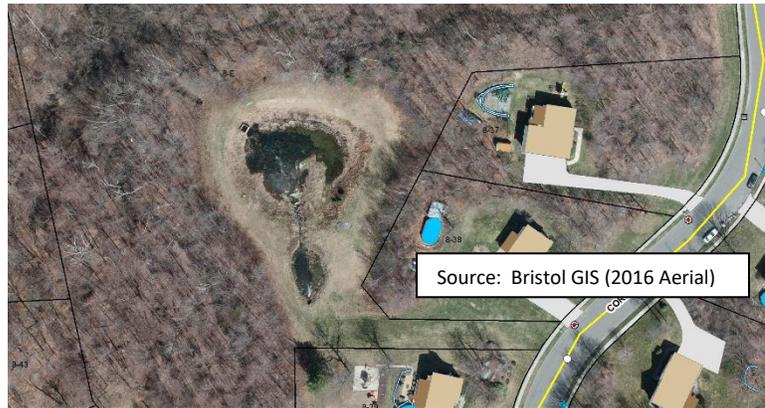
Rockwood Estates Basin A/North (Brandon Run Pond)

<u>Structures</u>	<u>Vegetation</u>	<u>Site Conditions</u>
Catch basin _____ Vac	Grass _____ (3)	Animals _____ N/O
Inlet condition _____ A	Trees _____ (4)	Debris _____ A
Outfall condition _____ G	Brush _____ A	Erosion _____ N/O
Overflow _____ A		Sink holes _____ N/O
Fences _____ N/A		Trespassing _____ N/O
Pond condition _____ (2)(3)		Other _____ (5)

(1) Clean minor litter (2) Keep trees trimmed along Brandon access path

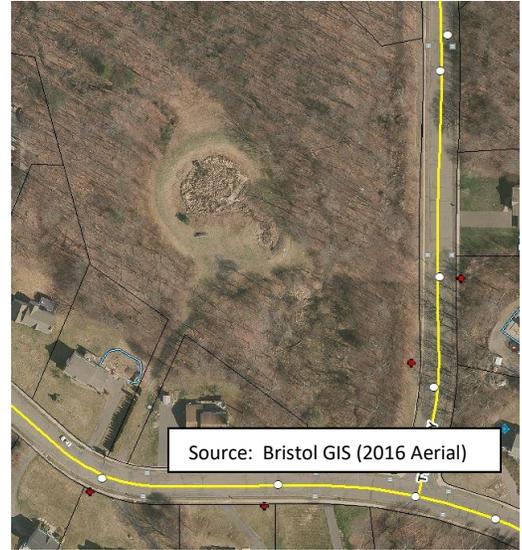
<u>Structures</u>	<u>Vegetation</u>	<u>Site Conditions</u>
Catch basin _____ A	Grass _____ A	Animals _____ (4)
Inlet condition ___(1)(2)(3)	Trees _____ A	Debris _____ N/O
Outfall condition ____ (5)	Brush _____ A	Erosion _____ N/O
Overflow _____ G		Sink holes _____ N/O
Fences _____ N/A		Trespassing _____ N/O
Course pool (n) _____ A		Other _____ (5)

- (1) Remove fore bay sediments and vegetation
- (2) Repair erosion at access drive
- (3) Clean minor pond litter
- (4) Keep outley structure clear of debris

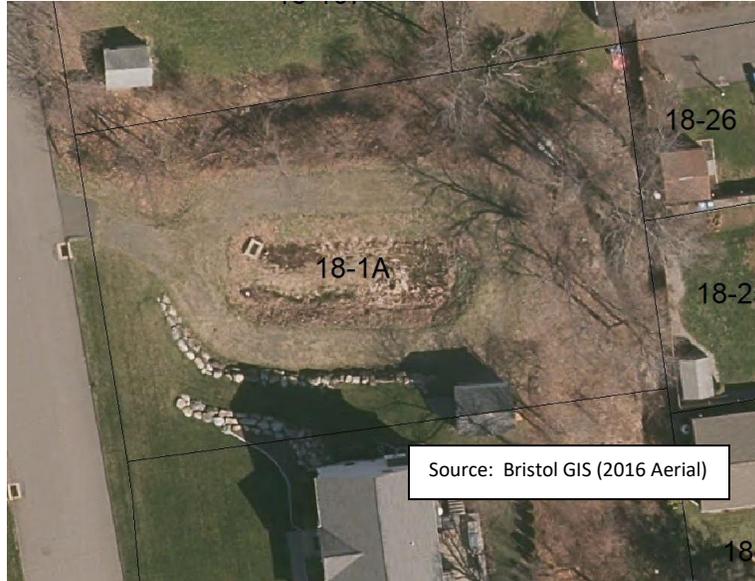
<u>Structures</u>	<u>Vegetation</u>	<u>Site Conditions</u>
Catch basin _____ Vac	Grass _____ V	Animals _____ N/O
Inlet Condition _____ e	Trees _____ V	Debris _____ N/O
Pond condition _____ (1)	Brush _____ AV	Erosion _____ N/O
Outfall Condition _____ (2)		Sink holes _____ N/O
Overflow _____ A		Trespassing _____ N/O
Berms _____ A		Other _____ None

(1) Invasives/vegetation removal needed (2) Repair/replace control structure top,
